Pedestrian Field Trip #4: Museum School

Address: 211 Maple St, San Diego, CA 92103

Date: April 11th, 2025

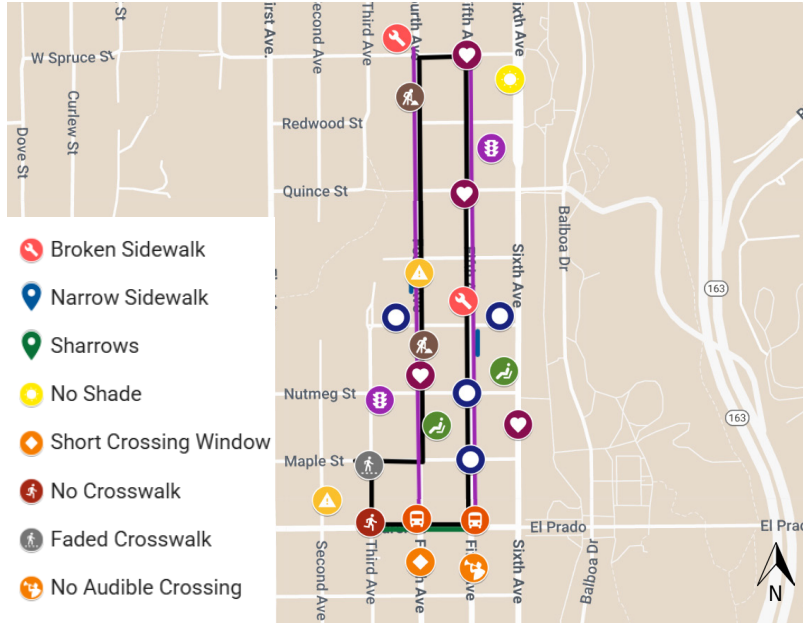
FIGURE 2. MUSEUM SCHOOL AUDIT RESULTS

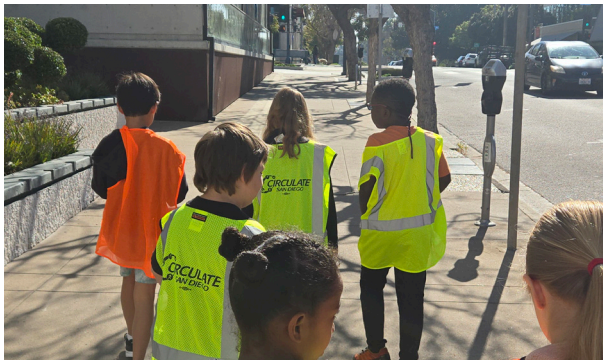
FIGURE 3: ON LAUREL STREET, THE GROUP ENJOYED THE WIDE CLEAR SIDEWALKS AND SHADE TREES DURING THE AUDIT.

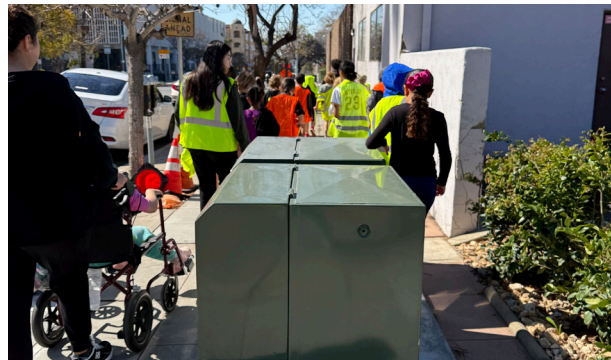
FIGURE 4: ON FOURTH AVENUE, PARTICIPANTS NAVIGATED AROUND OBSTRUCTIONS IN THE MIDDLE OF THE SIDEWALK.

The pedestrian field trip took place around the Museum School (see Figure 2). As the group traversed Laurel Street and Fifth Avenue, they enjoyed the shade trees, wide sidewalks, high-visibility crosswalks, and dedicated bike infrastructure (see Figure 3). However, some areas featured broken or narrow sidewalks. Despite these issues, the first half of the audit was enjoyable. The experience changed significantly starting at Spruce Street and continuing down Fourth Avenue toward the school. This portion of the audit was disrupted by frequent construction that blocked sidewalks, forcing the group to reroute and cross streets without designated crosswalks. In addition to these unsafe crossings, participants had to navigate sidewalks obstructed by electric boxes or poles (see Figure 4), which posed particular challenges for one student using a wheelchair. At the end of the audit, the students noticed the crosswalk near their school was faded on one side and missing on the other. This audit underscores the importance of smooth and unobstructed sidewalks, high-visibility crosswalks—especially near schools—and the need for construction zones to provide safe pedestrian detours, all of which contribute to a safer and more inclusive environment for students and the community.
