Sandburg Elementary School Pedestrian Audit

Address: 11230 Avenida del Gato, San Diego, CA 92126

Date: January 6th, 2026

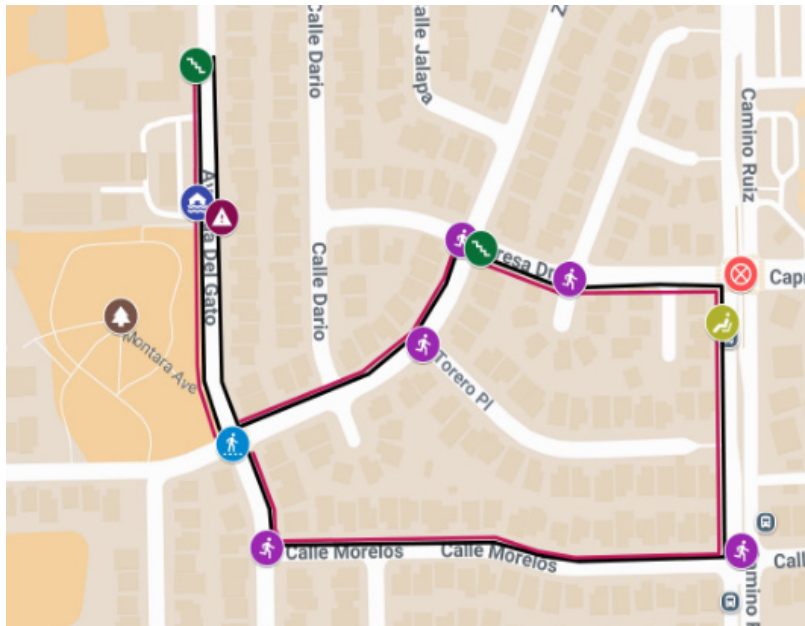
FIGURE 2. SANDBURG ELEMENTARY SCHOOL AUDIT RESULTS

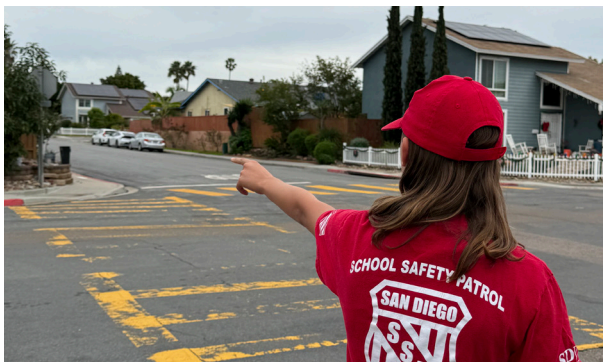
FIGURE 3: STUDENTS POINTING OUT FADED CROSSWALKS ON ZAPATA AVENUE, ONE BLOCK AWAY FROM THEIR SCHOOL

The pedestrian field trip was conducted in the area surrounding Sandburg Elementary School (see Figure 2). Along Avenida del Gato and Zapata Avenue, participants identified pedestrian infrastructure deficiencies, including narrow sidewalks, faded crosswalks, and missing curb ramps (see Figure 3). Conditions worsened beginning at Zapata Avenue and continuing along Teresa Drive toward Camino Ruiz, where the audit was frequently disrupted by absent curb ramps, missing crosswalks, and consistently narrow sidewalks. On Camino Ruiz, the group noted positive features such as protected bike lanes and a No Right Turn on Red signal. However, further along Camino Ruiz, the audit revealed multiple unmarked crosswalks along a high-speed roadway with a posted speed limit of 40 miles per hour and heavy vehicle traffic (see Figure 4). Overall, the audit highlights the need for wider sidewalks, high-visibility crosswalks—particularly near schools—improved curb ramp accessibility, clearer school zone signage, and better traffic management during school drop-off and pick-up. Safety Patrol students claimed more visible crosswalks and curb ramps would help students get to school safely, which would support a safer, more inclusive environment for the Sandburg Elementary community.

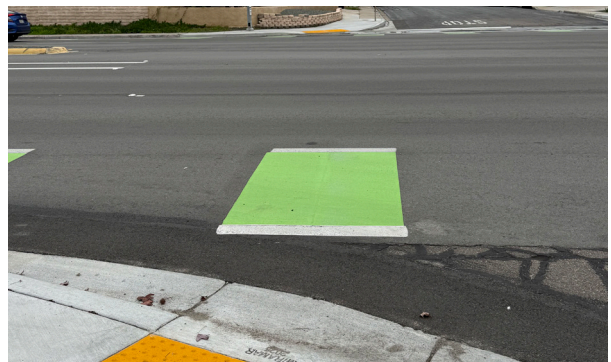
FIGURE 4: UNMARKED CROSSWALK ON CAMINO RUIZ, WHICH HAS A 40MPH SPEED LIMIT
