# Mountain Hawk Park and Salt Creek Recreational Center Pedestrian Audit

Address: 1475 Lake Crest Dr, Chula Vista, CA 91915

Date: July 15, 2026

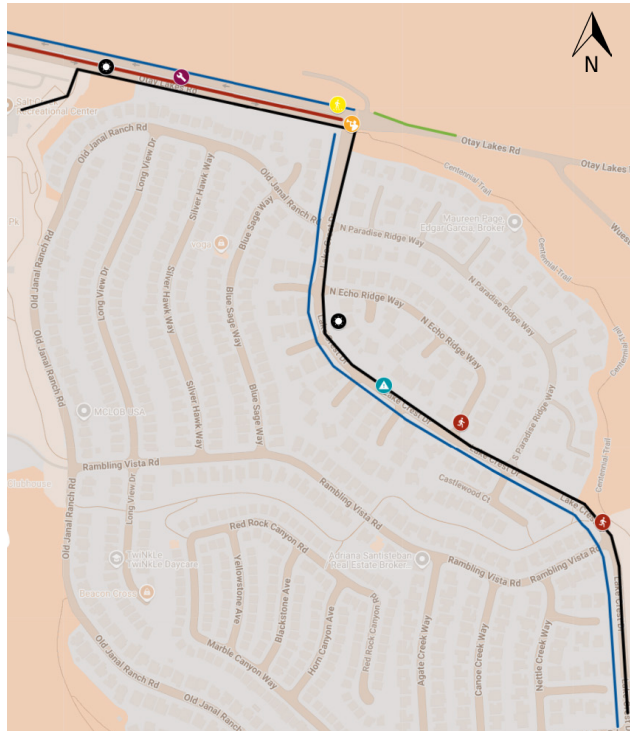
**FIGURE 2. MOUNTAIN HAWK PARK AUDIT RESULTS**

Circulate joined Salt Creek campers on their walk from Mountain Hawk Park to the Salt Creek Recreation Center (Figure 2). The audit took place on a hot day, making shade an important factor in pedestrian comfort. Along Lake Crest Drive, participants encountered smooth sidewalks and frequent shade from trees, with only one minor obstruction caused by overgrown vegetation. In contrast, conditions along Otay Lakes Road were less favorable. Participants encountered uneven, bumpy sidewalks and a long stretch with little to no tree canopy (Figure 3), making this segment of the route uncomfortable to traverse. During the audit, all observed cyclists were riding on the sidewalk, despite the presence of Class II bike lanes on both Lake Crest Drive and Otay Lakes Road. Further investigation revealed that the speed limit on Otay Lakes Road is 50 mph (Figure 4), which may explain why cyclists chose to ride on the sidewalk rather than in the bike lane. This observation suggests that the high vehicle speeds may discourage cyclists from using the designated on-street facilities. Along Otay Lakes Road, the group noted the lack of an audible pedestrian signal at the crossing, which resulted in participants missing a significant portion of the crossing window. The group also observed that the crosswalk was faded. These observations highlighted several opportunities to improve safety and comfort of pedestrian and bicyclists, including smoother sidewalks, high-visibility crosswalks, traffic-calming measures to reduce vehicle speeds, additional shade trees, and the installation of audible pedestrian signals.

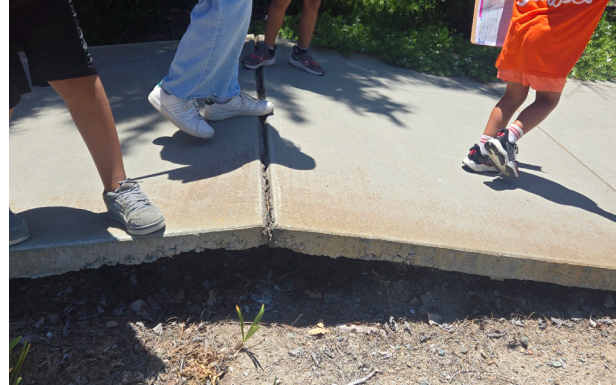
**FIGURE 3: THE GROUP ENCOUNTERED A BUMPY SIDEWALK AND LIMITED SHADE ON OTAY LAKES ROAD.**

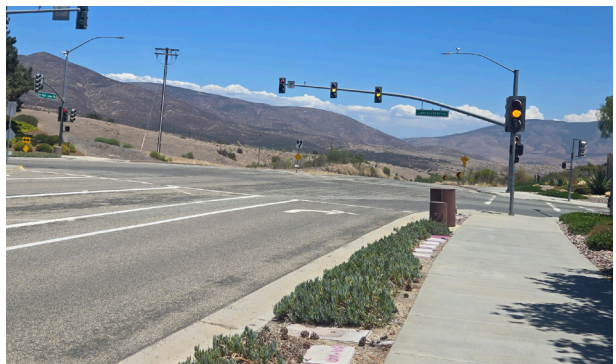
**FIGURE 4: DESPITE CLASS II BIKE LANES AND SHARROWS ON OTAY LAKES ROAD, THE 50 MPH SPEED LIMIT AND LACK OF PROTECTION LEADS CYCLISTS TO RIDE ON THE SIDEWALK.**
