Walking Field Trip #1: San Diego Housing Federation

Address: 25th St / Commercial Station, San Diego, CA 92113

Date: March 27, 2023

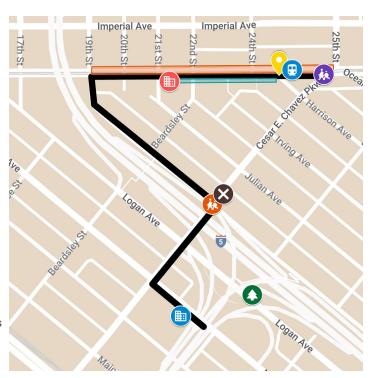
FIGURE 2. HOUSING FEDERATION WALKING FIELD TRIP RESULTS

Observations

Crossing Time Too Short

No Crosswalk

Shade Trees and Wide Sidewalks

Observed Speeding

Missing Sidewalk

Faded Crosswalk Markings

The walking field trip took place along Commercial Street, Kearney Avenue, Cesar Chavez Parkway, and National Avenue (see Figure 2). Participants noted issues such as missing crosswalks, portions of missing sidewalk, observations of speeding along Commercial Street, and faded crosswalk markings (see Figure 3). Sidewalks, with the exception of a portion on Commercial Street between Harrison Avenue and 21st Street, were noted to be narrow. That portion of Commercial Street sidewalk was wide, equipped with shade trees, and equipped with pedestrian-scale lighting which lead to a pleasant walking experience. The large group of participants had to travel in a narrow line throughout the duration of the walk (see Figure 4). Behavioral hazards, such as speeding drivers, drivers failing to come to a complete stop at stop signs, and drivers stopping in the middle of crosswalks rather than at the stop sign were observed. Pedestrian connections to the trolley stop and housing projects were decent but there is much room for improvement.
