Pedestrian Field Trip# 1: 30th Street

Address: 4044 Idaho St, San Diego, CA 92104

Date: February 21st, 2025

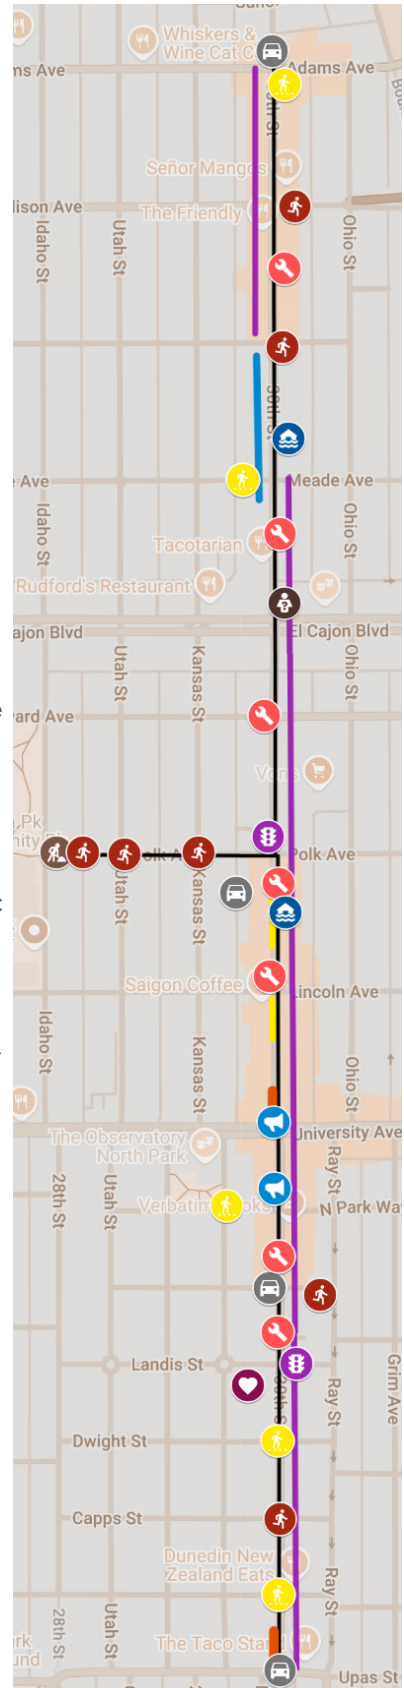
FIGURE 2. 30TH STREET PEDESTRIAN AUDIT RESULTS

- No Crosswalk
- Broken Sidewalk
- Faded Crosswalk
- Driver Infractions Observed
- Rectangular Rapid Flashing Beacon
- Wide Sidewalk
- Audible Crossing
- Class IV Bike Lane
- Narrow Sidewalk
- Flooding
- Construction
- Class II Bike Lane
- High Visibility Crosswalk
- Long Pedestrian Wait Times

This pedestrian field trip took place along 30th Street in North Park (Fig. 2). During the audit, the group observed intersections with varying levels of infrastructure for both cyclists and pedestrians, with some well-equipped with bike- and pedestrian-friendly features, while others lacked basic infrastructure, such as marked crosswalks. At the beginning of the audit, the group noticed that the intersections between Polk Avenue and 30th Street had missing crosswalks (Fig. 3) and for the majority of the audit, the group encountered broken sidewalks (Fig. 4), both of which made it difficult to walk safely. Throughout most of the audit, Circulate staff had to alert the group to upcoming broken sections of the sidewalk and flooding (Fig. 5) in the crosswalks to prevent injuries. While walking along 30th Street, participants noticed a clear difference in safety between intersections. Intersections with traffic calming measures, such as high-visibility crosswalks, protected bike lanes, and clearly marked conflict zones, felt much safer. In contrast, intersections without these features (Fig. 6) created confusion and increased risk. The group also observed more driver infractions at intersections with limited pedestrian and bicycle infrastructure. For example, on 30th Street near Lincoln Avenue, drivers used an unprotected section of the bike lane for right turns (Fig. 7). At intersections with faded or missing crosswalks, drivers encroached on the crosswalks or failed to yield to pedestrians' right of way (Figs. 8 and 9). North Park is a vibrant and beloved neighborhood, frequented by a diverse range of road users (Fig. 10). This audit underscores the urgent need for consistent and comprehensive bike and pedestrian infrastructure. Implementing key traffic calming measures—such as high-visibility crosswalks, raised crosswalks in flood-prone areas, smoother sidewalks, and protected bike lanes with clearly defined conflict zones—would significantly enhance safety for all road users and also foster a more welcoming environment for everyone on the road.

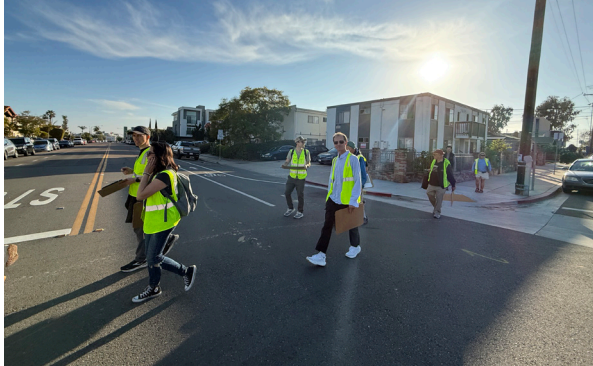
FIGURE 3: PARTICIPANTS CROSSED THE STREET AT POLK AVENUE AND KANSAS STREET, WHERE THERE IS NO CROSSWALK.

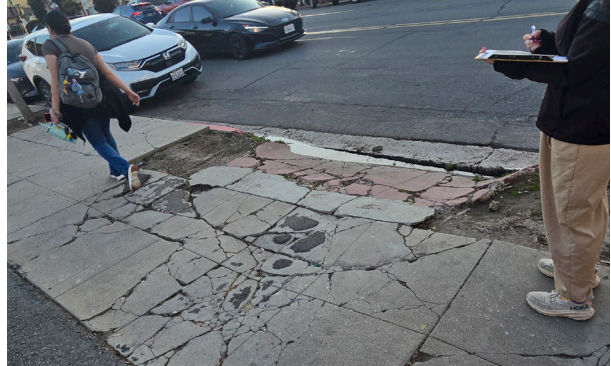
FIGURE 4: THERE WERE NUMEROUS BROKEN SIDEWALKS AND HOLES ALONG 30TH STREET, MAKING IT DIFFICULT TO NAVIGATE, ESPECIALLY FOR THOSE USING MOBILITY AIDS OR STROLLERS.

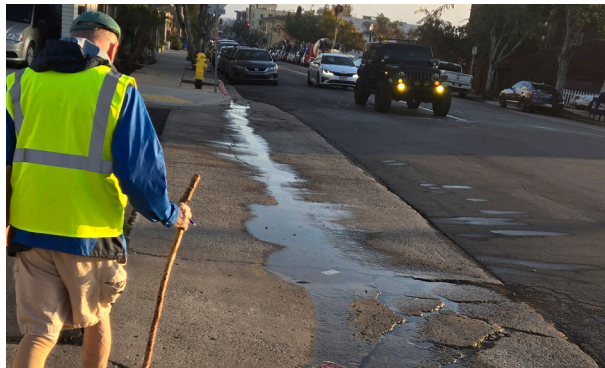
FIGURE 5: PARTICIPANTS ENCOUNTERED FLOODING IN THE CROSSWALKS AND BIKE LANES THROUGHOUT THE AUDIT.

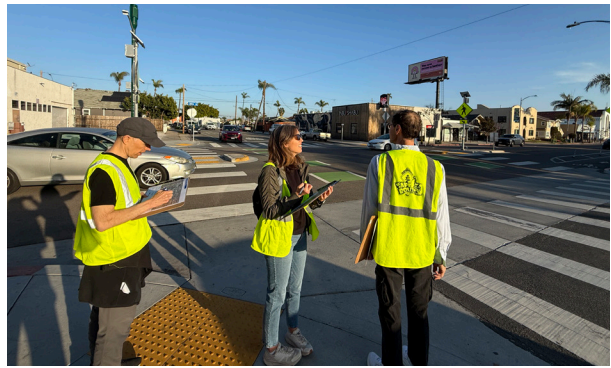
FIGURE 6: AT 30TH STREET AND LANDIS STREET, THE GROUP ENCOUNTERED AN INTERSECTION WITH INFRASTRUCTURE FOR ALL ROAD USERS.

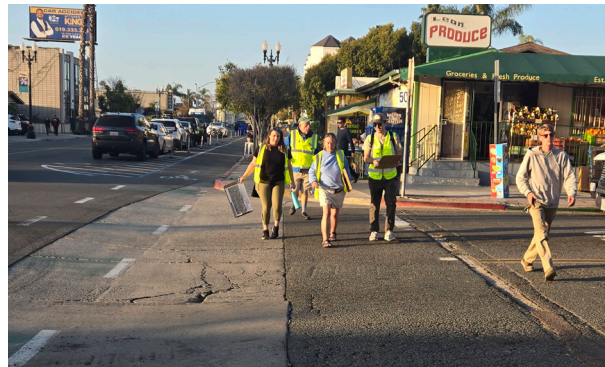
FIGURE 7: PARTICIPANTS CROSSED THE BUSY MADISON AVENUE AND 30TH STREET INTERSECTION WITHOUT A CROSSWALK.

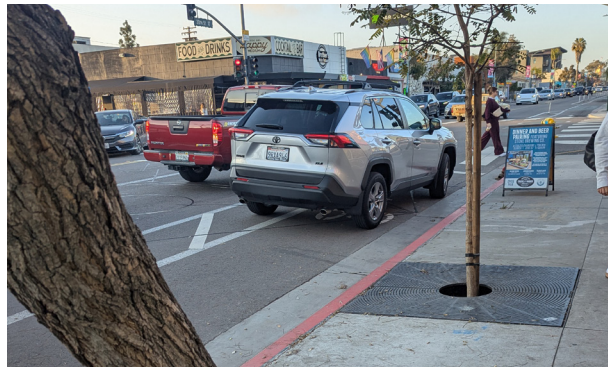
FIGURE 8: DRIVER USES BIKE LANE TO MAKE A RIGHT TURN ONTO LINCOLN AVENUE.

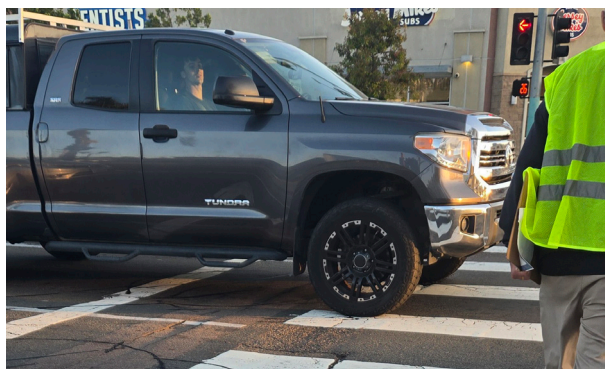
FIGURE 9: DRIVER ENCROACHING ON THE CROSSWALK IN FRONT OF PARTICIPANTS ON EL CAJON BOULEVARD.
