AUGUST 10, 2023 FLOOD INVESTIGATION REPORT

DRAFT SUMMARY REPORT WARD 8

Infrastructure and Water Services

December 14, 2023

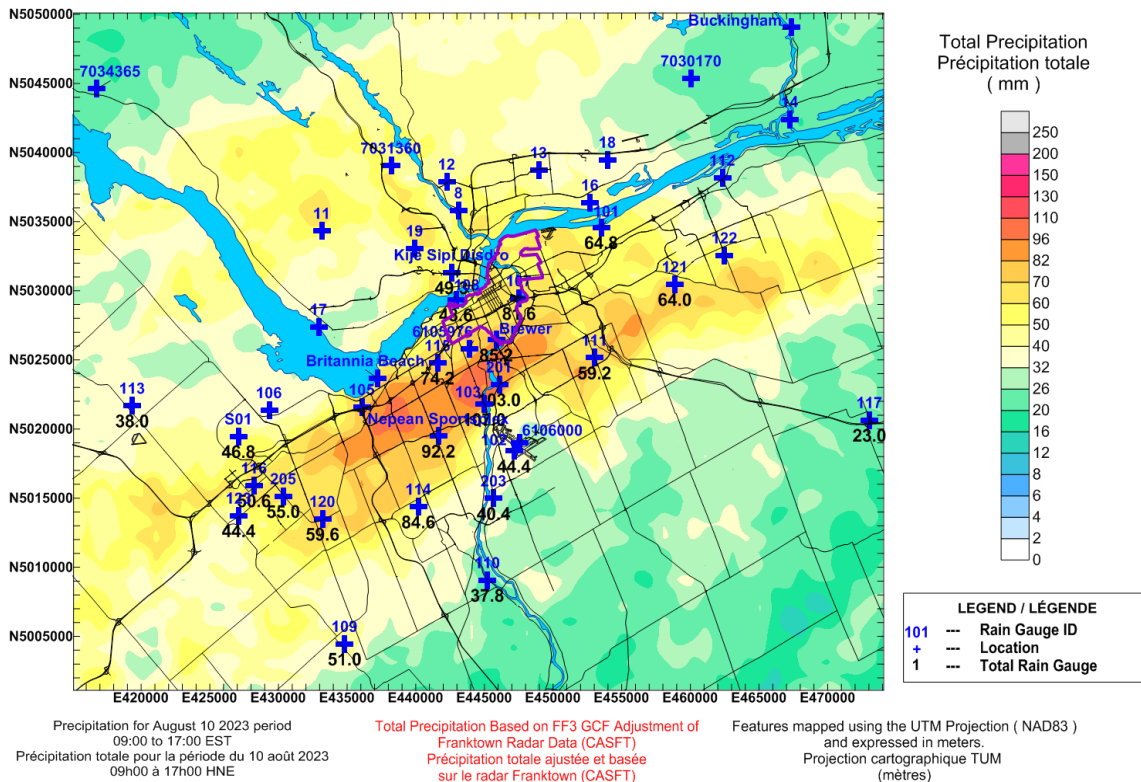
Figure 4 – Path of Storm Peak

Although the storm of August 10th affected the entire city, the peak of the storm followed a band near the south end of the City core. The rain gauges along that band showed the greatest rainfall

volume and intensity. Figure 4.0 shows the approximate path where the highest rainfall was experienced.

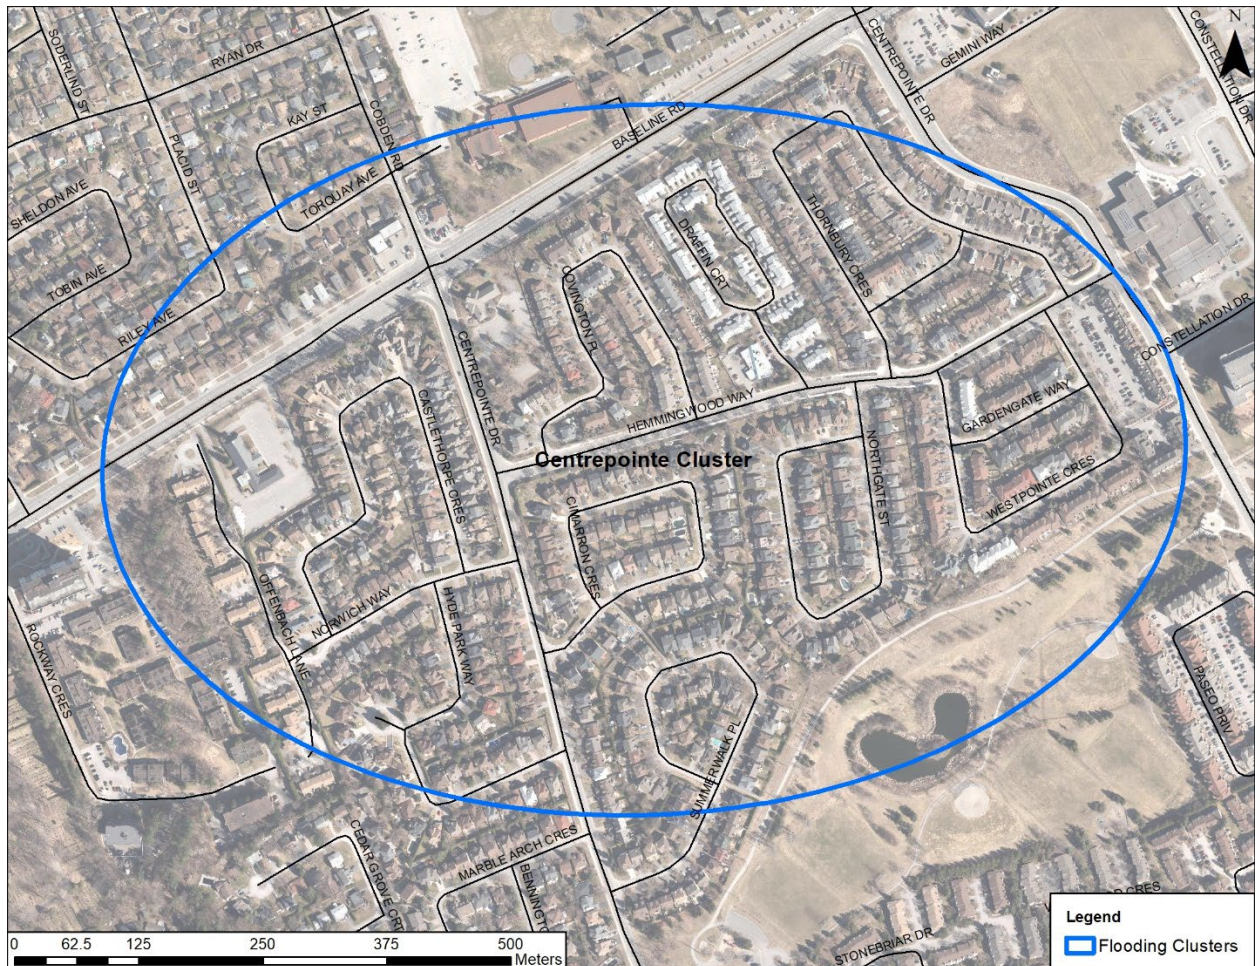
Figure 5 – CentrepoinTE Cluster, August 10 Flooding

- **Type of Flooding:** First response data does not provide any indication as to how the properties flooded. This area is fully separated, and stormwater management controls were implemented following a study in 2015 (i.e. control devices were installed in catch basins to limit the flow entering the storm sewer system).
- **Previous Flooding:** This cluster reported over 100 cases of basement flooding in the event of June 27th, 2002. The cause of flooding was surcharging of the storm sewer that backed up into the residential weeping tiles.

- **Current Investigation:** A review of the computer models showed that the storm sewer system would have surcharged during the August 10th event, however the level of surcharge would have been reduced due to the implementation of inlet control devices throughout the basin. Some sections of the storm sewer system would have surcharged to basement elevation and homes without a properly functioning backwater valve would have experienced basement flooding. The fact that only 6 properties reported basement flooding and that they were not grouped together, leads to the conclusion that faulty or missing backwater valves failed to protect against localized sewer surcharge.

- **Probable Cause of Flooding:** The measures that were implemented following the 2017 and 2018 studies increased the level of service in the area, which is apparent by the greatly reduced number of flooding reports compared to 2002. The event of August 10th, 2023 was greater than the level of protection for this system, which means that surcharging in some areas was expected. Residential backwater valves provide additional protection in these instances. It is suspected that the homes that flooded had faulty or missing backwater valves.

- **Next Steps:** Stormwater management control work has been undertaken in the past 10 years to improve the level of service and no additional measures are anticipated. Communication to residents about inspecting their lateral lines and installing backwater valves should be undertaken.

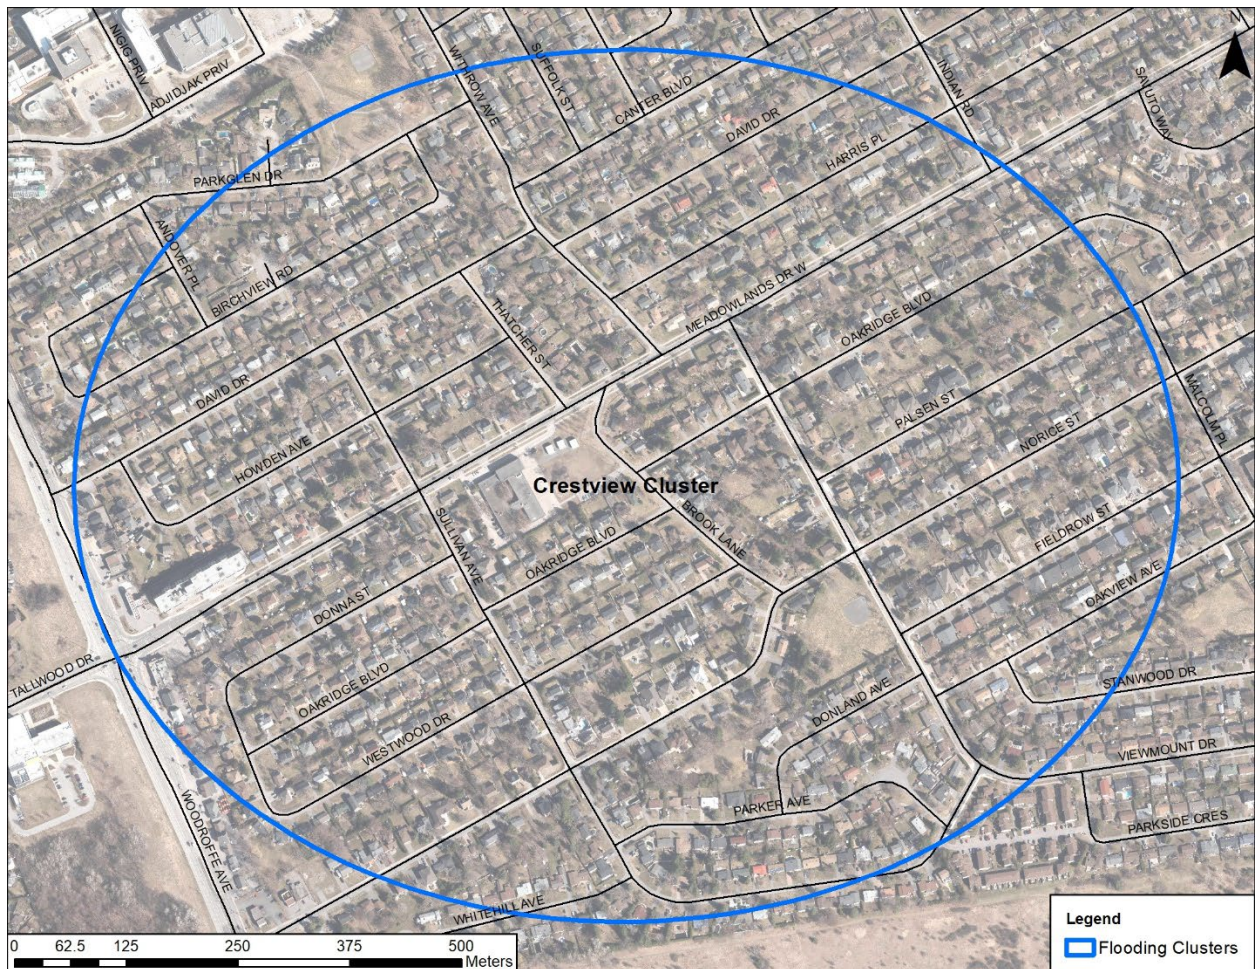
Figure 6 – Crestview Cluster, August 10 Flooding

- **Type of Flooding:** First response data does not provide any indication as to how the properties flooded.
- **Previous Flooding:** There are over 80 historical reports of basement flooding in this cluster in events from 1979, 1996, 2000, 2002, 2004, 2005 and 2017. Approximately 60 of these incidents occurred in 2004, 2005 and 2017, which produced events that typically created flooding via the sanitary system. This is evident by the fact that over 40 homes flooded in September 2004, which was due to the surcharge of the sanitary system. Home that reported flooding in areas with storm sewers are much less in numbers and were influenced by high intensity events in 1996, 2000 and 2002.

- **Current Investigation:** The homes that reported flooding in this event are located along a storm sewer system that is uncontrolled. It appears that the homes in this sector flooded due to storm sewer surcharge. A review of the sewer computer models for this area show that the storm sewer would surcharge to basement elevation during the event of August 10th, 2023. However, the homes that flooded are not closely grouped together. This may indicate that homes that flooded may have had backwater valves that failed or that they had lower basements or that their weeping tile lateral pipe is in poor condition.

- **Probable Cause of Flooding:** Surcharging in the storm system due to the severity of the event is the most likely cause of basement flooding in this area. Homes with missing or faulty backwater valves would have been most at risk.

- **Next Steps:** The City will be further investigating the storm sewer system to see if stormwater management in the form of control devices can be implemented to reduce storm sewer surcharge. Communication to residents about inspecting their lateral lines and installing backwater valves should be undertaken.

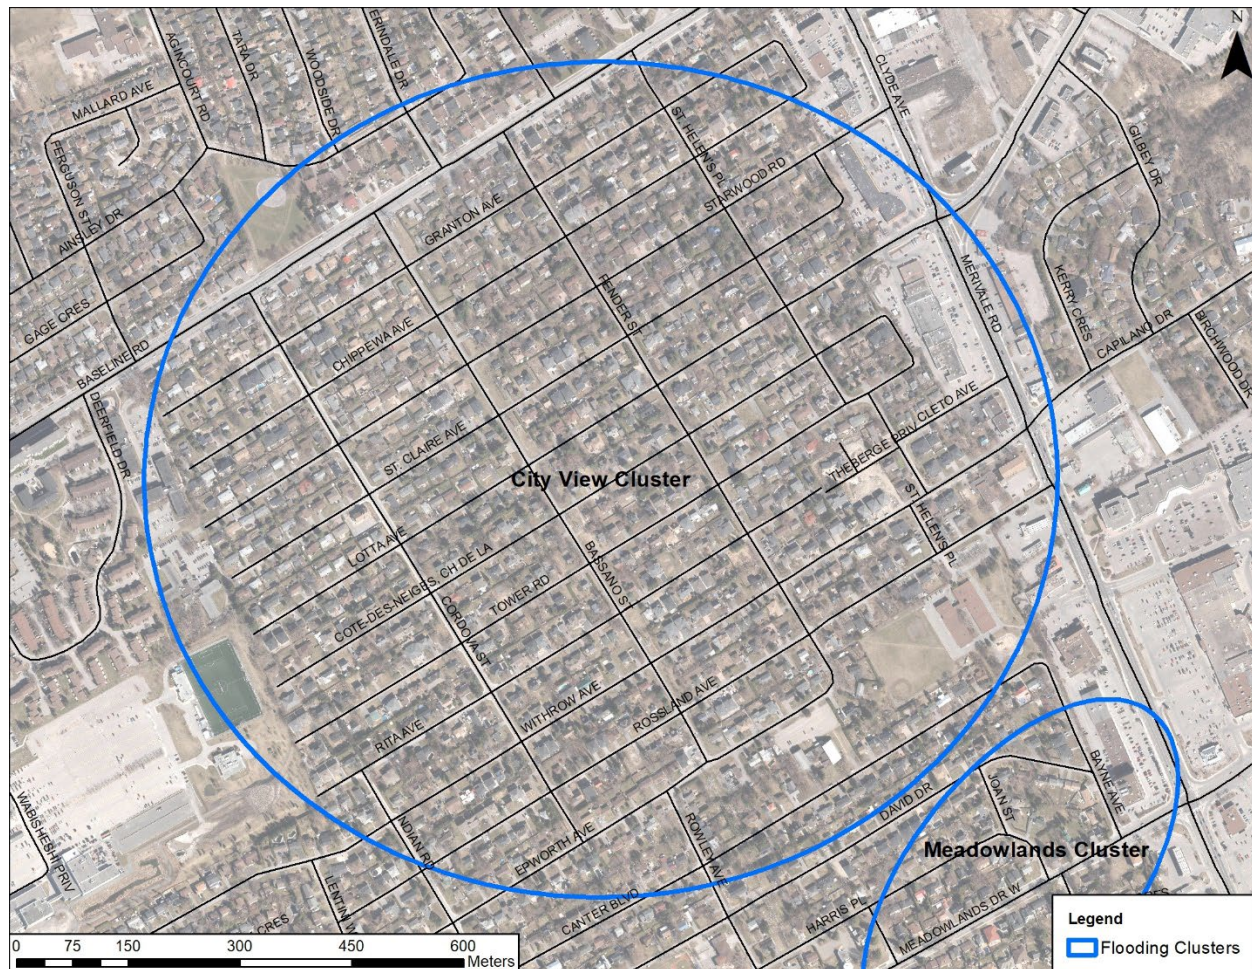
Figure 7 – City View Cluster, August 10 Flooding

- **Type of Flooding:** First response data does not provide any indication as to how the properties flooded.
- **Previous Flooding:** This area suffered widespread flooding in the event of September 9th, 2004, where over 50 homes reported incidents of basement flooding. Other smaller incidents of flooding were also reported in 1996, 1997, 1998, 1999, 2005 and 2006. None of the other incidents formed clusters like the event of 2004.
- **Previous Investigations and Remedial Measures:** Following the event of September 2004, the City undertook a detailed study of the City View area and determined that the cause of flooding from that event was a combination of excess extraneous flow into the sanitary system combined with a surcharged trunk sanitary sewer. The trunk sewer was

- **Current Investigation:** The homes that reported flooding are sporadic in location and not indicative of a widespread infrastructure issue. We do not have information as to how the homes flooded at this time, but it is suspected that local issues such as lateral pipes in poor conditions or surface flooding due to poor grading may be the cause.

- **Probable Cause of Flooding:** Local issues due to lateral pipe condition or site grading may be the cause. If weeping tiles or sump pumps are connected to the lateral pipe, then any partial blockage on the lateral pipe would create a backup into the home.

- **Next Steps:** Communication with residents will be required to explain the benefits of installing backwater valves, having their lateral pipes inspected and how to protect homes from surface flooding. The sporadic nature of the flooding may be indicative of private property issues, more specifically the condition of their lateral pipes or property grading.

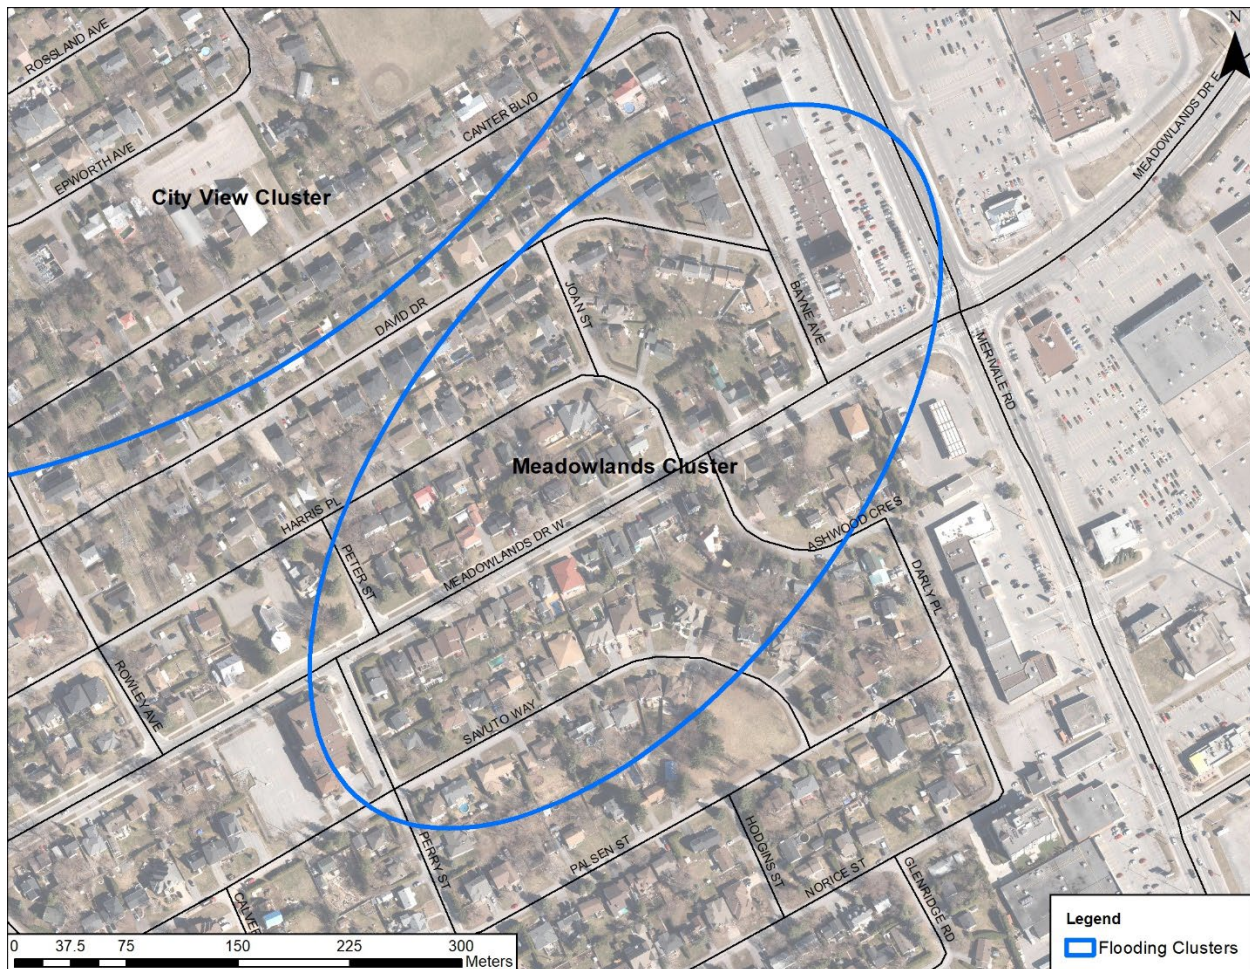
Figure 8 – Meadowlands Cluster, August 10 Flooding

- **Type of Flooding:** First response data does not provide any indication as to how the properties flooded.
- **Previous Flooding:** This area has incidents of flooding in 2000, 2001, 2004, 2005 and 2008. The incidents did not create specific cluster and problems were deemed to be related to private property.
- **Previous Investigations and Remedial Measures:** Given the sporadic nature of many of the previous flooding incidents, no investigation was undertaken in the past.

- **Current Investigation:** The homes that reported flooding are located along storm sewers, which leads to believe that storm sewer surcharge may have been the cause of flooding. A review of the storm system computer model for a similar critical event shows that the surcharging from this sewer would have reached basement elevations and even the surface at some locations. The lack of reported flooding in this area from the 2004 events tends to indicate that this area is not prone to flooding from the sanitary sewer, however a review of the sanitary model indicates that there was also potential for sanitary surcharge reaching basements in an extreme event.

- **Probable Cause of Flooding:** Preliminary analysis indicates that surcharging of the storm sewer was the most likely cause of flooding in this cluster. Furthermore, sanitary sewers may have been indirectly impacted due to flooded basements draining back to the sanitary system via floor drains.

- **Next Steps:** Communication with residents will be required to explain the benefits of installing backwater valves and how to protect homes from flooding. Further analysis will be required to confirm the source of basement flooding. The local storm and sanitary sewer systems will also be reviewed to see if any improvements can be done to reduce the surcharge level during critical events.
