Powder Wood at Landmark HOA

Level 1 Reserve Study

Report Period – 01/01/2024 – 12/31/2024

Executive Summary – Powder Wood at Landmark HOA – ID # 10228

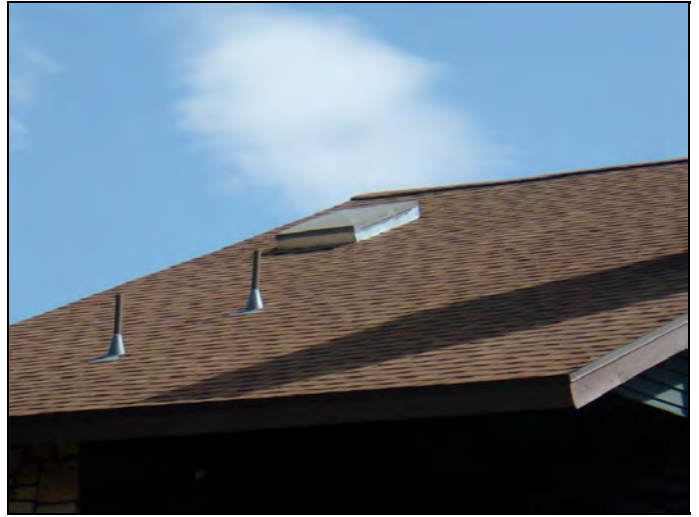
Comp #: 105 Roofs - Replace

Location: Clubhouse, Maint., Residential, Spa

Quantity: Approx. 108,275 SF

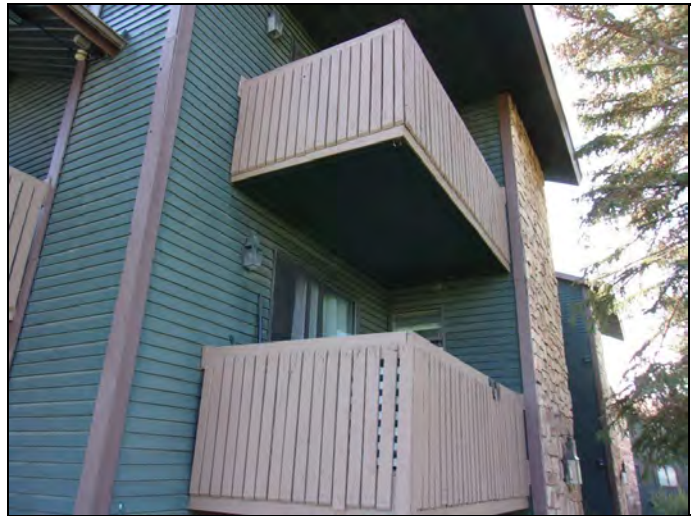
Comp #: 217 Wood Surfaces - Repair/Repaint

Location: **Building Exteriors**

Quantity: **Approx. 108,795 SF**

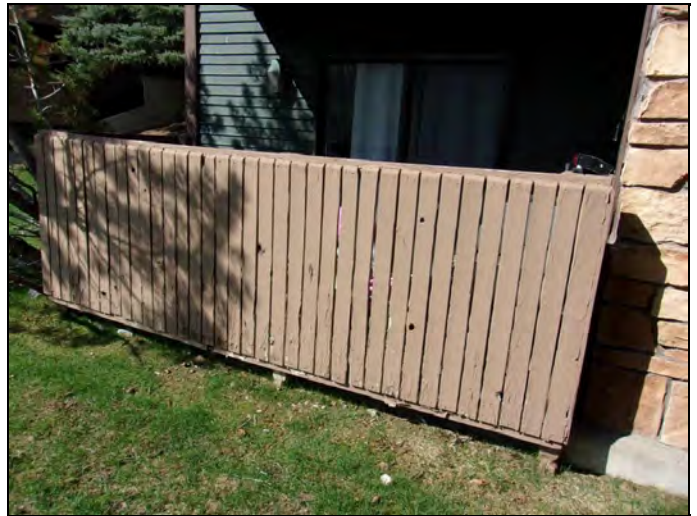
Comp #: 690 Wood Railing - Replace

Location: **Balconies, Landings, & Stairs**

Quantity: **Approx. 21,605 LF**

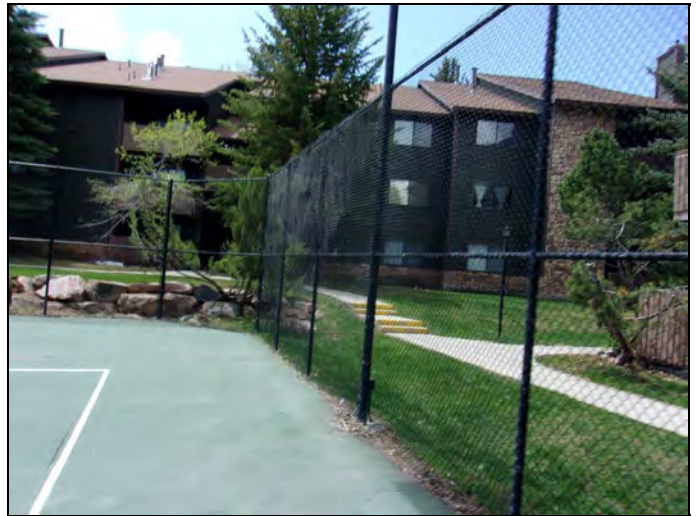
Comp #: 1204 Tennis Court Fencing - Replace

Location: **Tennis Court**

Quantity: **Approx. 440 LF**

This component is replaced as a part of Component #1203 Tennis Court Replace. No extra reserve funding necessary.

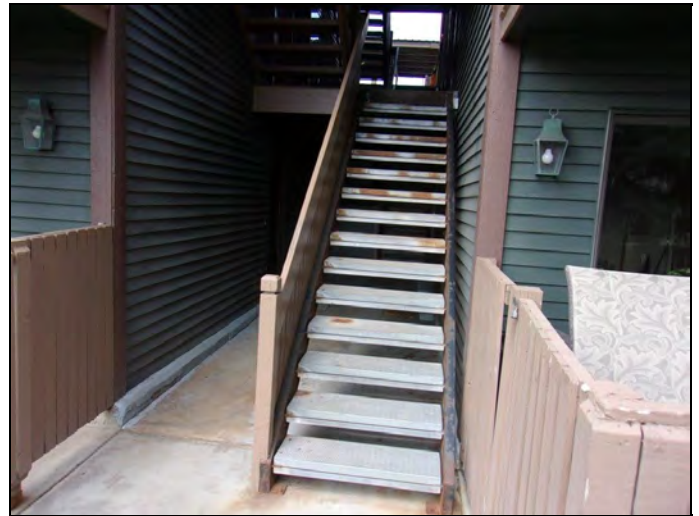
Comp #: 2306 Stair Stringers - 2019 - Replace

Location: **Building Exteriors**

Quantity: **(15) Stringers**
