**MEMO**

**Subject: Existing Conditions and Restoration Opportunities in the San Gabriel River and Azusa Floodplain**

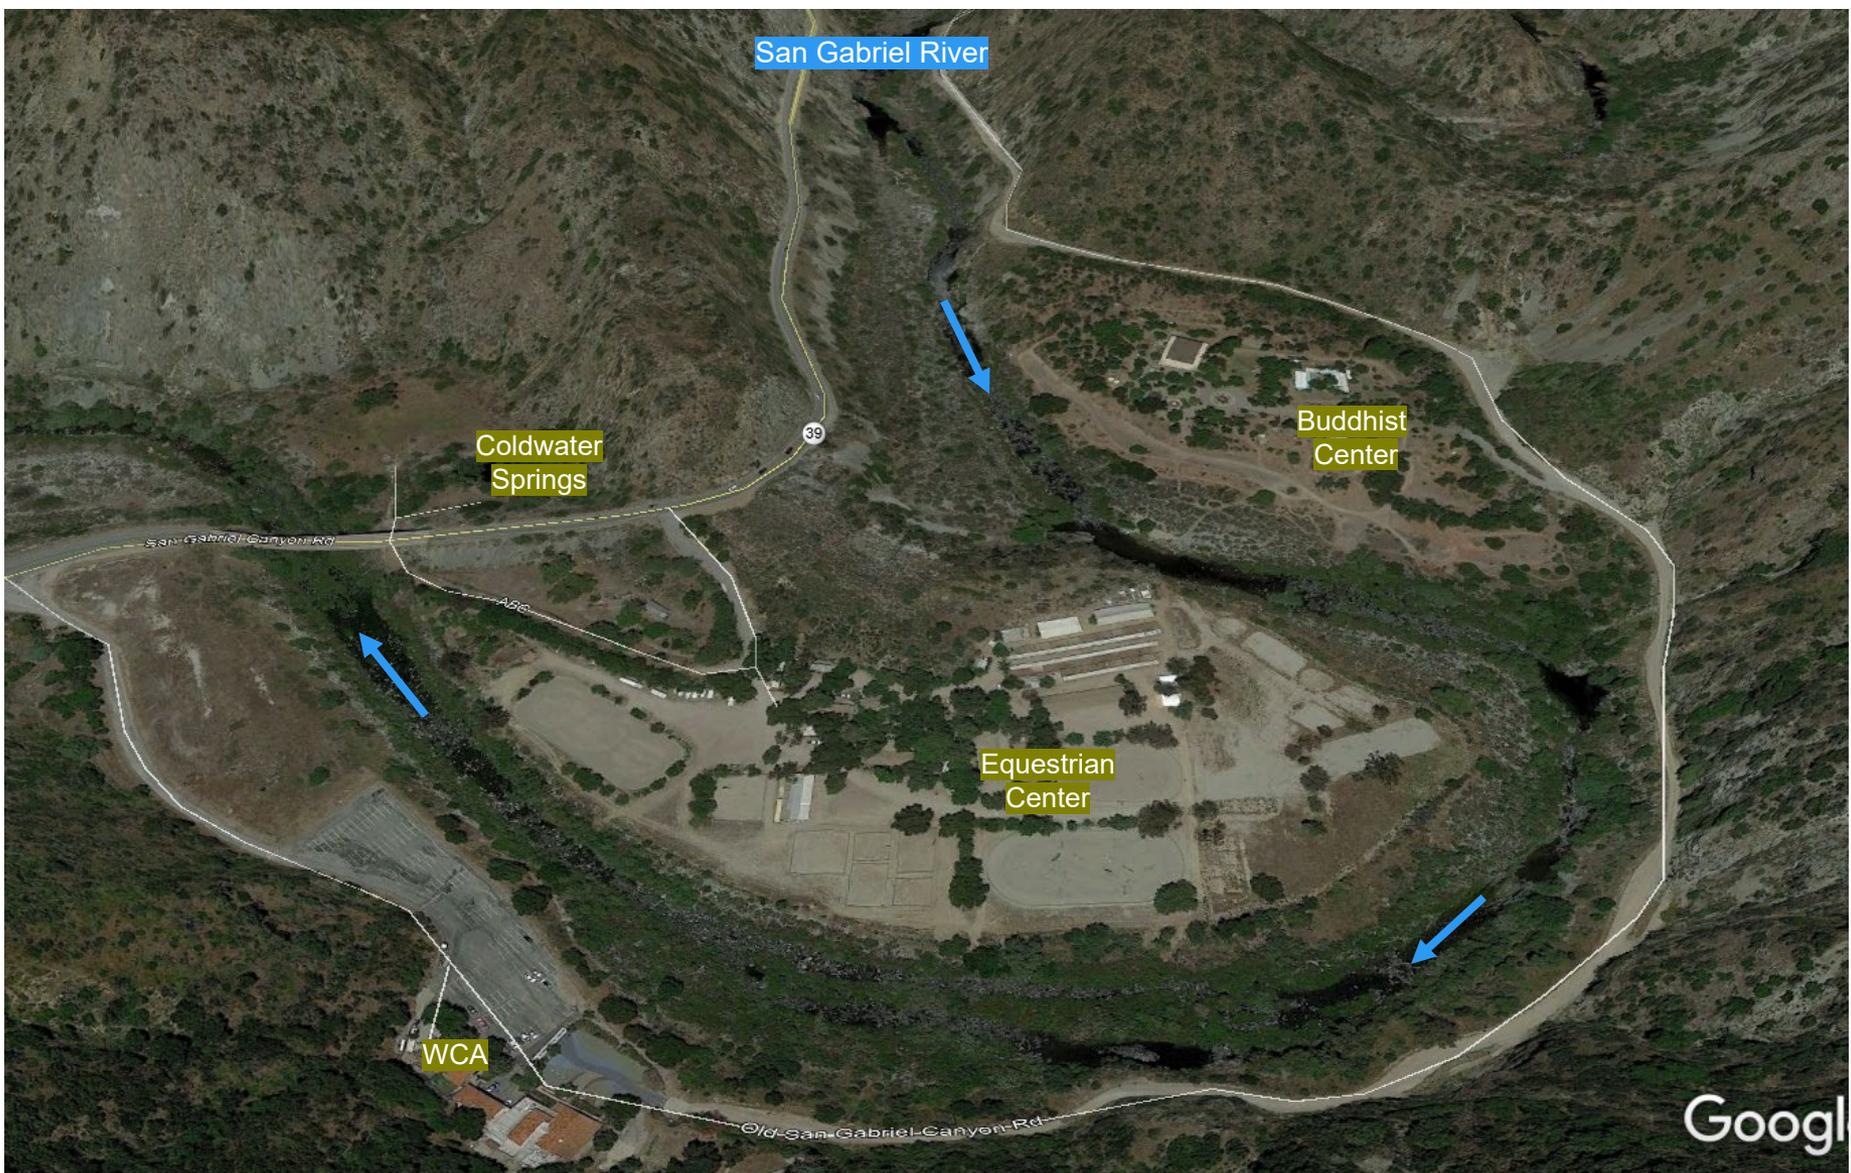
Balance staff member Anne Senter joined two WCA staff members for a field site visit on Wednesday, April 14, 2021. The team visited the San Gabriel River meander bend (Figure 2), Robert’s Creek and Van Tassell Canyon. Fish Canyon was reviewed via aerial imagery as time did not allow for an on-the-ground visit to this watershed.

**Figure 2. San Gabriel River meander bend below Morris Dam.** The meander bend, located approximately 1.5-miles downstream of Morris Dam, has two relatively low-density occupants: a Buddhist Center and an Equestrian Center.

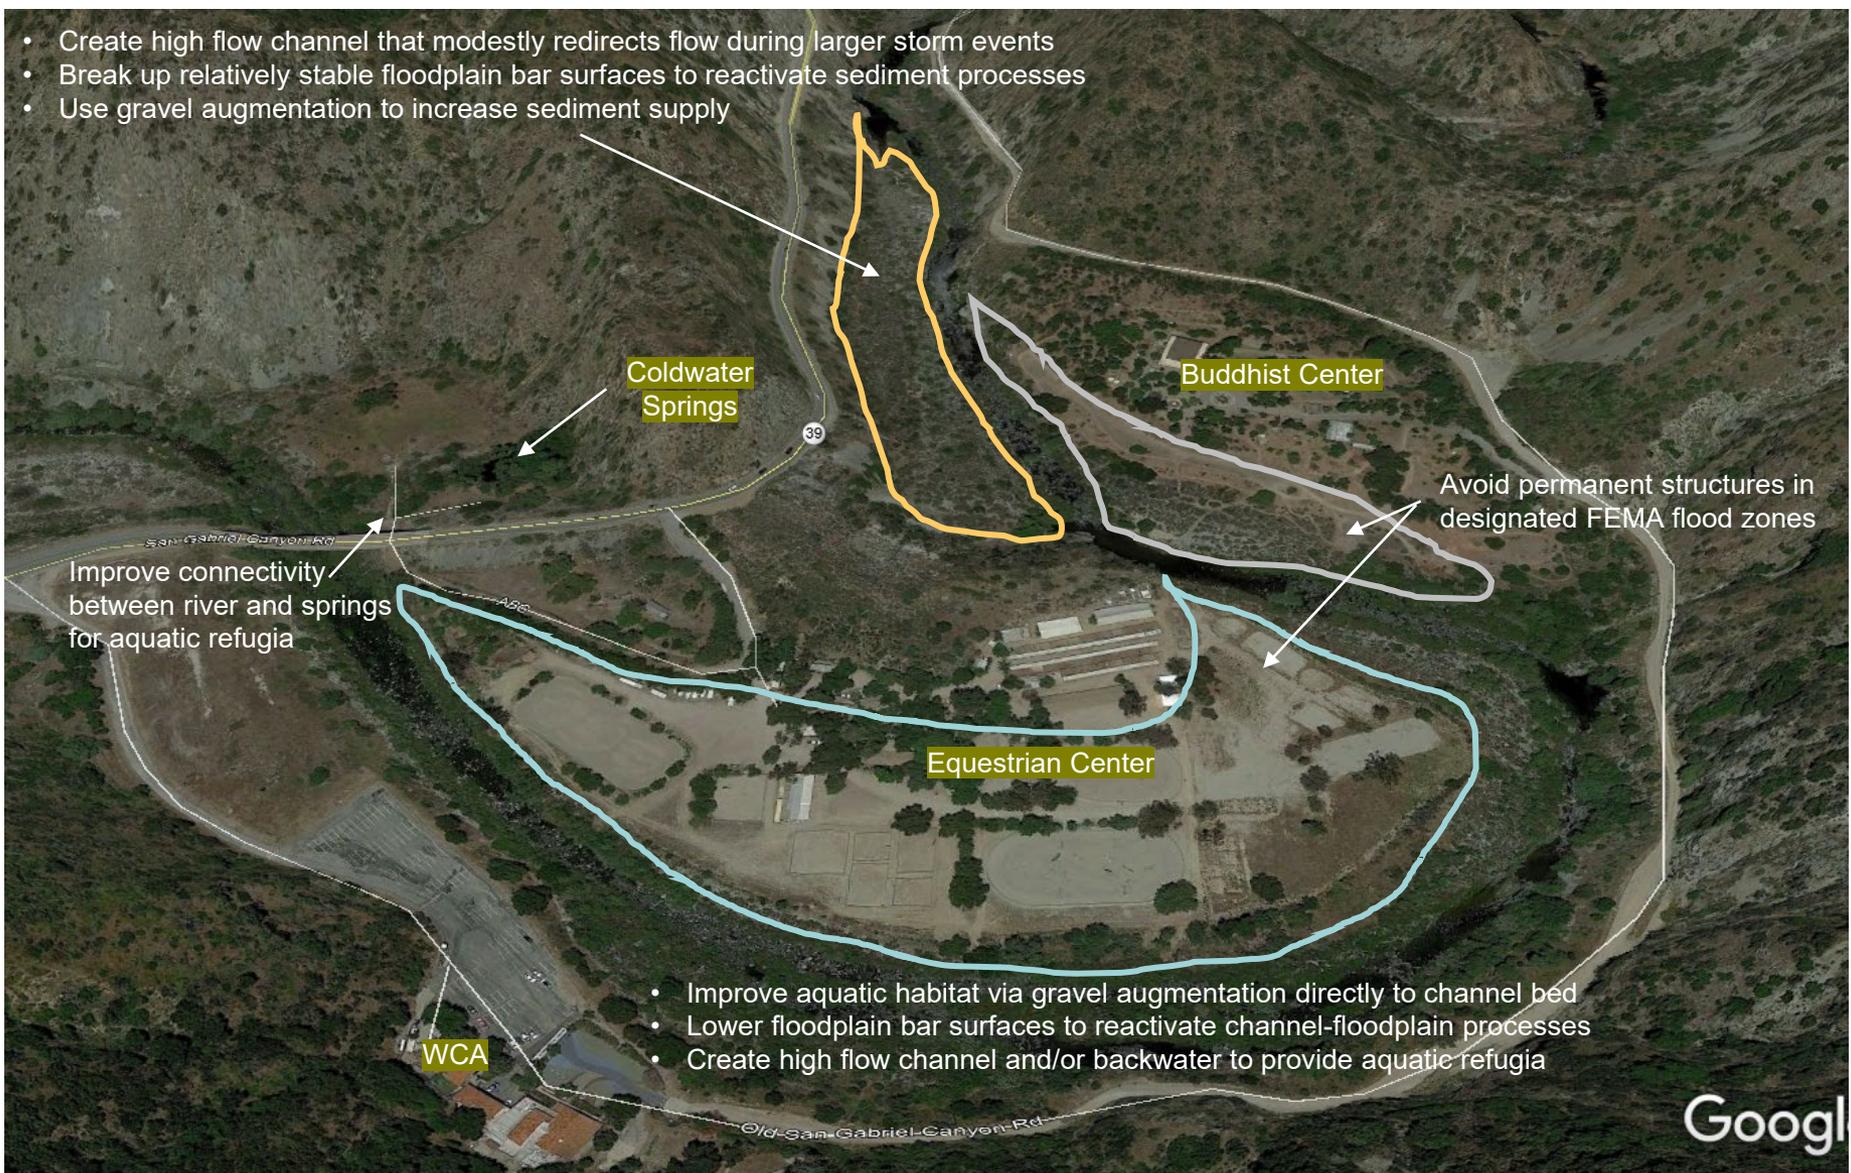
- The channel/floodplain interface between the river and the floodplain bars is disconnected where the Equestrian Center and the Buddhist Center are located (Figure 3) due to channel downcutting in the decades following upstream damming.

- Create high flow channel that modestly redirects flow during larger storm events
- Break up relatively stable floodplain bar surfaces to reactivate sediment processes
- Use gravel augmentation to increase sediment supply

- Improve aquatic habitat via gravel augmentation directly to channel bed
- Lower floodplain bar surfaces to reactivate channel-floodplain processes
- Create high flow channel and/or backwater to provide aquatic refugia

**Figure 3. Restoration opportunities in the San Gabriel River along the meander bend.** Next step recommendations include a restoration feasibility study including a geomorphic investigation, hydrologic analysis of dam releases, existing and proposed conditions hydraulic modeling, sediment supply study, and stakeholder engagement.

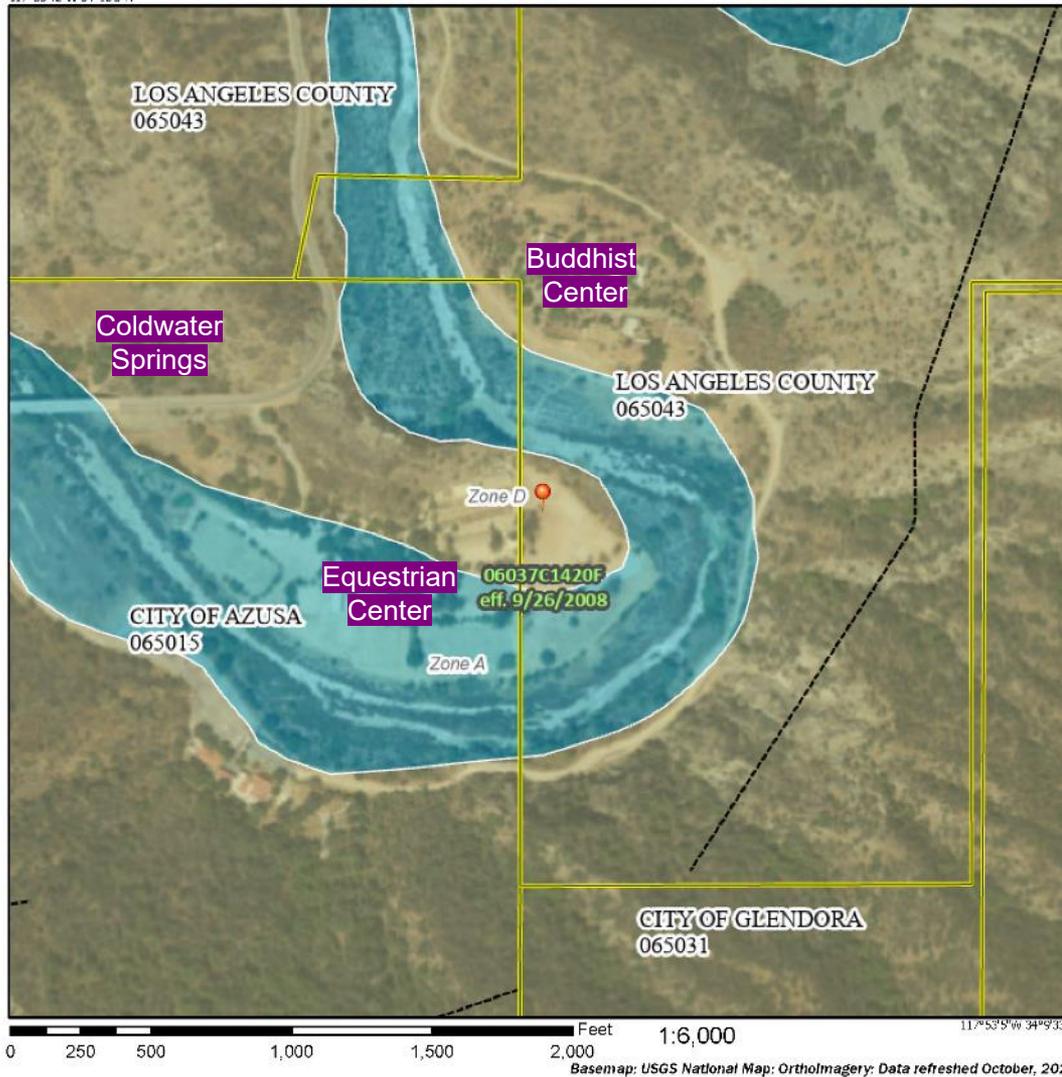
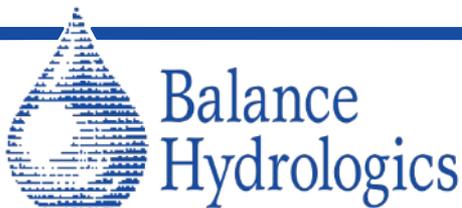
- Dams dampen the highest flood flows and tend to extend the lowest flows into seasons where the channel might have been historically dry. Flooding is possible at very high flows along all bars in the meander bend, as indicated by FEMA flood mapping (Figure 4).

**Figure 4. Federal Emergency Management Agency (FEMA) Flood Insurance Rate Map (FIRM #06037C1420F, effective 9/26/2008).** FEMA used approximation methods to delineate the 100-year flood extent. Note that a portion of the outer bend occupied by the Buddhist Center is predicted to flood, and even more of the interior floodplain/bar occupied by the Equestrian Center.

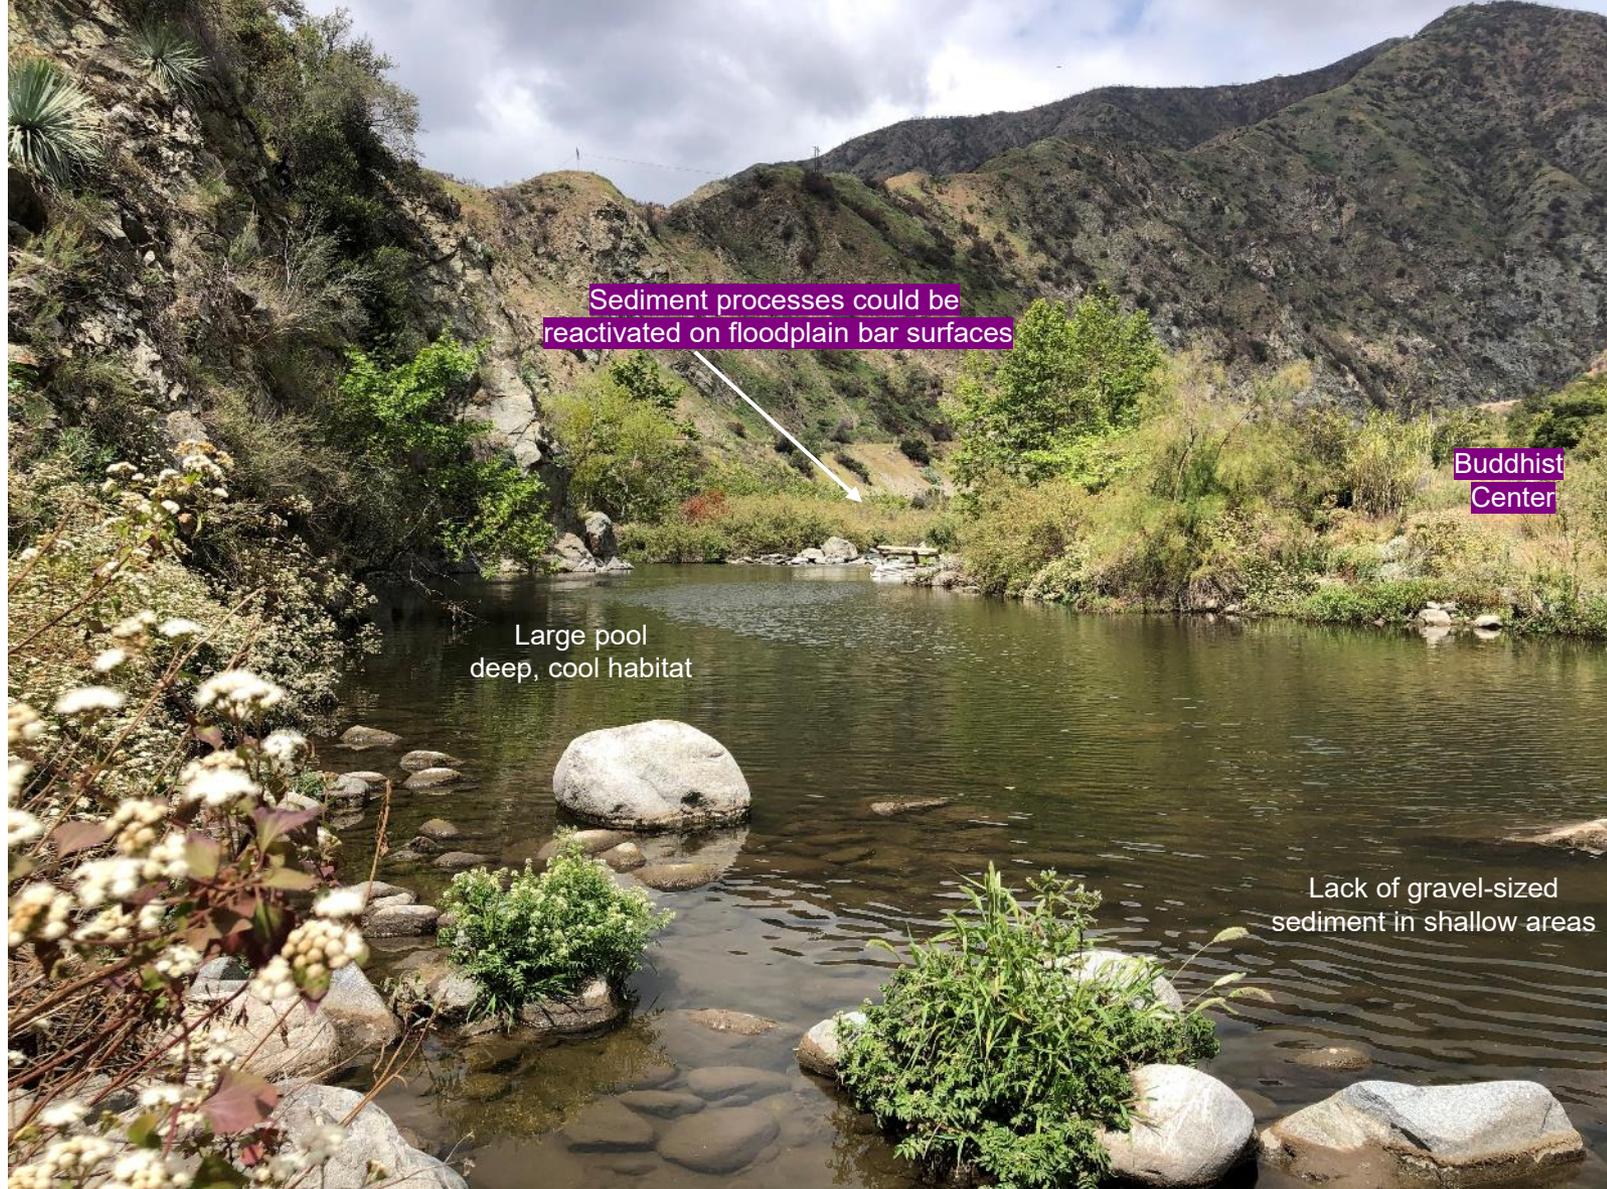
Sediment processes could be reactivated on floodplain bar surfaces

Buddhist Center

Large pool deep, cool habitat

Lack of gravel-sized sediment in shallow areas

- This action could be constructed to modestly redirect higher flood flows away from the Buddhist Center on the opposite bar.
- Gravel augmentation in the channel itself would provide an immediate upgrade to habitat for aquatic species. It is evident that the riverbed is largely comprised of cobble to boulder clast sizes coated with a layer of silty sediments, and that the riverbed lacks gravel-sized sediments that are key geomorphic components to healthy habitat for fish and other aquatic species (Figure 5 and 6).

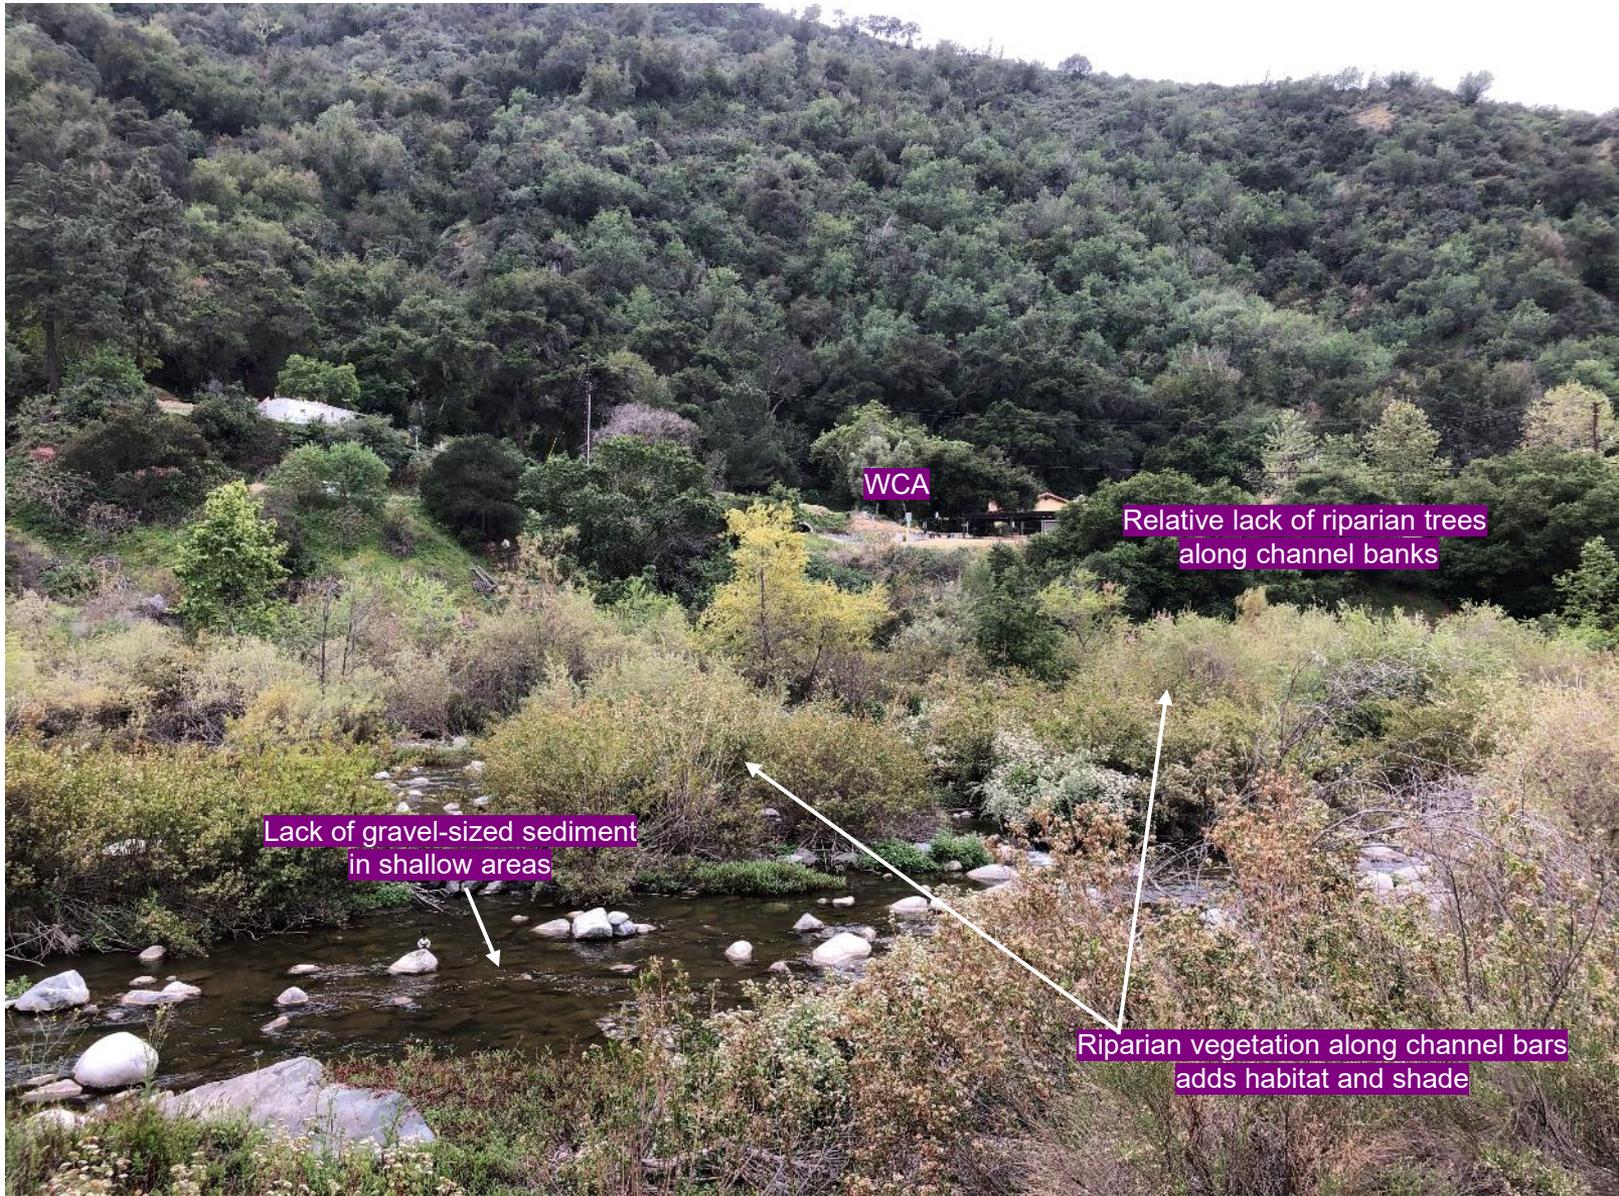
- Damming tends to result in channel downcutting in reaches below-dam, leaving silt and large clasts but few in-between sediment sizes, as was observed in the San Gabriel River meander bend reaches.

**Figure 6. Looking from Equestrian Center to WCA.** Channel was downcut with relatively steep banks. Winnowing of gravel-sized sediments and downcutting are symptomatic of below-dam channels where low flow is more prevalent and high flow is less prevalent than under natural conditions.

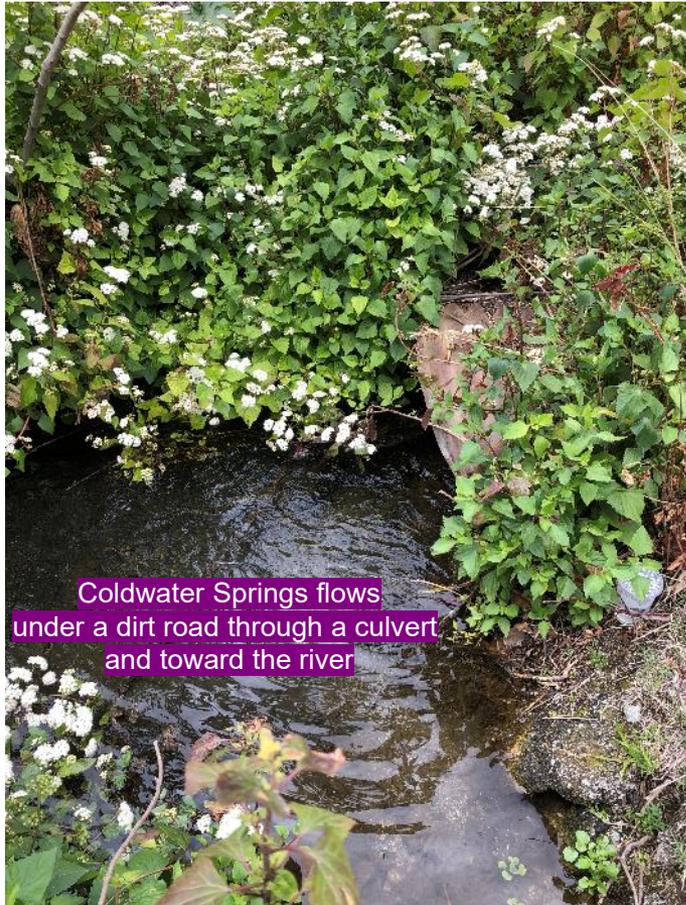
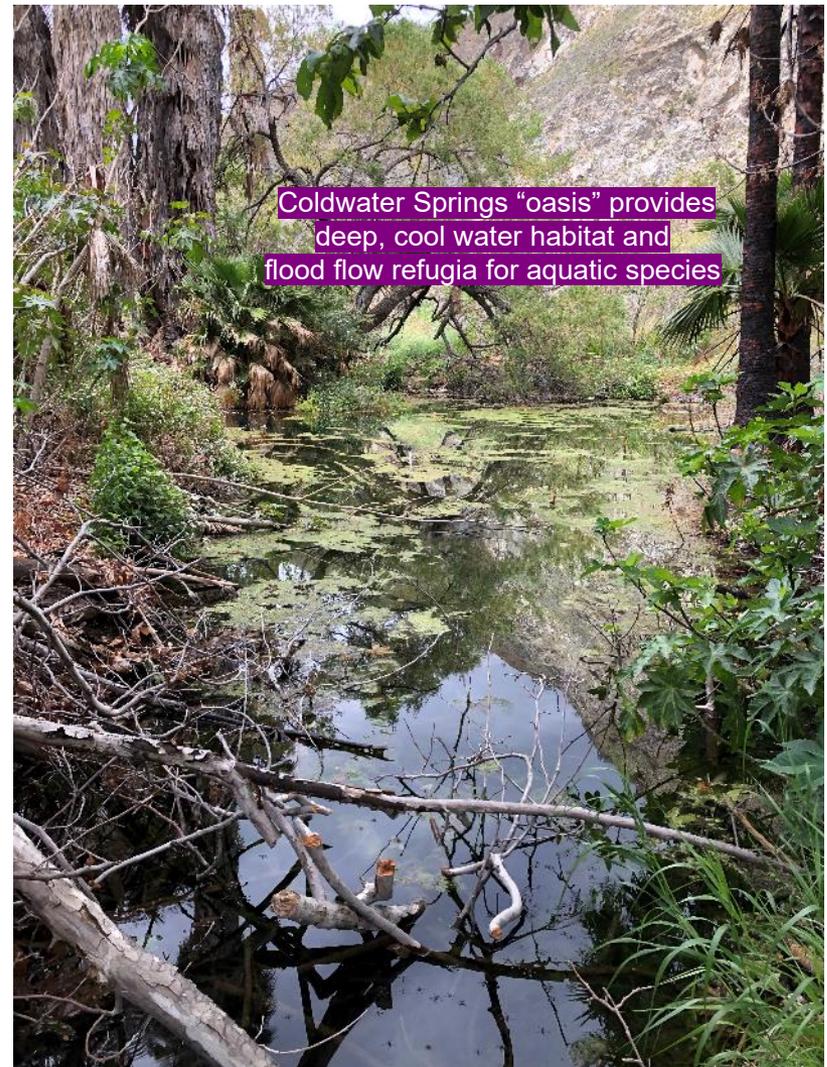
- Dry Creek (Russian River, off-channel habitat)
  - Stevens Creek (San Francisco Bay tributary, off-channel habitat for steelhead)
- Coldwater Springs (Figure 7) delivers a source of additional water to the river channel just west of San Gabriel Canyon Road (Figure 8), and includes a pond that currently provides cool, deep, off-channel habitat for aquatic species.

- As we understand it, however, this is not a natural spring with a near-permanent water supply from groundwater upwelling. Instead, if Morris Dam flows cease during extended dry or drought conditions, this water supply is also cut off, so designation of this area as refugia may be limited.

- Moreover, outflow to the river passes through a buried culvert (approximately 20 feet long under an access road), which is a likely fish passage barrier in its current condition.

Coldwater Springs flows under a dirt road through a culvert and toward the river

Coldwater Springs "oasis" provides deep, cool water habitat and flood flow refugia for aquatic species

- Nevertheless, flow from the springs to the pond could be managed such that ponded water could persist through an extended dry period and provide a dry season refugia.

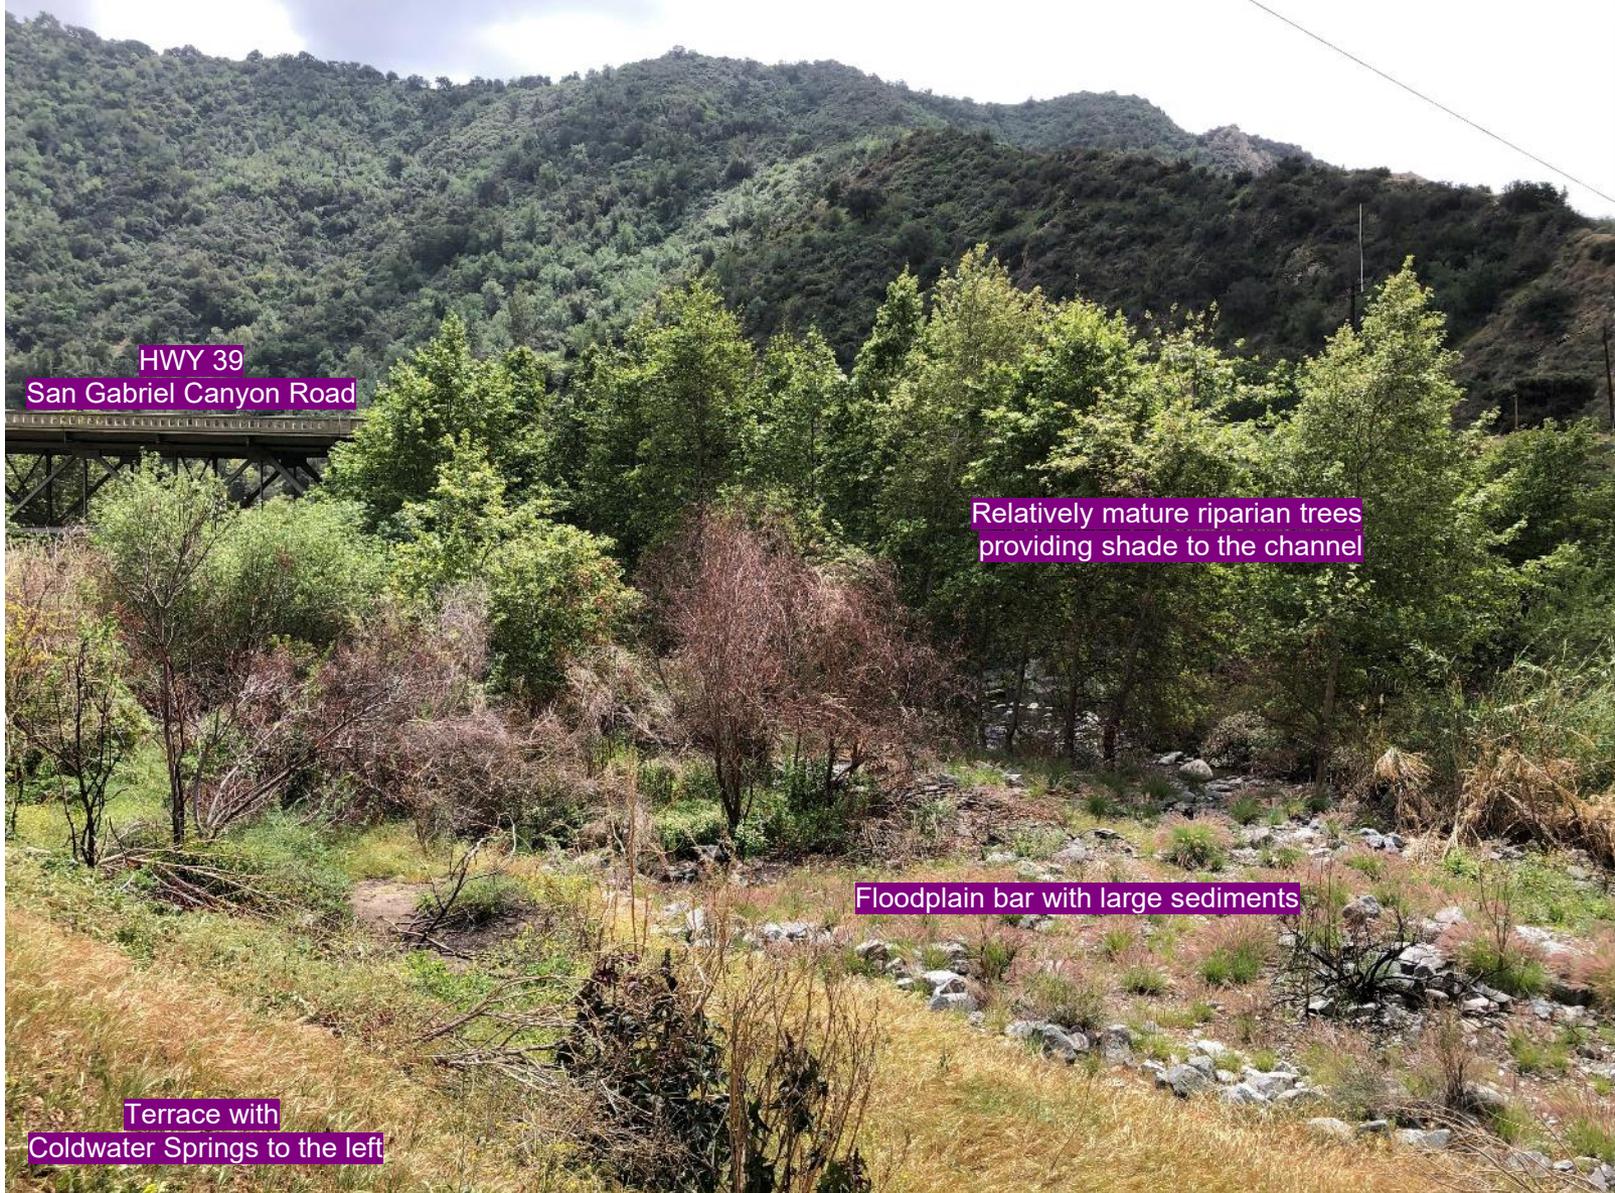
**Figure 8. Looking upstream toward river.** Recent fire evidence can be seen in the browned and blackened vegetation in the fore- and mid-ground of the image. Note that not all riparian vegetation burned. Riparian corridors are known to resist burning to some degree due to temperature and water content.

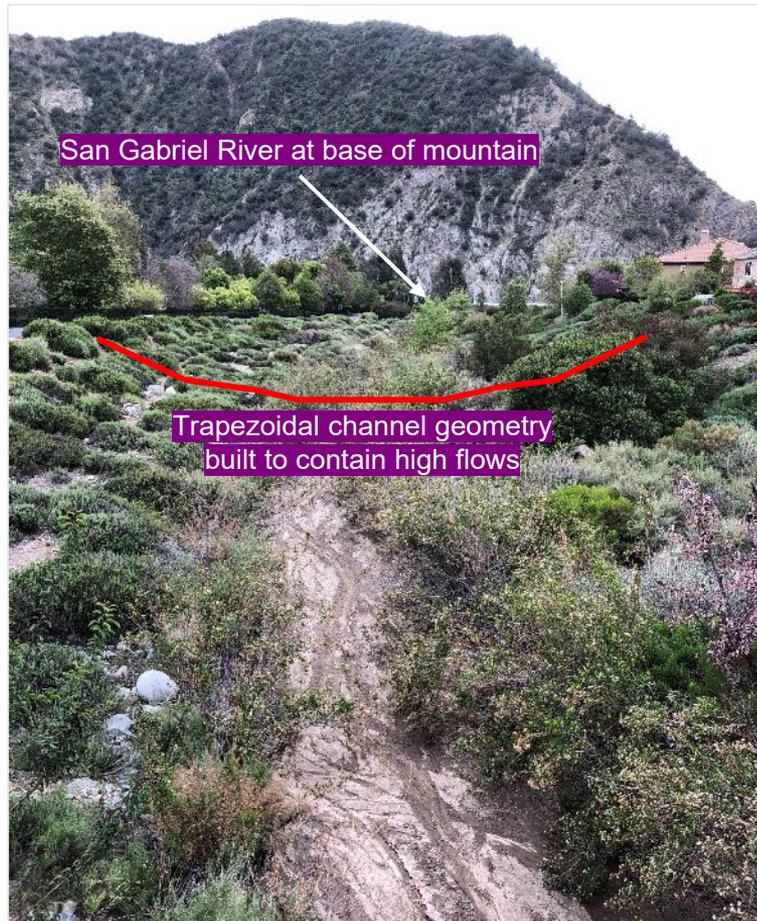
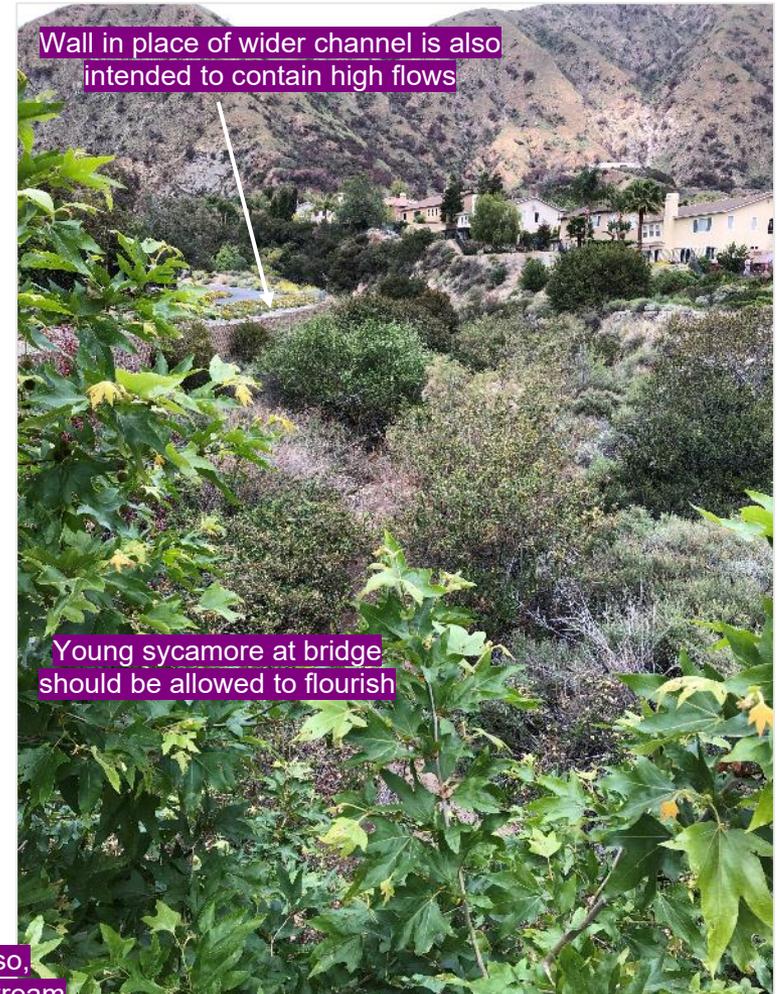
- The creek reach that runs through the Mountain Cove residential development is a straight channel with trapezoidal cross-sectional geometry that was most likely built to contain an estimated 100-year flood event from the upper watershed (a typical configuration for creeks that flow through developments).

San Gabriel River at base of mountain

Trapezoidal channel geometry built to contain high flows

Wall in place of wider channel is also intended to contain high flows

Young sycamore at bridge should be allowed to flourish

Lack of channel features may make it difficult for fish to navigate from the San Gabriel River into the upstream watershed over the next year or so, until channel roughness increases as fine post-fire sediments are washed downstream and depending on what channel structure lays below the silted layer.

**Figure 9. Robert's Creek looking downstream (left) and upstream (right) from bridge in development.** Trapezoidal channel geometry and a wall are intended to contain high flows moving through the Mountain Cove development. The channel lacks mature riparian trees in this area. Recent fire evidence from the 2020 Ranch 2 Fire can be seen in the fine silty sediment on the creek bed.

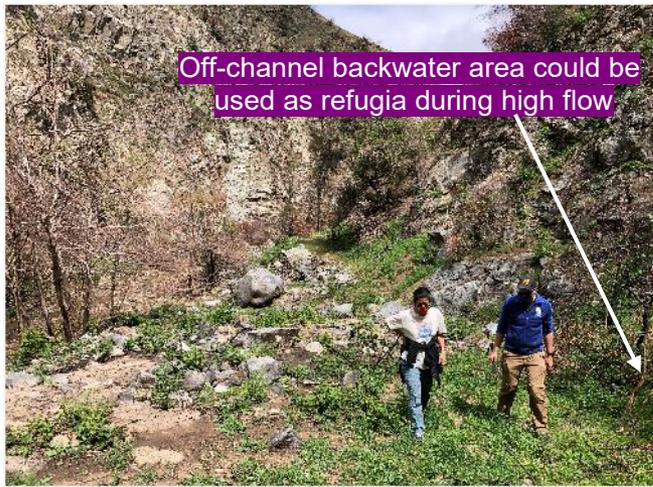
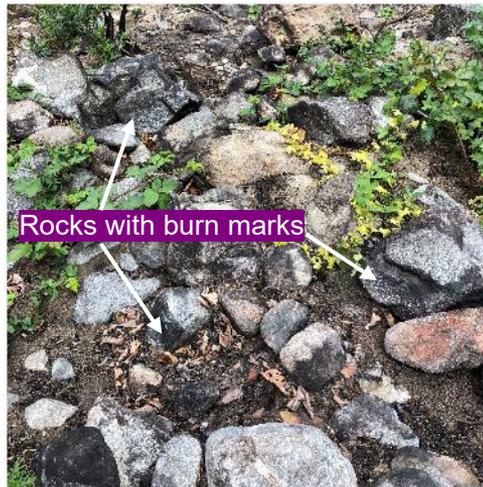
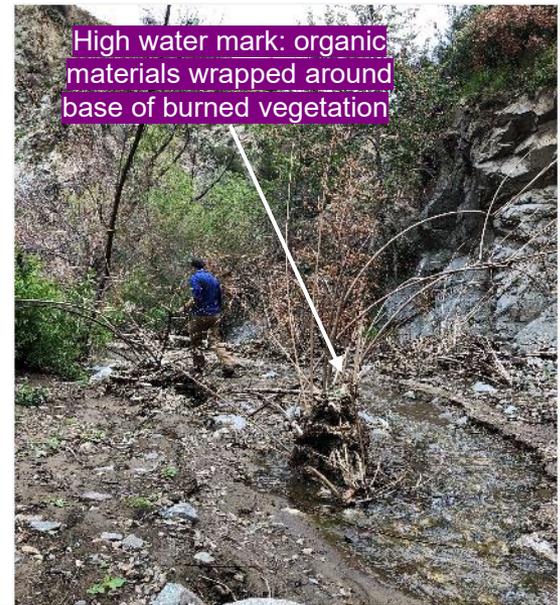
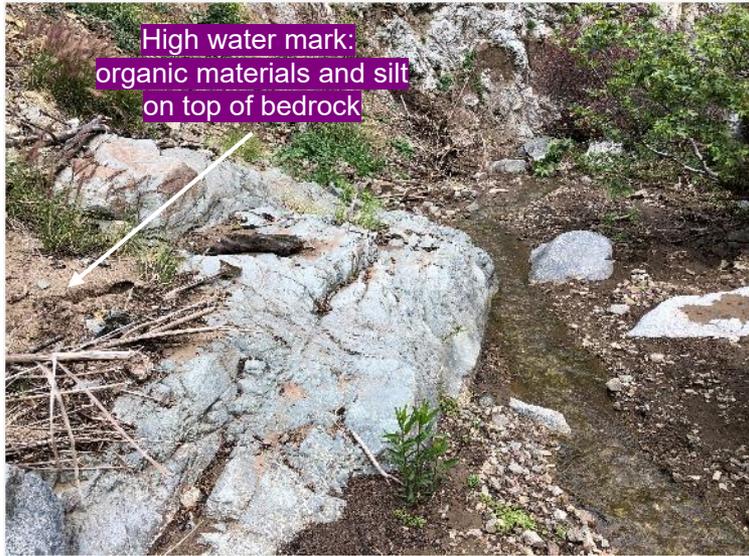
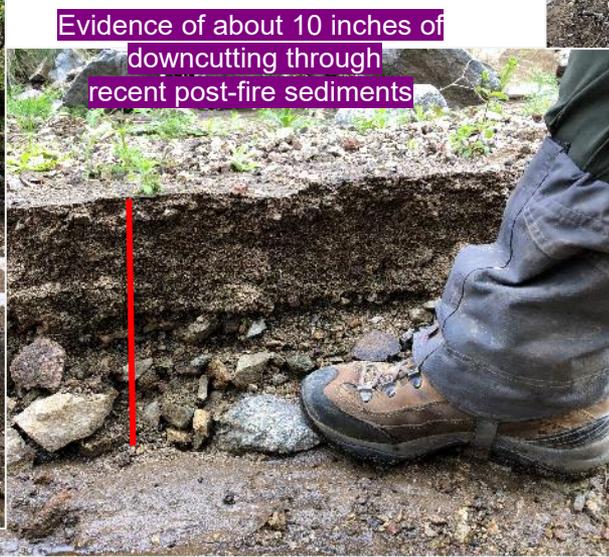
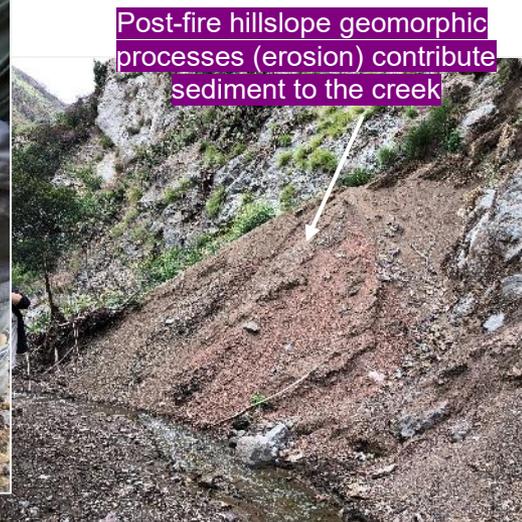
- In the Mountain Cove reach, channel bed structure was not evident under the sedimentation from post-fire erosion from the 2020 Ranch 2 Fire.
  - In the upstream reaches, the channel showed signs of downcutting through the fine post-fire sediments, and a return to toward an equilibrium condition where gravels and cobbles predominate on the channel bed (Figure 10).

- Upstream reconnaissance extended to a point where an off-channel refugia area was identified (Figure 10, upper left-hand corner). Given the size of the watershed and its tributaries, such features may be relatively common but would need to be verified.

**Figure 10. Robert's Creek upstream of development.** Creek flow was present due to recent rain and/or snowmelt. The creek exhibited typical signs of the fire-flow response sequence. Fire promotes higher rates of erosion from hillslopes into channels, creating a higher sediment load that fills the channel. Flows that follow scour out fine sediments until the channel downcuts to a more typical equilibrium condition.

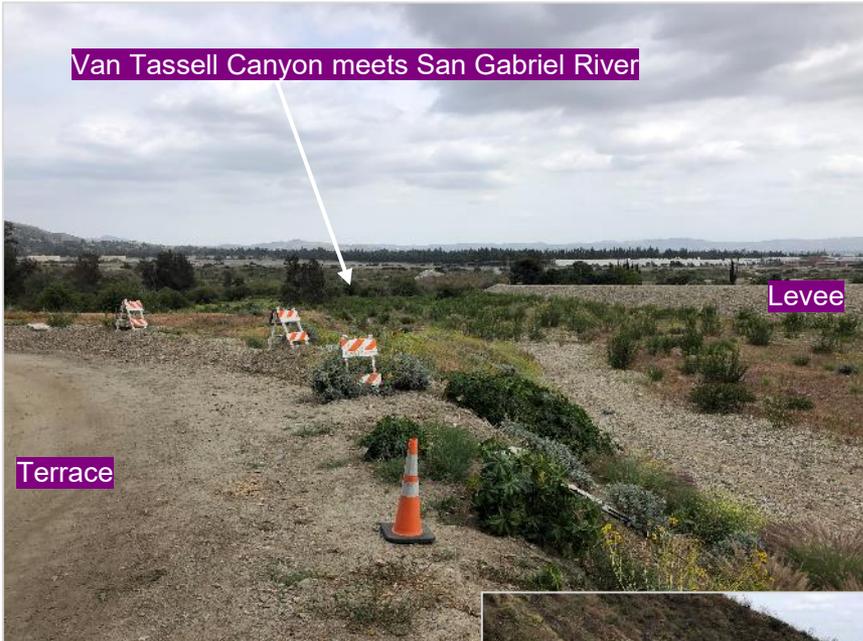
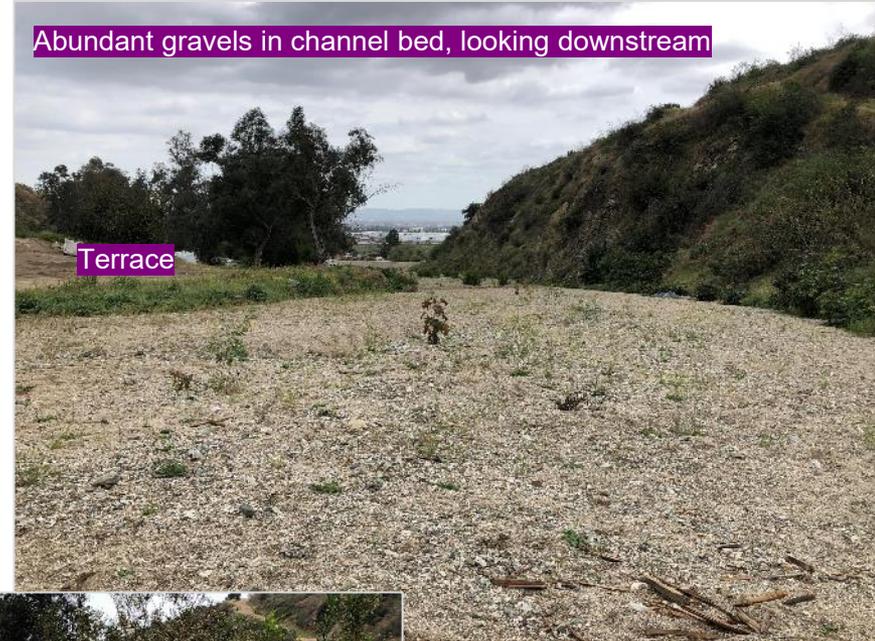
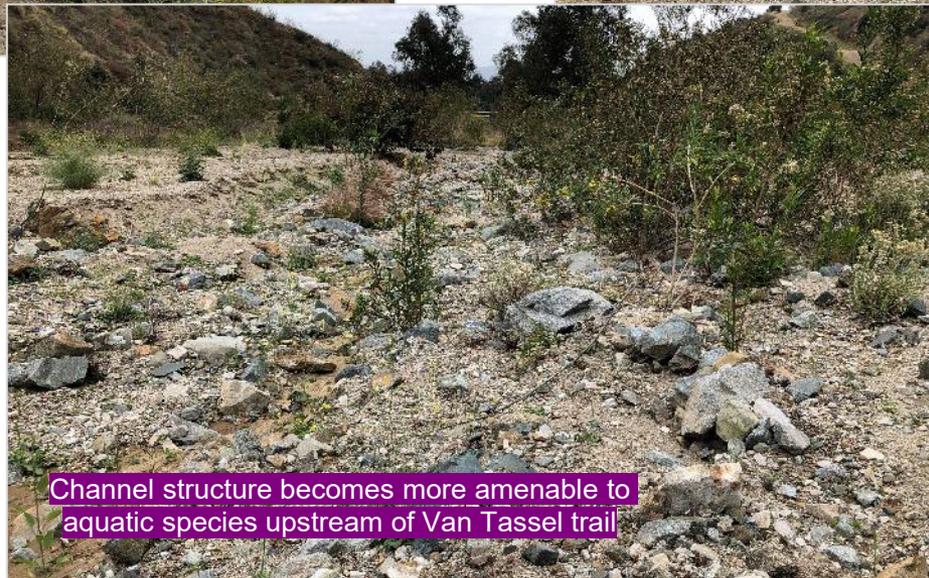
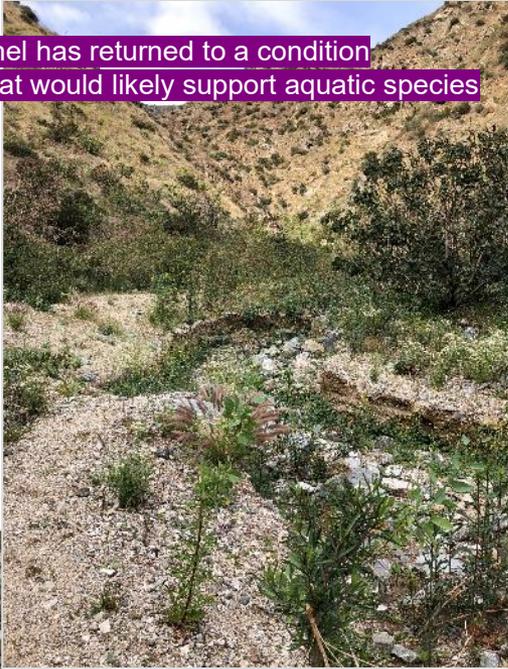
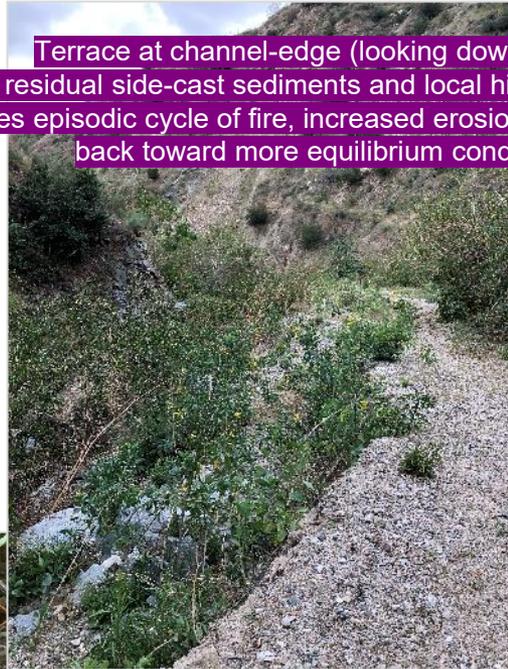
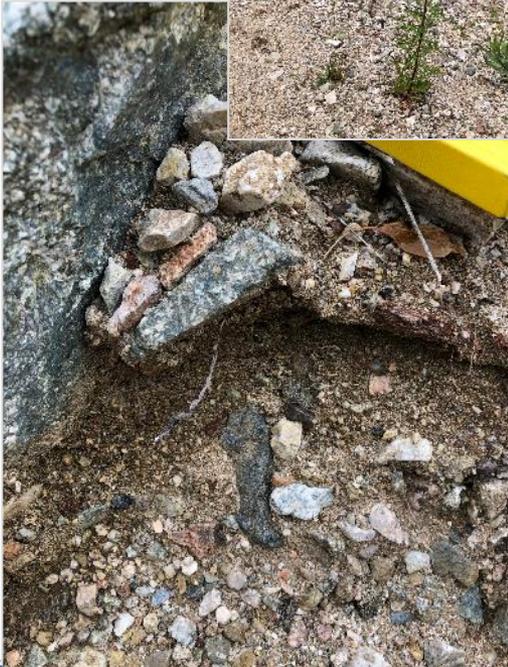
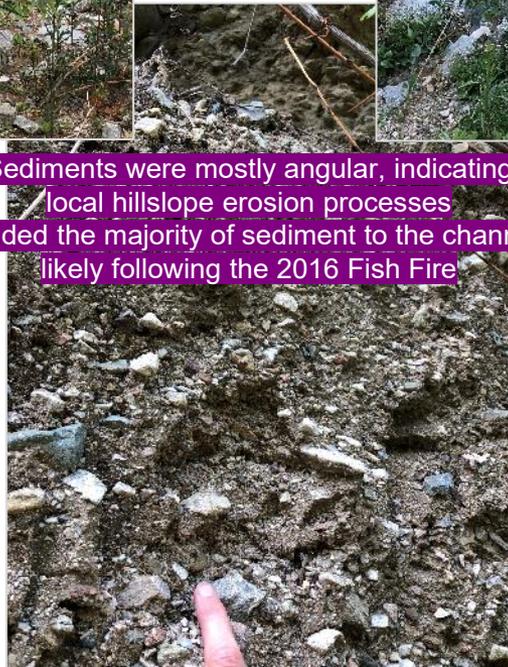
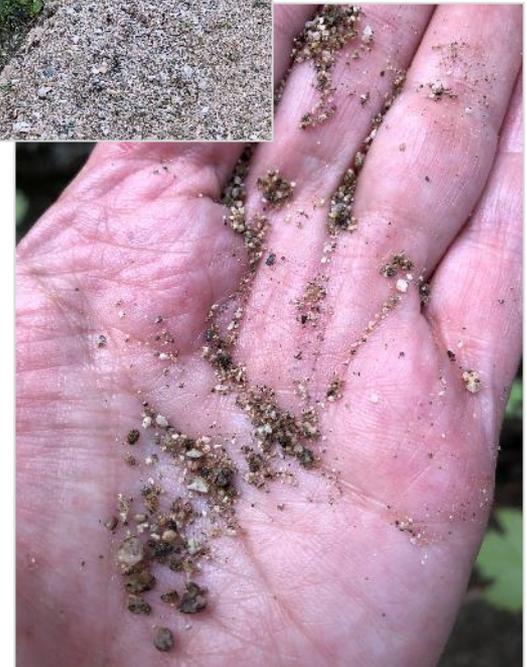
- The channel bed upstream of where the Van Tassell Mtway Trail crosses the creek contained ample angular sediment, but also exhibited channel structure that was likely to be structurally-diverse enough for upstream and downstream fish movement (Figure 12).

Upstream channel has returned to a condition with physical structure that would likely support aquatic species

Terrace at channel-edge (looking downstream) with residual side-cast sediments and local hillslope shedding indicates episodic cycle of fire, increased erosion and downcutting back toward more equilibrium conditions,

Sediments were mostly angular, indicating local hillslope erosion processes provided the majority of sediment to the channel, likely following the 2016 Fish Fire

**Figure 12. Geomorphic processes in Van Tassell Canyon.** Recent fire evidence from the 2016 Fish Fire includes still-standing burned riparian trees as well as angular sediments. Angular sediments indicate shedding from local hillslopes into the channel – a common post-fire occurrence. Conversely, rounded sediments indicate particle smoothing during fluvial (water) transport.
