**MEMO**

**Subject: Existing Conditions and Restoration Opportunities in the San Gabriel River and Azusa Floodplain**

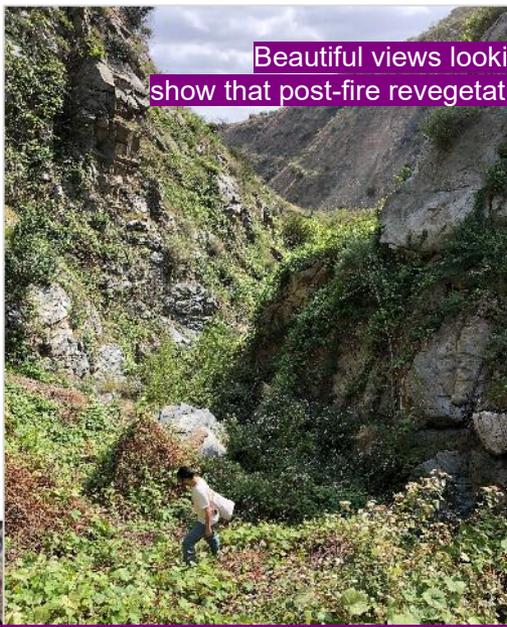
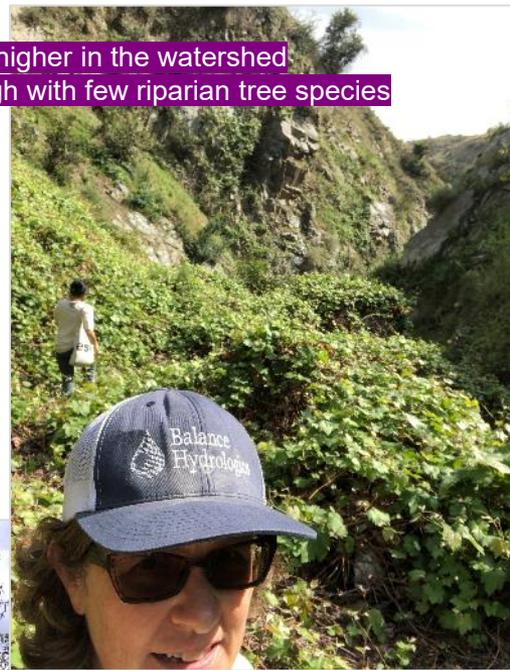
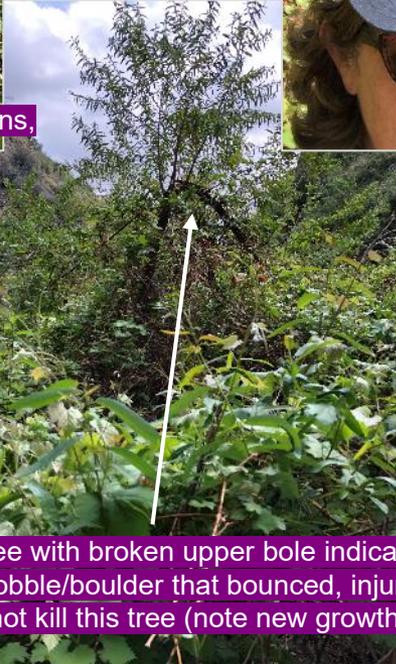
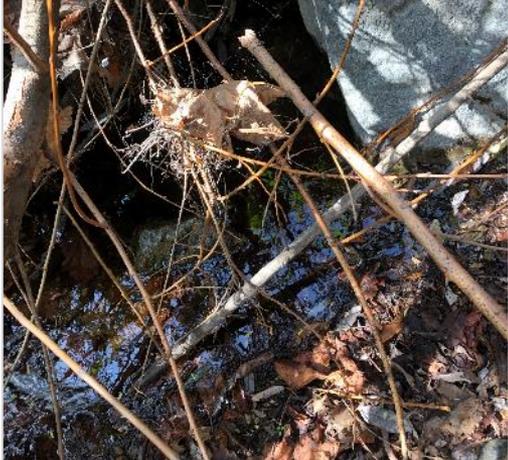
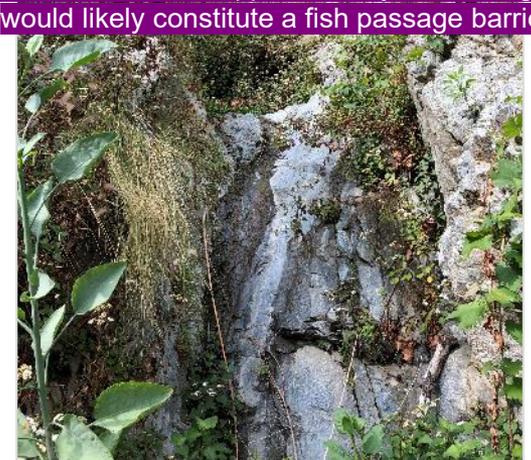
- Reconnaissance was turned around at a waterfall approximately 6-10 feet in height with just enough water to wet the boulder surface (Figure 13, lower right corner). The waterfall is very likely a fish passage barrier under almost all circumstances.

- Returning downstream, we found one small pool of water (Figure 13, lower left corner) with trickling flow. In addition, water appeared to be seeping from a few locations along the right bank (when looking downstream), indicating groundwater expression from local bedrock aquifers. Finally, the confluence of the largest tributary to the west (the trail traverses its ridge) was also wet. Additional reconnaissance would be needed to investigate whether fresh water refugia might be available to fish in this tributary throughout the dry season.

Beautiful views looking downstream from higher in the watershed show that post-fire revegetation is occurring, though with few riparian tree species

Bedrock waterfall approximately 10 feet high would likely constitute a fish passage barrier

Upper watershed channel was moist-to-wet in numerous locations, indicating groundwater seepage and possible presence of refugia locations for aquatic species

Riparian tree with broken upper bole indicates probable cobble/boulder that bounced, injured, but did not kill this tree (note new growth)

**Figure 13. Van Tassell upper watershed.** The channel was steep and fairly narrow; vegetative cover was thick, and moisture, standing water and/or very low flow was present throughout. Likely refugia locations would be available in the mainstem or potentially in larger tributaries along the southern extent of the watershed.

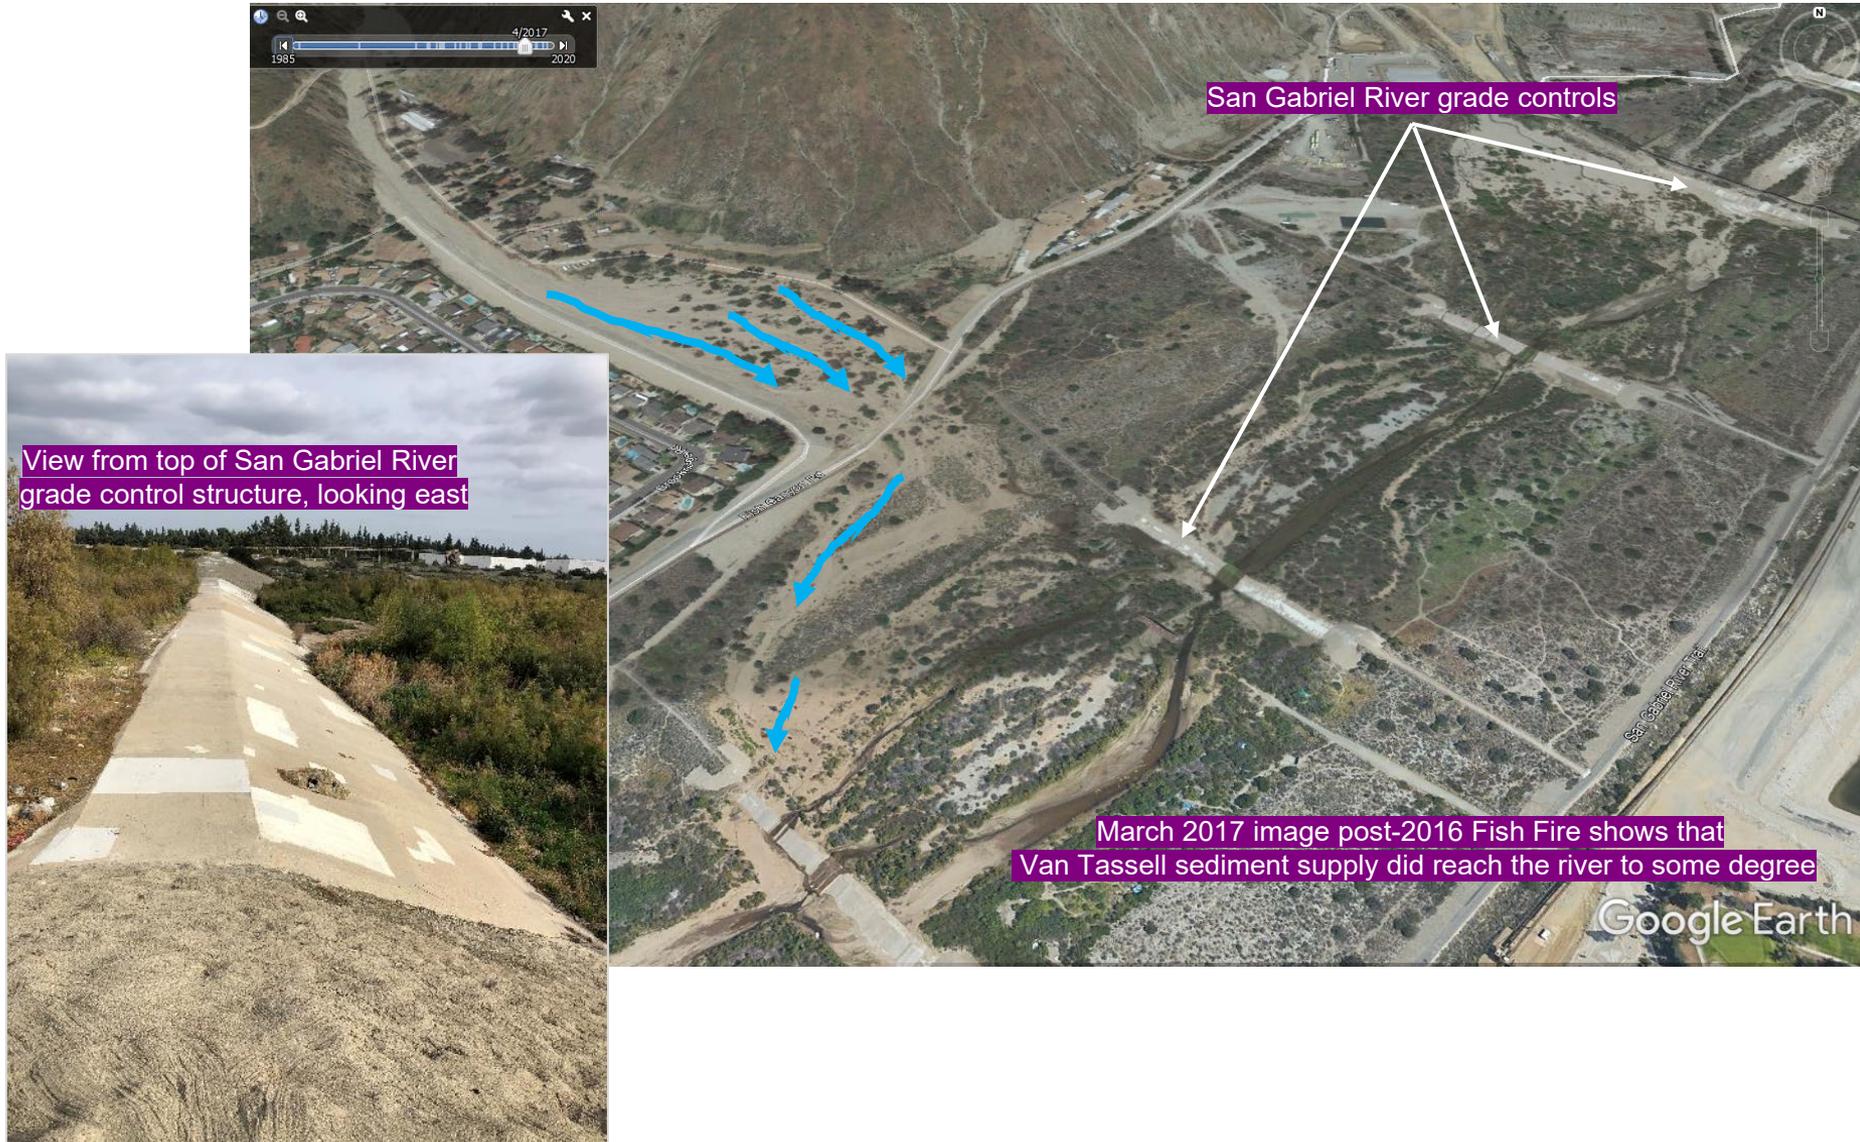
Downstream of the San Gabriel River meander bend, a series of grade control structures stretch across the channel to prevent downcutting (see Figure 14). The structures present barriers at a smaller scale than the dams, but which still moderate flow and sediment transport and present insurmountable fish passage barriers except under higher flow conditions. A thorough hydrology and hydraulics study would be needed to better understand how these structures control flow patterns. In addition, Santa Fe Dam is another barrier a few miles downstream. The river, the tributaries, and the fish and other aquatic species that depend on flow and habitat are in essence “trapped” between Morris Dam and Santa Fe Dam under current conditions.

- Review of the confluence of Van Tassell with the San Gabriel River was attempted by walking along the local earthen grade control structure to where the concrete grade control structure begins (Figure 14), but no clear confluence was found. Upon review, aerial imagery shows that Van Tassell turns south and empties into the San Gabriel River at the next-downstream grade control (Figure 14, right).

**Figure 14. San Gabriel River grade controls.** Van Tassel Canyon sediment supply does not reach the San Gabriel River except under episodic conditions such as post-fire flows. Fish Canyon Road is a sediment barrier, as are management practices such as installation of k-rails (see Google Earth image for better view). Grade control structures in the river promote channel stability instead of natural geomorphic processes. © 2021 Balance Hydrologics, Inc.

- The primary restoration concept for Van Tassell would be to restore physical linkages between the canyon and the river to promote fish passage and sediment transport processes.

- A best-case restoration scenario would be to replace the surface road with a freespan bridge across the lower Van Tassell Canyon floodplain.
  - A more practical restoration scenario would be to install new (additional or larger) culverts under the road to allow for more connectivity than under current conditions.
