Pedestrian Audit #7: Silvercrest Residence

Address: 636 Third Avenue, Chula Vista, CA 91910

Date: August 14, 2025

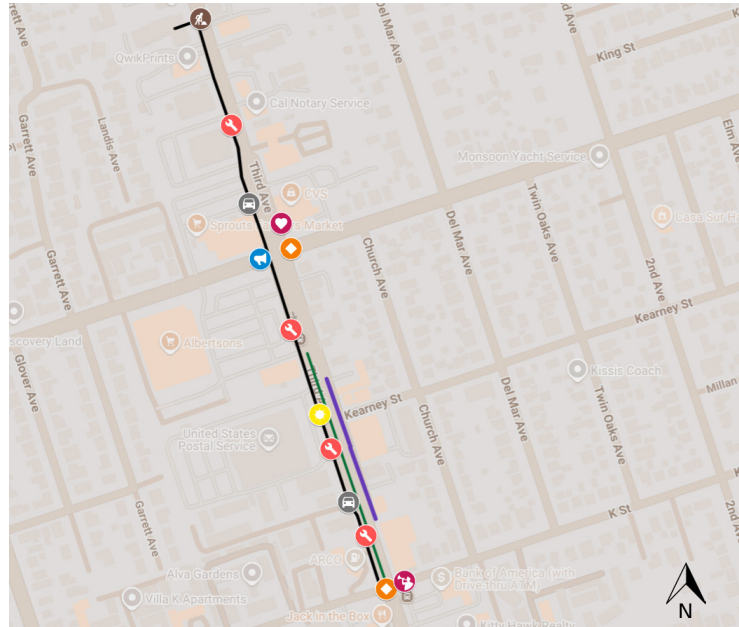
FIGURE 2. SILVERCREST RESIDENCE AUDIT RESULTS

Broken Sidewalk
-

Short Crossing Window
-

Driver Infractions Observed
-

Construction
-

Sharrows
-

High Visibility Crosswalk
-

Audible Crossing
-

Narrow Sidewalk
-

No Audible Crossing
-

No Shade

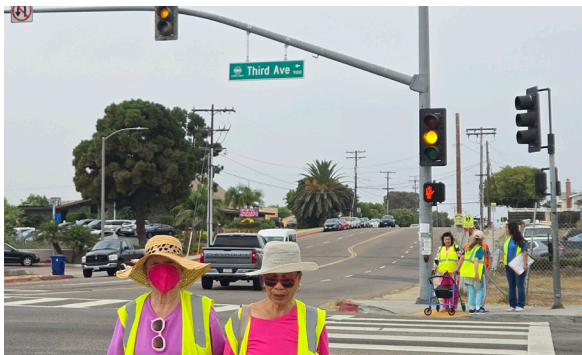
FIGURE 3. THE GROUP SPLIT AT THIRD AVENUE AND K STREET DUE TO A SHORT CROSSING WINDOW.

This audit focused on safety concerns raised by Silvercrest residents (Figure 2), who wanted Circulate to accompany them as they often traverse Third Avenue for groceries. Participants encountered short crossing windows at every intersection: about 15 seconds each (Figure 3). This caused the group to split frequently and led to long pedestrian wait times, which was especially challenging for those with limited mobility. Residents also highlighted broken and narrow sidewalks, pointing out tripping hazards and cautioning the group when surfaces were uneven. Near the post office, the sidewalk became so narrow that some participants had to walk in the street (Figure 4). During the audit, residents noted a lack of shade and benches, so breaks were taken on steps, against walls, or using mobility devices. Only one bus stop provided seating, and that was at the start of the audit. The group also encountered drivers blocking sidewalks, forcing them to detour into the street, and observed drivers not yielding to cyclists on sharrows. Residents expressed that walking can feel unsafe when cyclists use sidewalks due to limited bike infrastructure and drivers speeding. Overall, the audit highlighted the need for smoother sidewalks, longer crossing windows, audible crossings, more benches, and improved bicycle facilities to enhance safety and accessibility for all users.

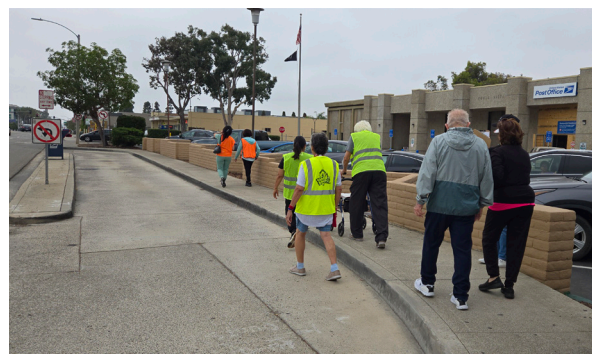
FIGURE 4. PARTICIPANTS WITH LIMITED MOBILITY STRUGGLED ON THIRD AVENUE'S NARROW AND BROKEN SIDEWALKS.
