# Silvercrest Residence Pedestrian Audit

Address: 636 Third Avenue, Chula Vista, CA 91910

Date: March 5, 2026

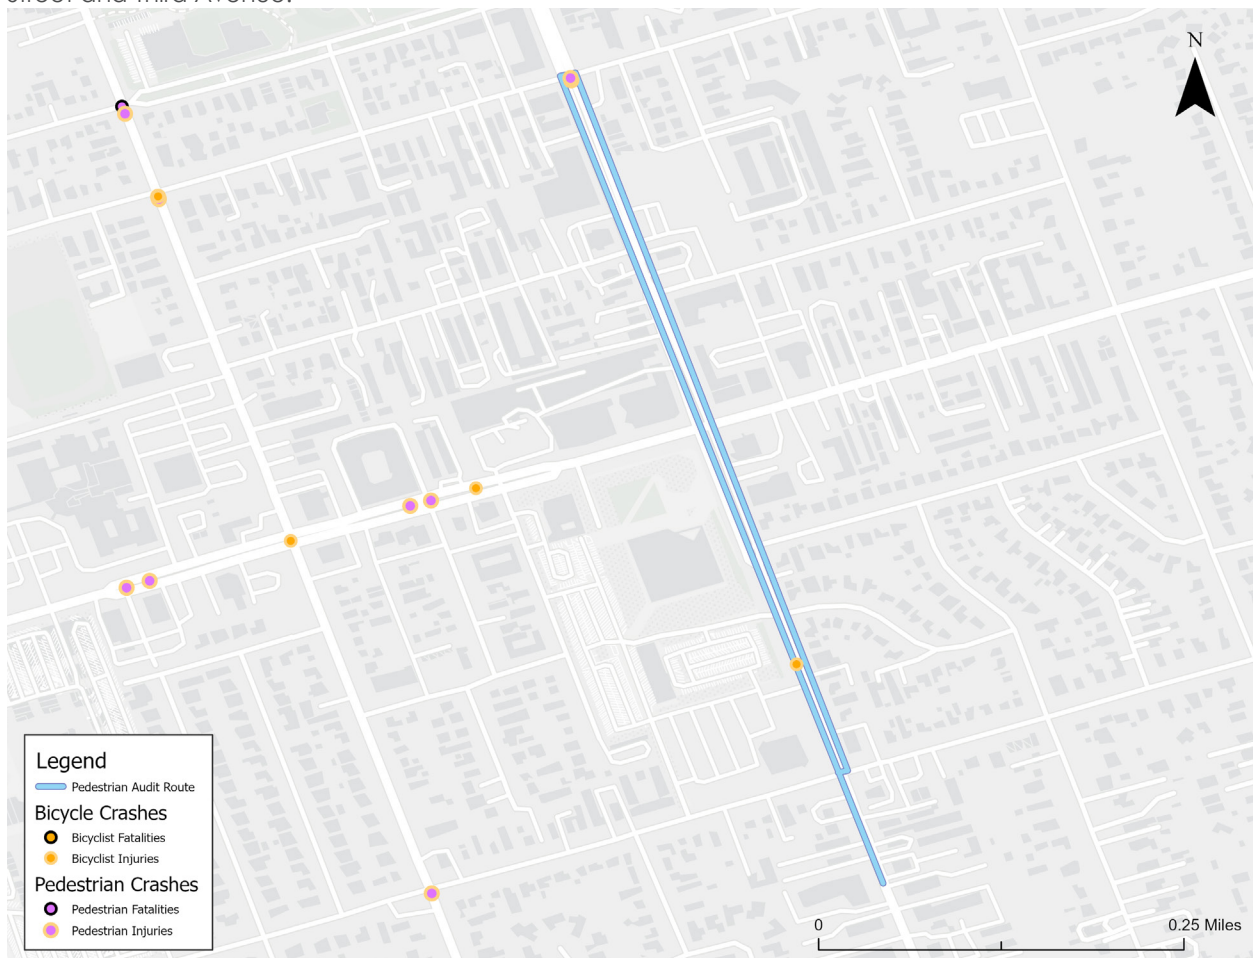
Silvercrest Residence is located near Downtown Chula Vista, near the County of San Diego's Assessor Office and other grocery stores. This audit took place along Third Avenue, between G Street and I Street. Between 2020-2024, there were 10 pedestrians injured, 1 pedestrian killed, and 4 bicyclists injured within a quarter mile of the audit route (see Figure 1). On July 22, 2025, 87-year-old Agustina Acosta was killed after being struck by a driver in a pickup truck inside a Chula Vista parking structure at the intersection of H Street and Third Avenue.

FIGURE 1. PEDESTRIAN AND BICYCLE FATALITIES AND INJURIES PROXIMATE TO SILVERCREST RESIDENCE (2020-2024)

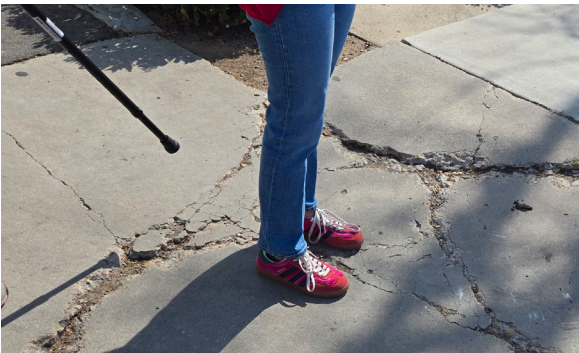
**FIGURE 3. BROKEN SIDEWALKS ALONG THIRD AVENUE MADE TRAVERSING DIFFICULT FOR THOSE USING MOBILITY AIDS.**

This audit focused on pedestrian infrastructure concerns raised by Silvercrest residents (Figure 2), highlighting locations near their residence where improvements could enhance safety and comfort. During the audit, participants noticed how the sidewalk conditions improved in some areas as they got closer to downtown Chula Vista. As the group traversed south on the eastern side of the street, they encountered multiple areas with broken sidewalks, particularly near I Street, which made traversing difficult (Figure 3). While most crosswalks provided participants with sufficient time to cross, the signal at Third Avenue and I Street was concerning. The east-to-west crossing had a short crossing window, meaning some participants with mobility challenges were still in the crosswalk when the countdown ended, and the light changed (Figure 4). Residents also identified locations lacking basic pedestrian infrastructure, noting, for example, that the bus stop near their residence lacked a bench and a sheltered bus stop. During the audit, the group had to constantly point out tripping hazards such as broken utility boxes, poles with exposed wires, trash, and overgrown plants, cautioning participants to navigate carefully. Overall, the audit highlighted the need for smoother sidewalks, longer crossing windows, benches, and sheltered bus stops, and removal of tripping hazards to enhance safety and comfort for all pedestrians, including those with mobility aids.

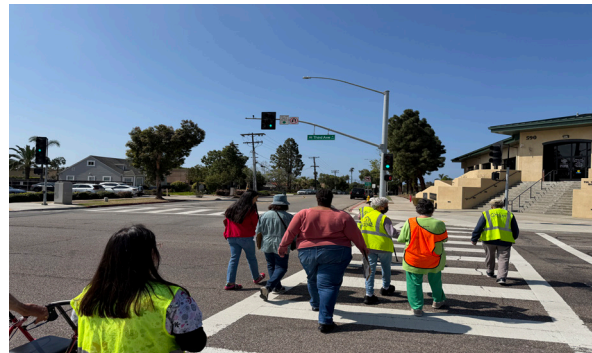
**FIGURE 4. AT THIRD AVENUE AND I STREET, PARTICIPANTS ENCOUNTERED A SHORT CROSSING WINDOW**
