# The Pasea Pedestrian Audit

Address: 1420 E Palomar Street, Chula Vista, CA 91913

Date: May 7th, 2026

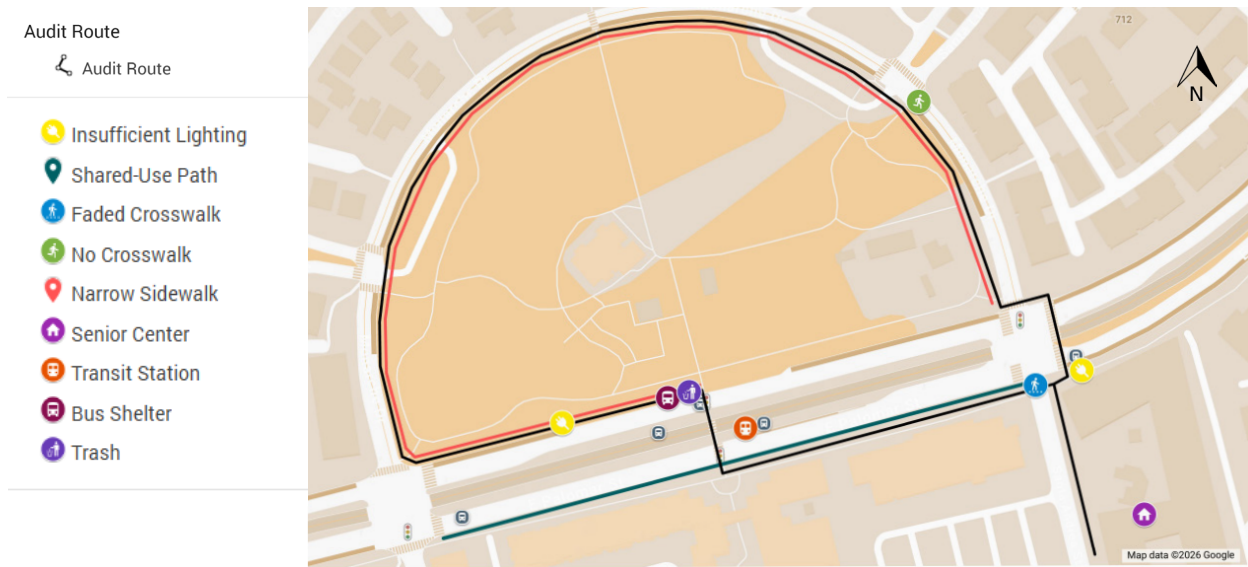
The Pasea is a senior living residency, making it important to install signage that alerts drivers to the presence of older adults in the surrounding area. Observations mapped in Figure 2 identify gaps that affect pedestrian comfort and safety, particularly related to crossings, sidewalk conditions, and accessibility. Sidewalk conditions along Monarche Drive vary. The

Figure 2. The Pasea Pedestrian Audit results

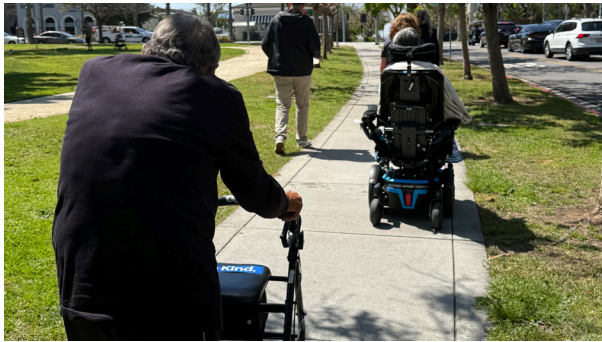
Figure 3. Participants frequently stated that the sidewalks are not wide enough for two people with mobility aids to walk next to each other throughout Heritage Park.

intersection of Monarche Drive and Santa Lucia Road, located directly across from Heritage Park, has an unmarked crosswalk, creating potential safety concerns for pedestrians. Additionally, Figure 3 highlights narrow sidewalks throughout Heritage Park and near The Pasea, limiting pedestrians' ability to comfortably pass one another. These sidewalks are especially difficult for individuals using mobility devices or strollers, as they can not adequately accommodate side-by-side movement. Along East Palomar Street uneven pavement and exposed tree well areas create tripping hazards and further reduce accessibility. Installing metal tree plates in these locations would improve mobility by allowing wheelchairs and other mobility devices to pass more easily when pedestrians are traveling in opposite directions (see Figure 4). Bicycle infrastructure along the corridor is limited to a shared-use path on East Palomar Street, where bicyclists and pedestrians share the same space. Participants noted that the path becomes congested during after school hours, seeing students go high speeds on their e-bikes, increasing the potential conflicts between bicyclists and pedestrians. Improved signage and ground markings identifying the corridor as a shared-use path is recommended to encourage safer speeds and clearer expectations for all users. Additionally, participants reported that nighttime lighting in the area is inadequate, with many relying on illumination from nearby buildings rather than pedestrian-scale street lighting. Overall, the corridor would benefit from a combination of short- and long-term improvements, including re-striping and adding crosswalks, widening sidewalks, improving visibility and wayfinding for the shared-use path, installing additional street lighting, and enhancing bicycle infrastructure. Prioritizing these upgrades, would create a safer, more accessible, and more comfortable environment for all residents.

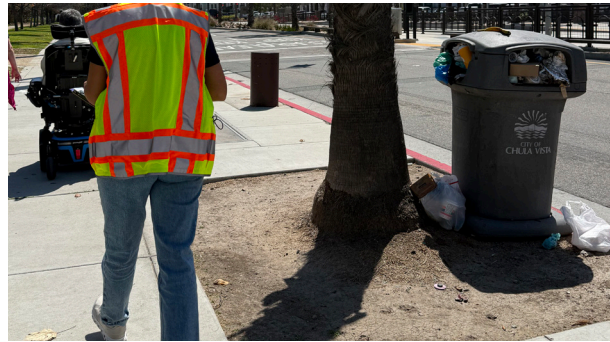
Figure 4. Participants stated that on East Palomar Street there should be metal tree plates so that mobility aids don't get caught on the dirt or tip over.
