# Logan Heights CDC Pedestrian Audit

Address: 3040 Imperial Avenue, San Diego, CA 92102

Date: May 29, 2026

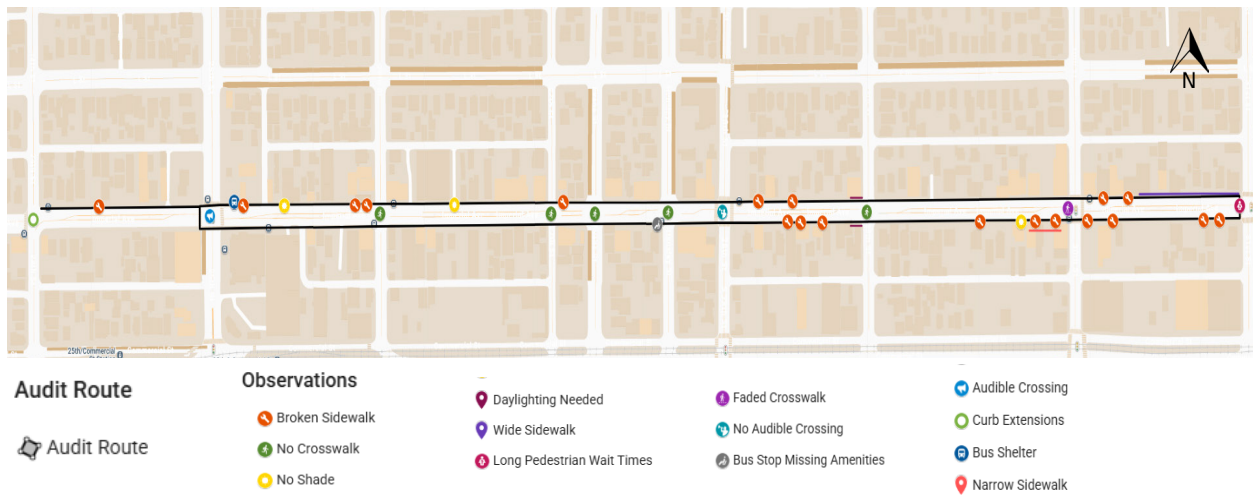
**Figure 2. Logan Heights CDC audit results**

Throughout the pedestrian audit, the group observed a lack of pedestrian-scale lighting, deteriorating sidewalk conditions, and aggressive driver behavior. As shown in Figure 2, many of the issues raised by residents were observed during the pedestrian audit. Participants noted numerous broken and uneven sidewalks along Imperial Avenue that narrowed the pedestrian walkway and created hazards for people walking (see Figure 3). The group also observed several intersections with unmarked crosswalks along Imperial Avenue, a corridor that has speeding vehicles. At the intersection of Imperial Avenue and 26th Street, participants witnessed a driver traveling at a high speed that failed to properly stop at the stop sign, crossing beyond the stop bar and encroaching into the pedestrian crossing area (see Figure 4). Additional concerns included limited shade along the north side of Imperial Avenue, a lack of pedestrian-scale lighting throughout the route, transit stops without shelters, and signalized intersections that provided insufficient crossing time for pedestrians. For example, participants noted that the pedestrian signal at 28th Street did not allow adequate time to safely cross. These observations highlight several opportunities to improve pedestrian safety and comfort in the area. Potential enhancements include longer pedestrian crossing times, leading pedestrian intervals, audible pedestrian signals, high-visibility marked crosswalks, smoother sidewalks, additional street lighting, increased tree canopy, improved transit stop amenities, and curb extensions similar to the existing ones on 24th Street.

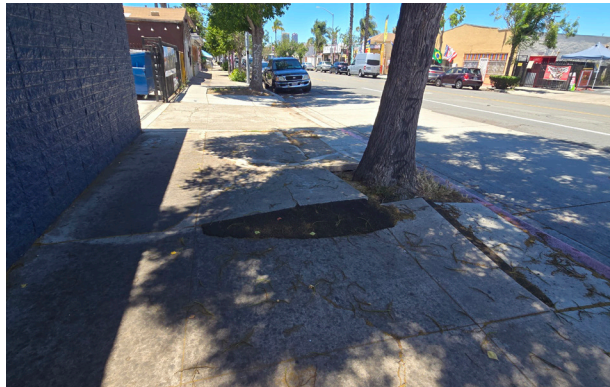
**Figure 3: Uneven and broken sidewalks observed all throughout Imperial Avenue.**

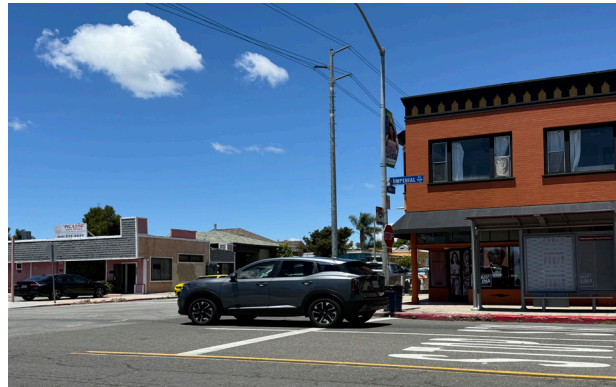
**Figure 4: Speeding driver on 26th Street failed to properly stop at the stop sign.**
