Walking Field Trip #3: Park Boulevard and El Cajon Boulevard

Address: Corner of Park Boulevard and El Cajon Boulevard

Date: April 28, 2023

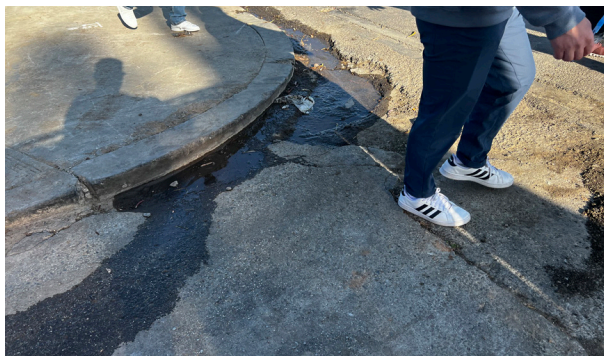
FIGURE 3: NO PAINTED CROSSWALK AND FLOODED POT-HOLE CREATES UNSAFE WALKING CONDITIONS

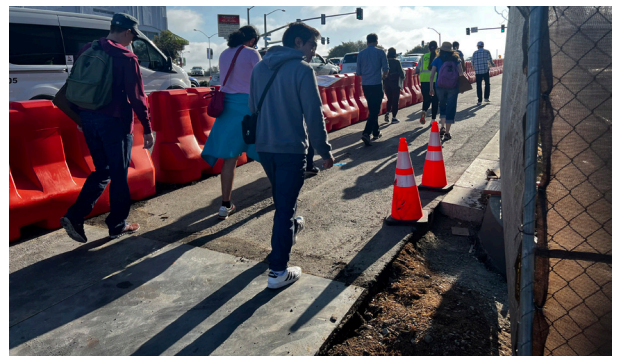
FIGURE 4: GROUP PARTICIPATING ON TRIP; TEMPORARY SIDEWALK AMIDST THE CONSTRUCTION
