Pedestrian Field Trip #7: Potiker Senior Residence

Address: 525 14th St, San Diego, CA 92101

Date: February 18th, 2025

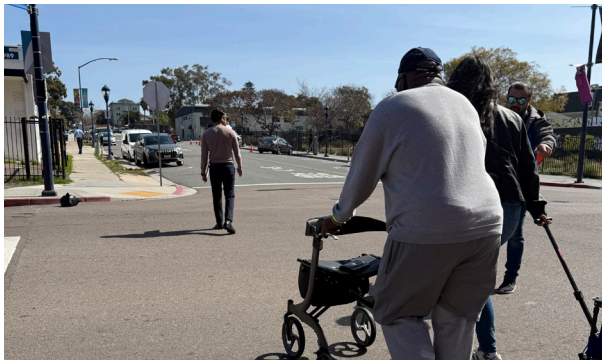
FIGURE 3: PARTICIPANTS NOTED MANY INTERSECTIONS ON ISLAND AVENUE WITHOUT CROSSWALKS AND CURB EXTENSIONS WHILE CROSSING.

Circulate and the participants assessed the pedestrian conditions between the Potiker Senior Residence building and Interstate 5 (see Figure 2). Between 15th and 17th Streets on Island Avenue, participants noted the absence of traffic calming measures, such as curb extensions and crosswalks, which made it challenging for participants using mobility aids to feel visible. Serving Seniors staff assisted by stopping traffic to help the older adults cross the street safely (see Figure 3). As the group approached Market Street, participants noticed broken sidewalks and the absence of crosswalks on both 15th and 17th Street. At these intersections, diverters are also in place to prevent drivers from going straight or making left turns; however, participants observed that the diverters were broken. At the intersection of 16th Street and Market Street, the group observed drivers encroaching on the crosswalk, despite the short crossing window (see Figure 4). Nonetheless, participants appreciated the wide sidewalks around their residence building. This pedestrian audit reinforced the need for high-visibility crosswalks, curb extensions, and median islands to ensure individuals of all ages and abilities can travel safely on our streets. Installing a hardened median at the intersections of 15th, 17th, and Market Streets would assist in preventing driver infractions.

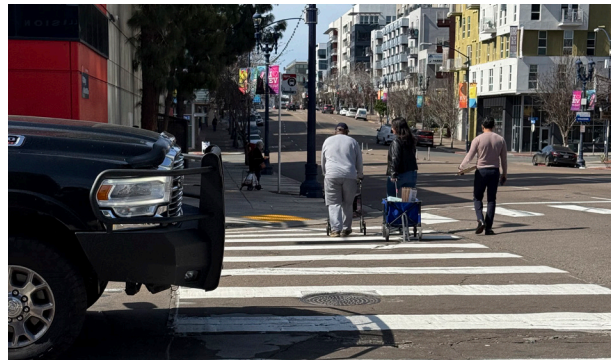
FIGURE 4: PARTICIPANTS OBSERVED DRIVERS FAILING TO YIELD AS THEY CROSSED THE INTERSECTION OF 16TH STREET AND MARKET STREET.
