Biological Resources Survey and Report for “Baseline Dry Season In-Channel Vegetation Mapping”

Los Angeles River (and selected reference sites)

Date: February 28, 2022

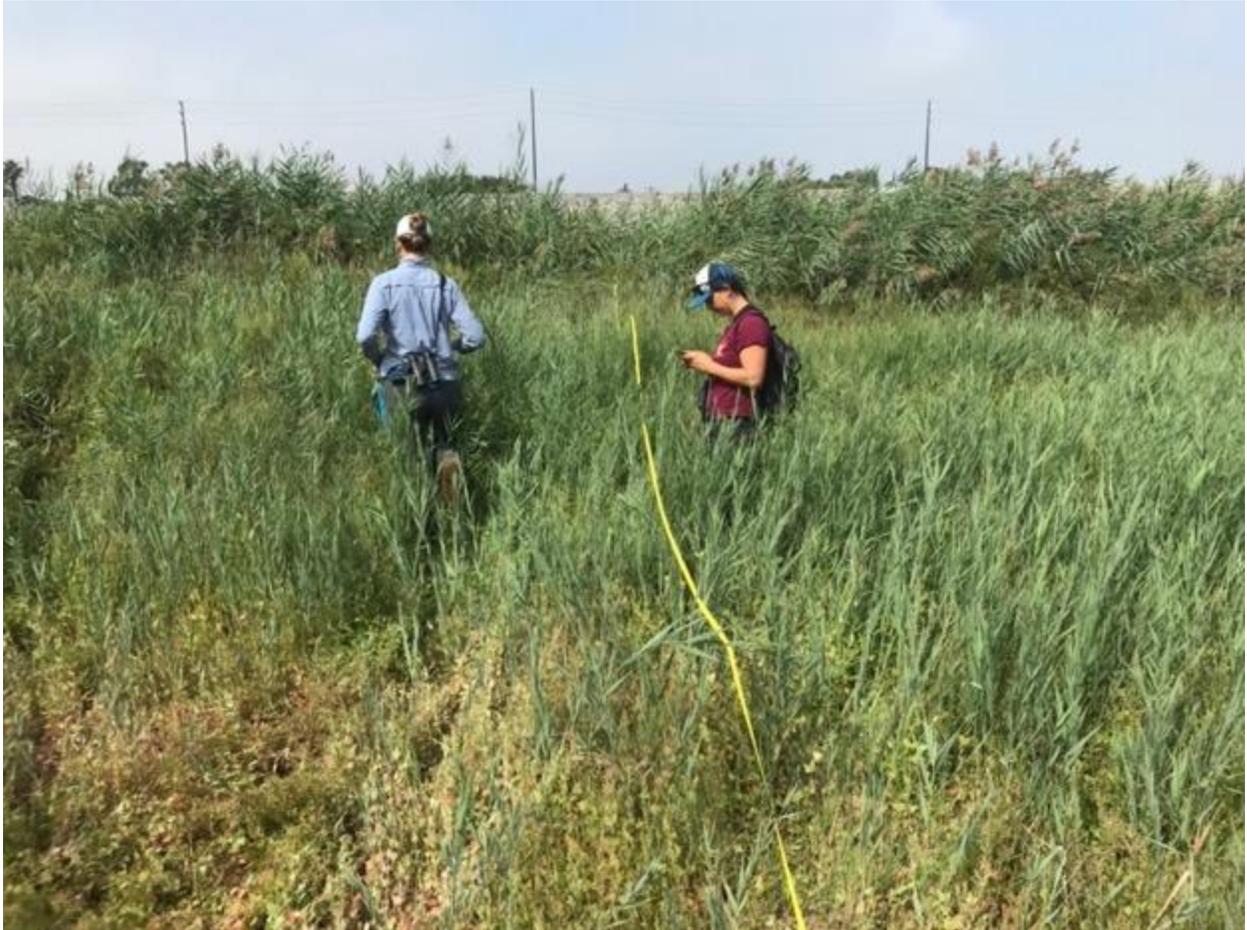
Figure 1. Collecting vegetation data along a line transect, Willow St. (Long Beach), 1 Sept. 2021.

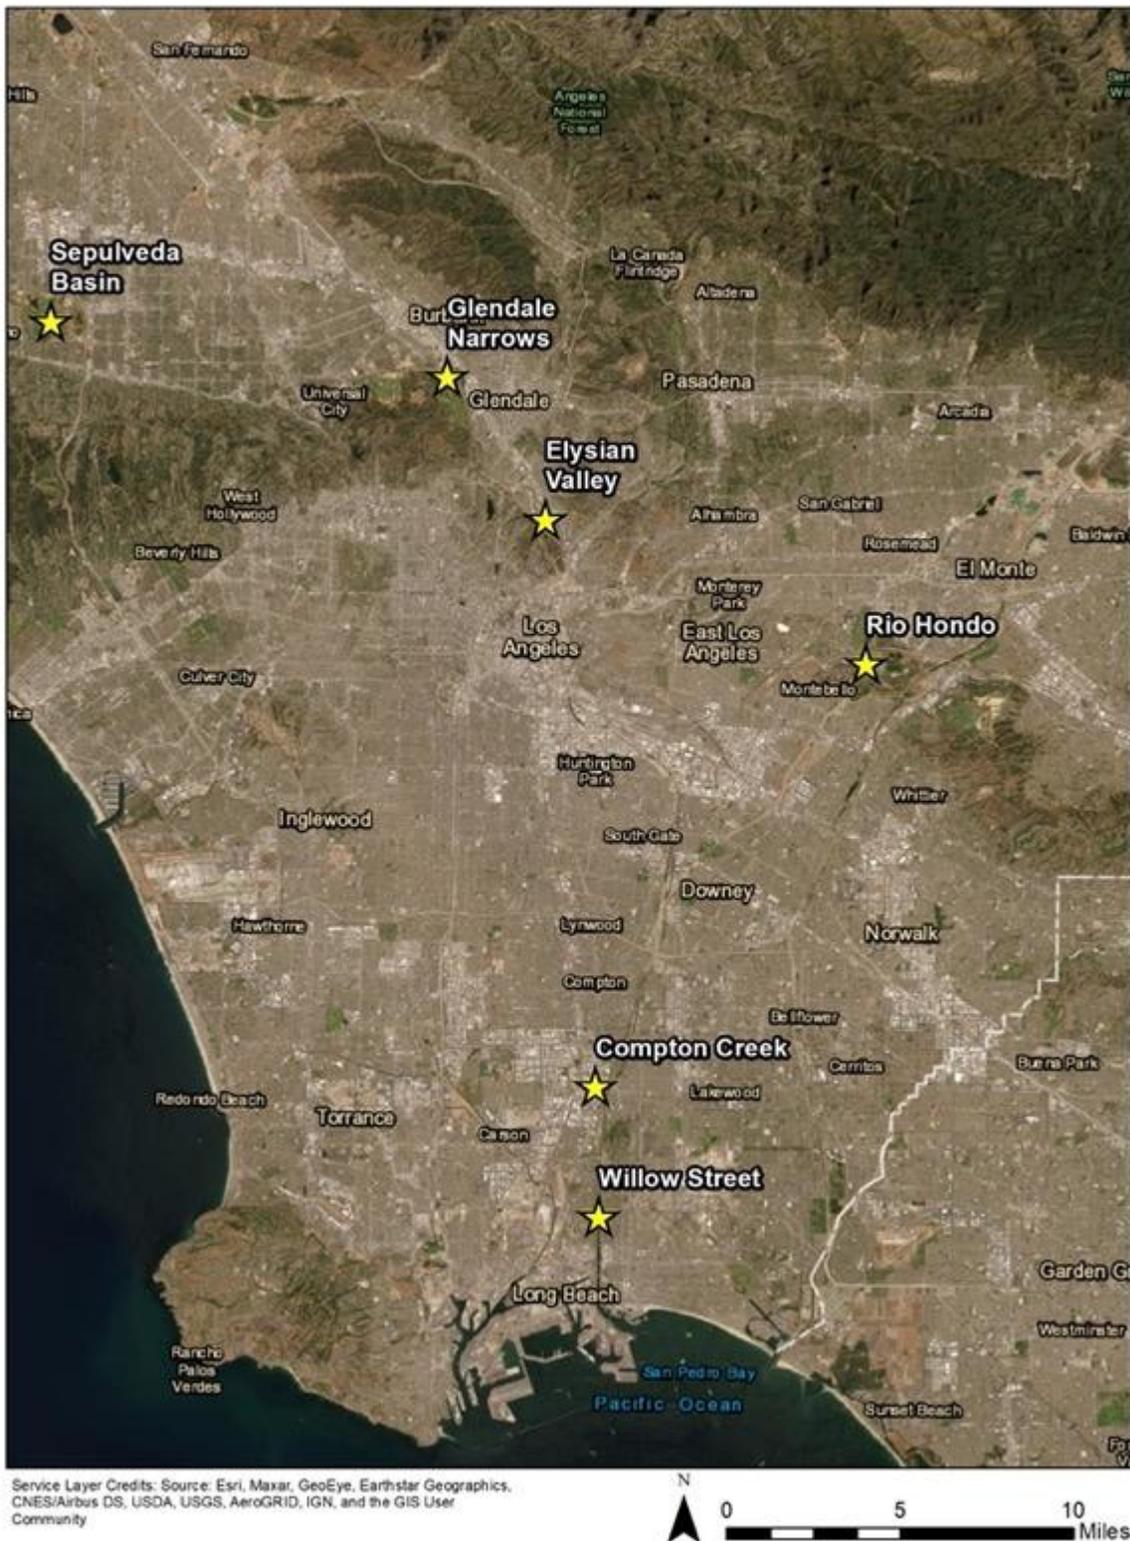
Figure 2. Locations of line transects used in vegetation mapping.

Figure 2 for map of sites where transects were used). For analysis, these points were pooled by site, and the resulting break-down of dominant species and vegetation height was analyzed.

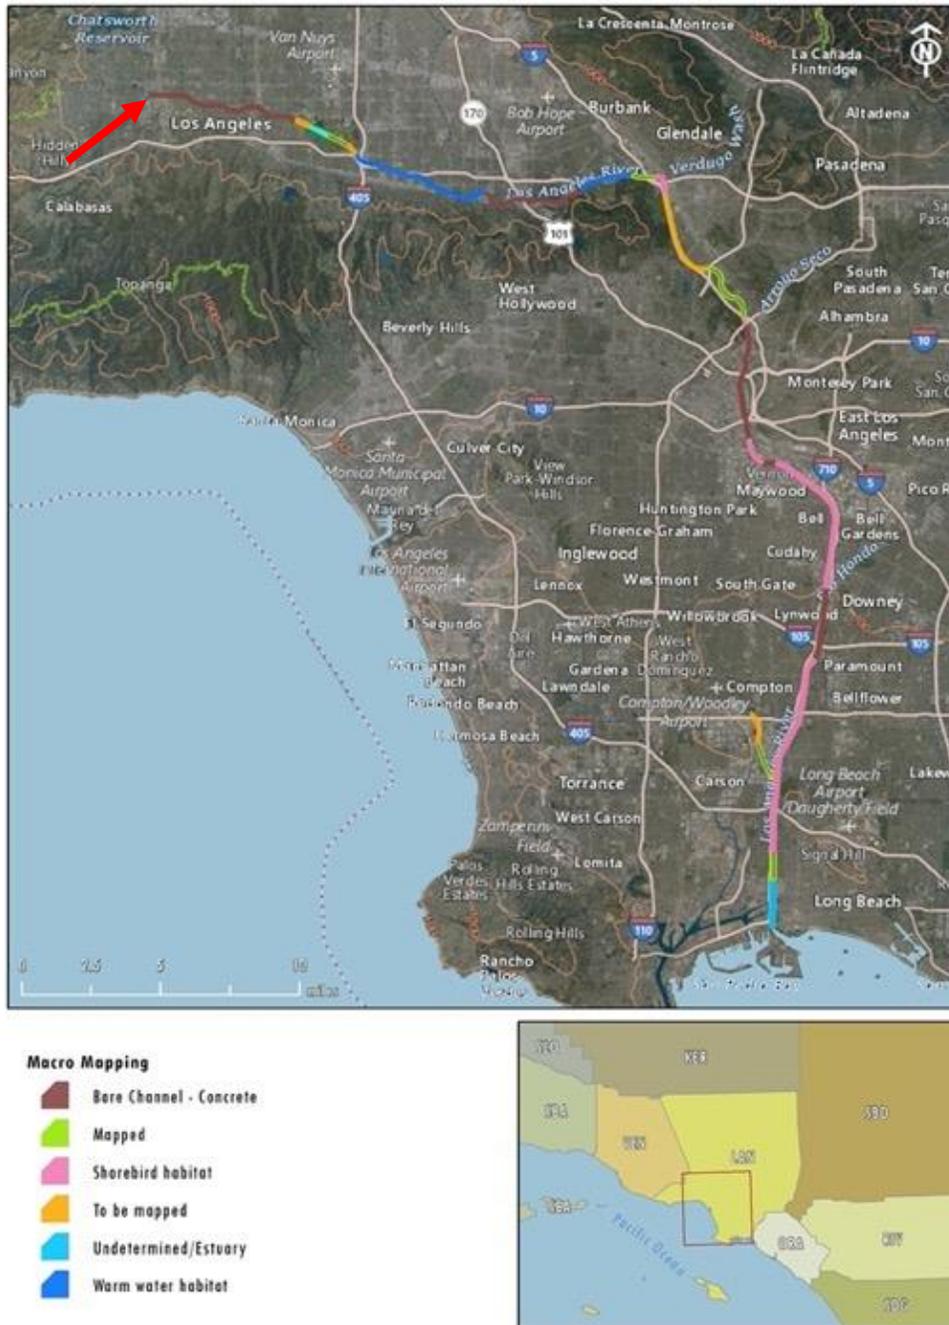
Figure 3. Major in-channel habitats and focal areas of Los Angeles River, this study. Please see **Appendix A** for detailed/fine-scale mapping of areas listed as “Mapped” (green). As a note, we consider the start of the “Los Angeles River channel” to be the confluence of Bell and Calabasas creeks in the west San Fernando Valley (red arrow). The Rio Hondo reference site is located well to the east, and is not shown here.

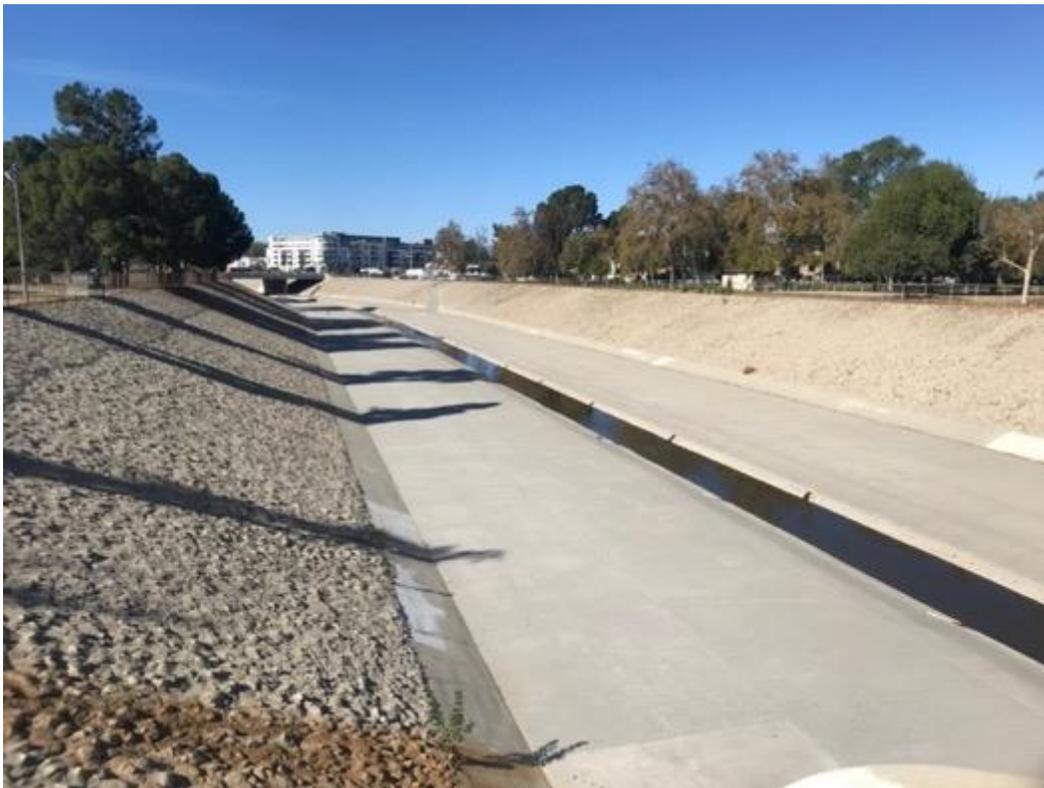
Figure 4. Bare Channel – Concrete habitat (Reseda Blvd., 27 Nov. 2021).

These were areas with neither vegetation nor water along the river channel. We also mapped areas with only a narrow flow of water through a lowered central channel through the concrete as “Bare channel – Concrete” since the rest of the channel area here was largely concrete (**Figure 4**).

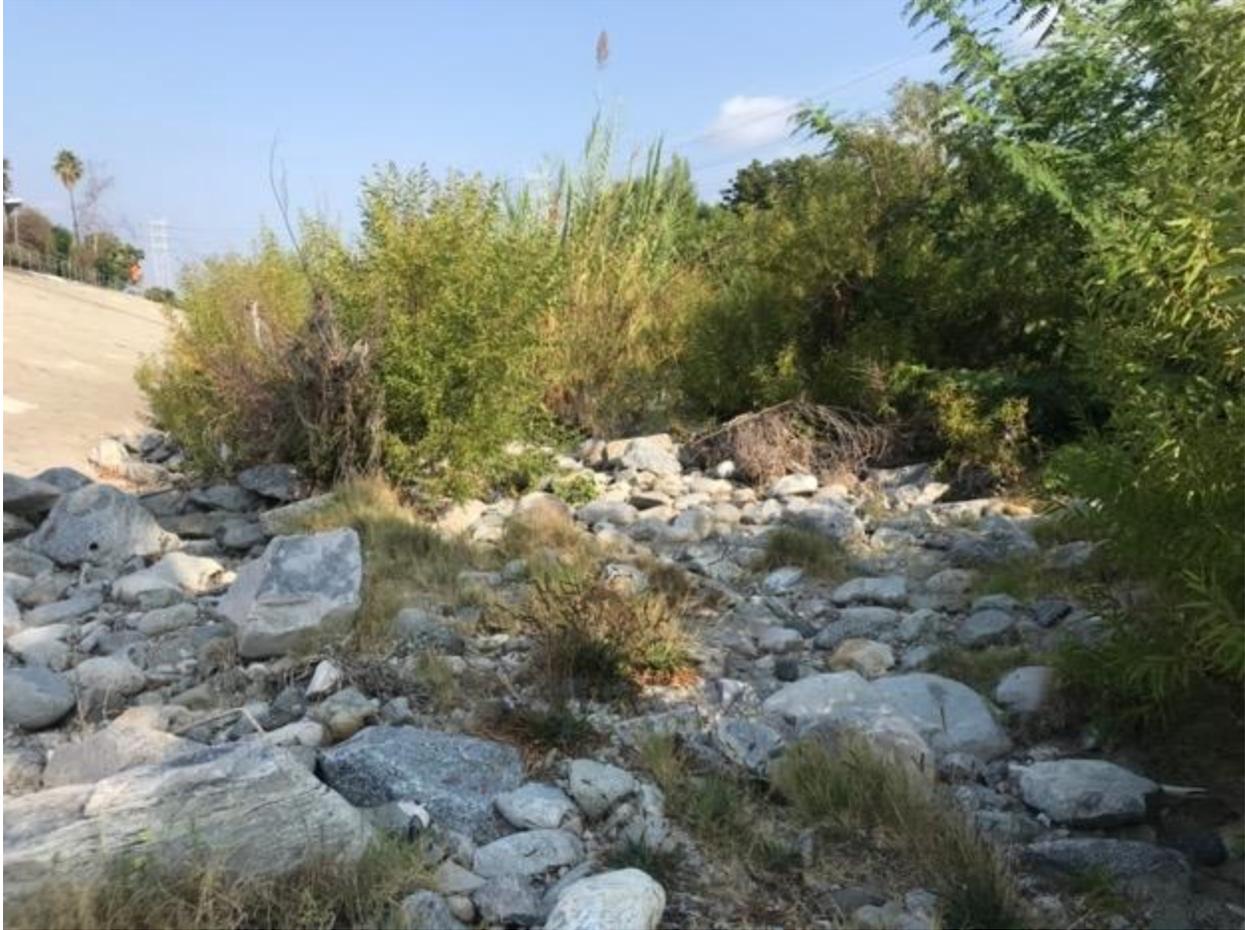
Figure 5. Bare Channel – Natural habitat, within an opening in riparian vegetation, well away from normal water flows and supporting a largely “upland” vegetation and wildlife community (e.g., scrubland insects and reptiles (Elysian Valley, 29 Sept. 2021).

Naturally-forming areas of boulders, cobbles, gravelly/sandy soil, or dried mud along the channel (**Figure 5**), if un-(or sparsely-) vegetated, cannot be easily placed into the other categories, and like many areas of Transitional Herbaceous habitat, are transitory (if important) components of the river channel system. These provide foraging areas for a variety of birds, reptiles, and other wildlife, depending on how wet they are, and essentially re-create what would have been natural open-soil areas of the formerly un-channelized Los Angeles River (most natural rivers are characterized by large areas of sand and/or bare soil). Therefore, we felt it was important to draw attention to these areas. In the study area, most examples were found at Willow St., with Elysian Valley having areas of sandy soil with scattered herbs/forbs. At Rio Hondo, we observed natural river bars and braided-channel/wash areas on the floor of the channel, some of which had drying pools during our visits in October 2021. These ecosystems are strongly reminiscent of natural rivers throughout the West, and have been largely lost along the mainstem of the Los Angeles River.

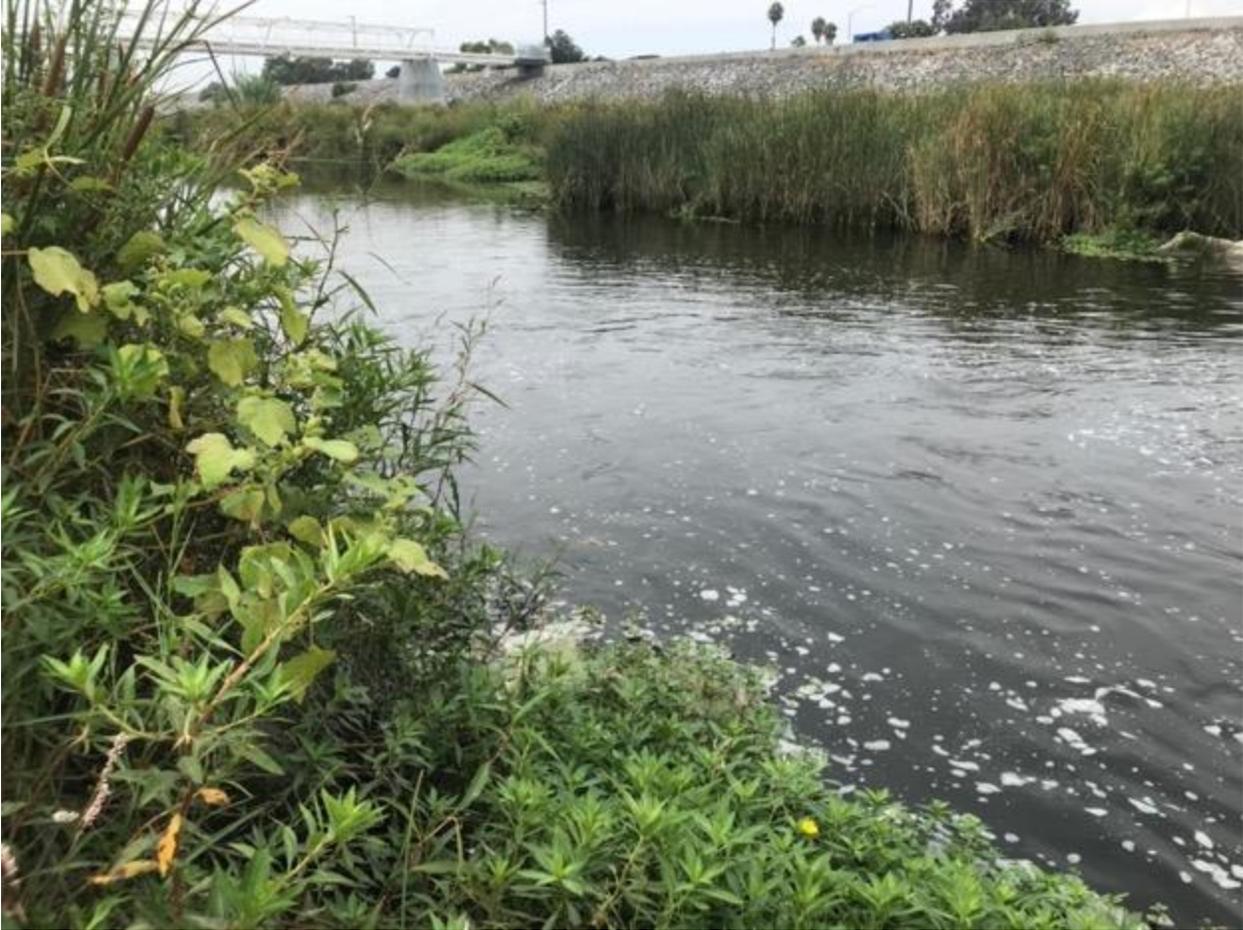
Figure 6. Freshwater Marsh habitat south of Willow St., Long Beach, showing water-primrose (*Ludwigia* sp.) in foreground and a large patch of cattail (*Typha* sp.) in the background and at upper left. 1 Sept. 2021.

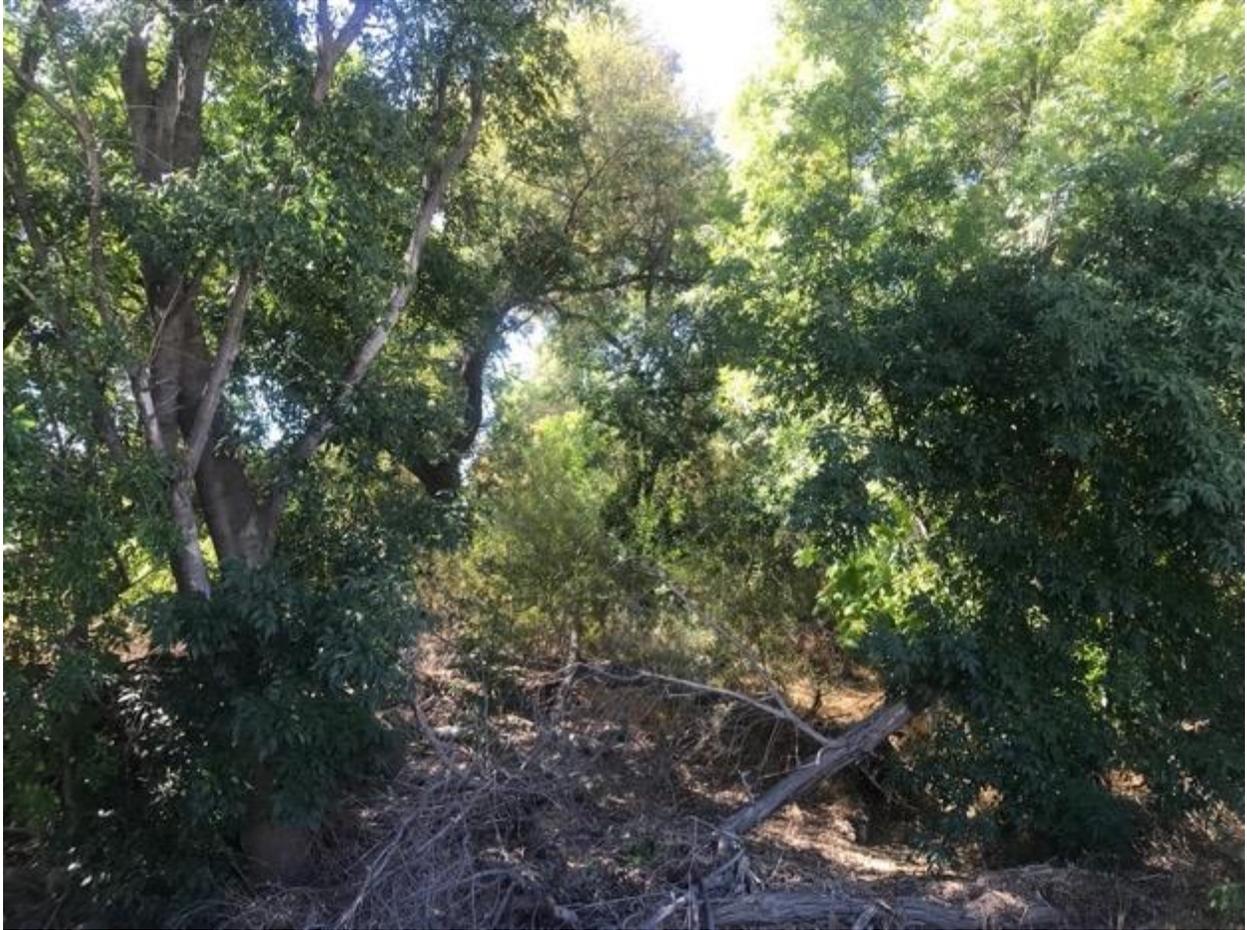
Figure 7. Evergreen woodland dominated by non-native Shamel ash (*Fraxinus udbei*), Sepulveda Basin. 15 Oct. 2021. Scattered willows share the canopy with this tree, but, being essentially an upland species, Shamel ash does not contribute appreciably to supporting a native riparian plant and wildlife community.

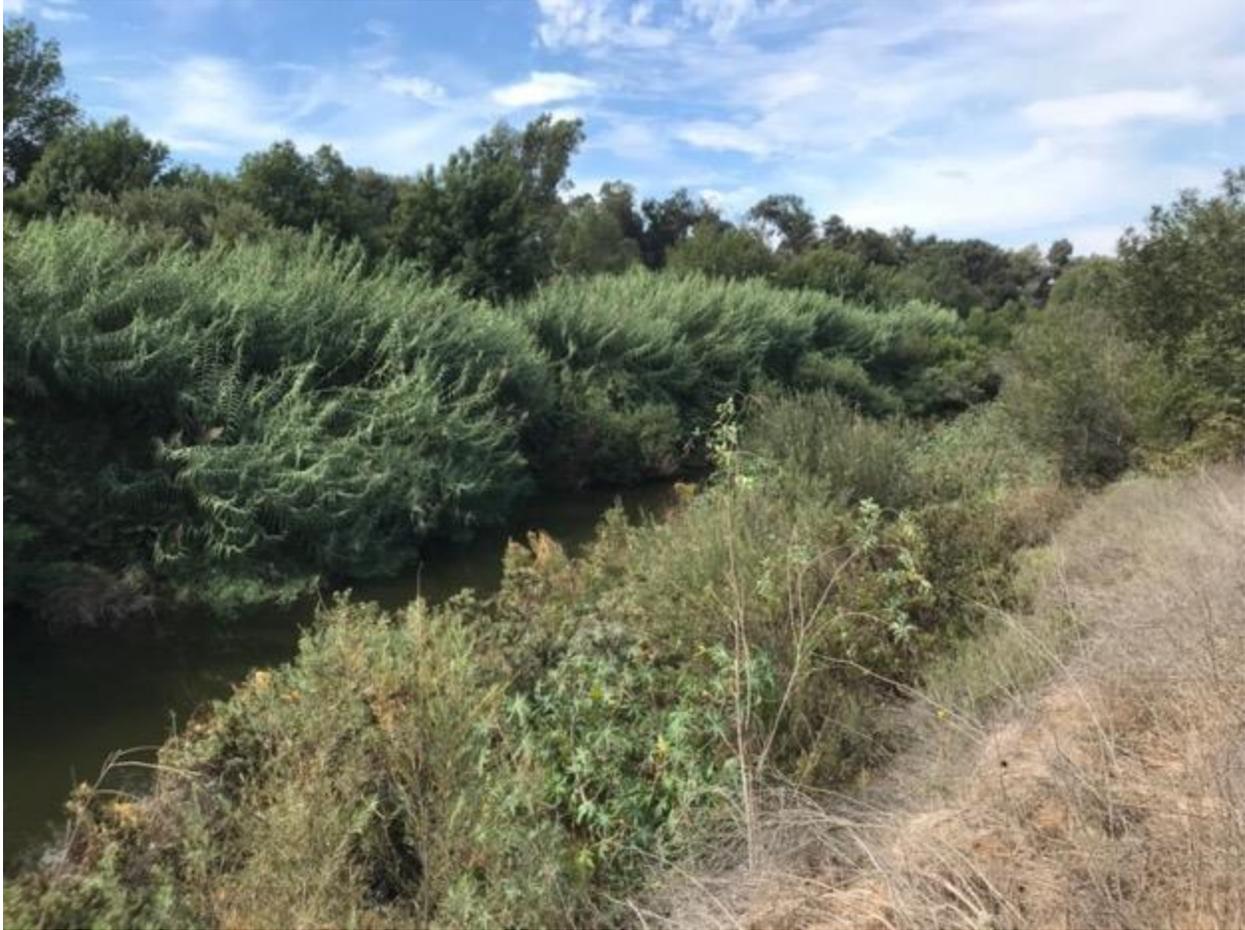
Figure 8. Another type of Non-native Trees and Shrubs: a massive infestation of giant cane (*Arundo donax*) just south of Lake Balboa (Sepulveda Basin, 4 Oct. 2021).

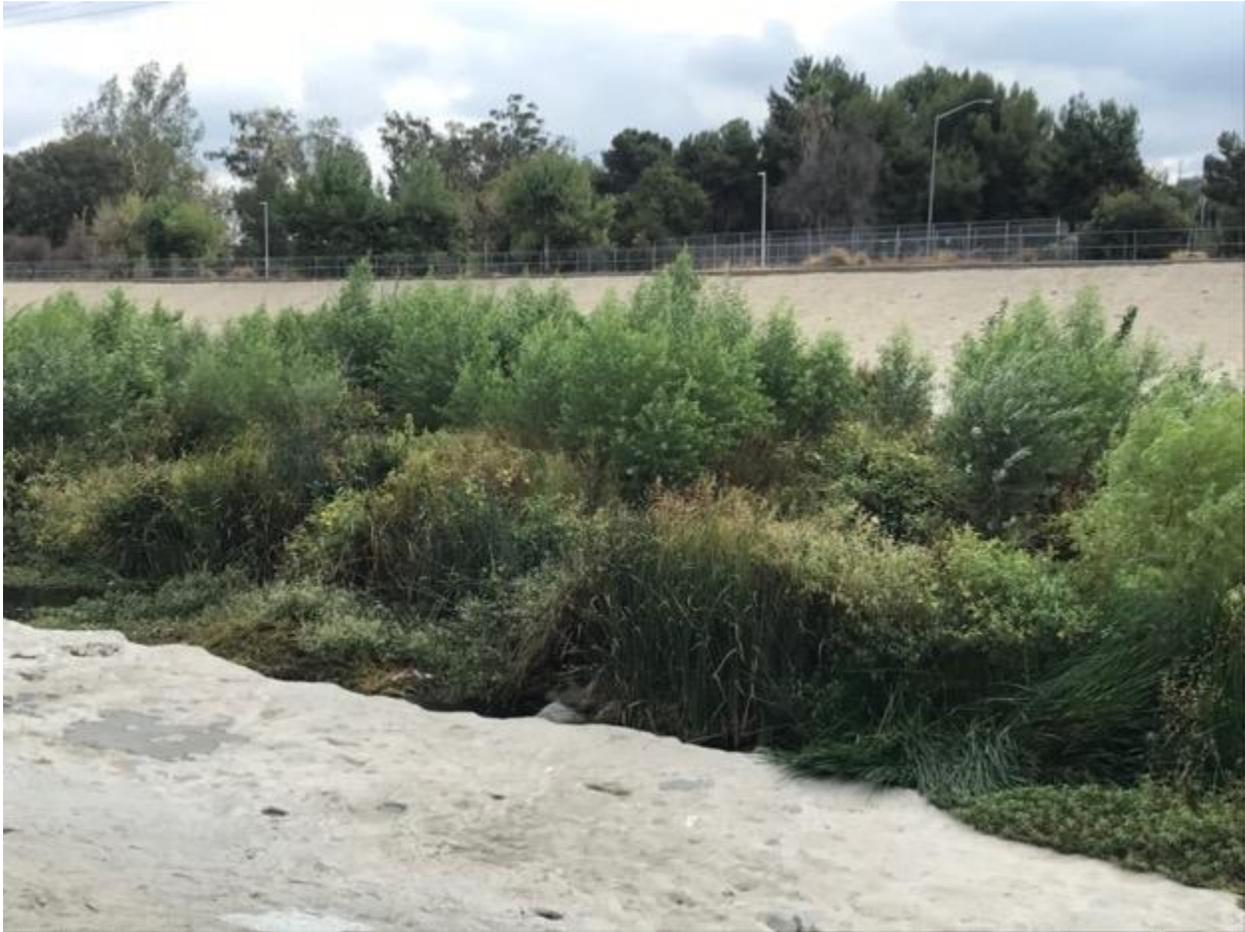
Figure 9. Riparian scrub habitat, Glendale Narrows, showing small black willows (*Salix gooddingii*) no more than a few years old, mixing with Freshwater Marsh and Transitional Herbaceous habitat around the edges. 8 Oct. 2021.

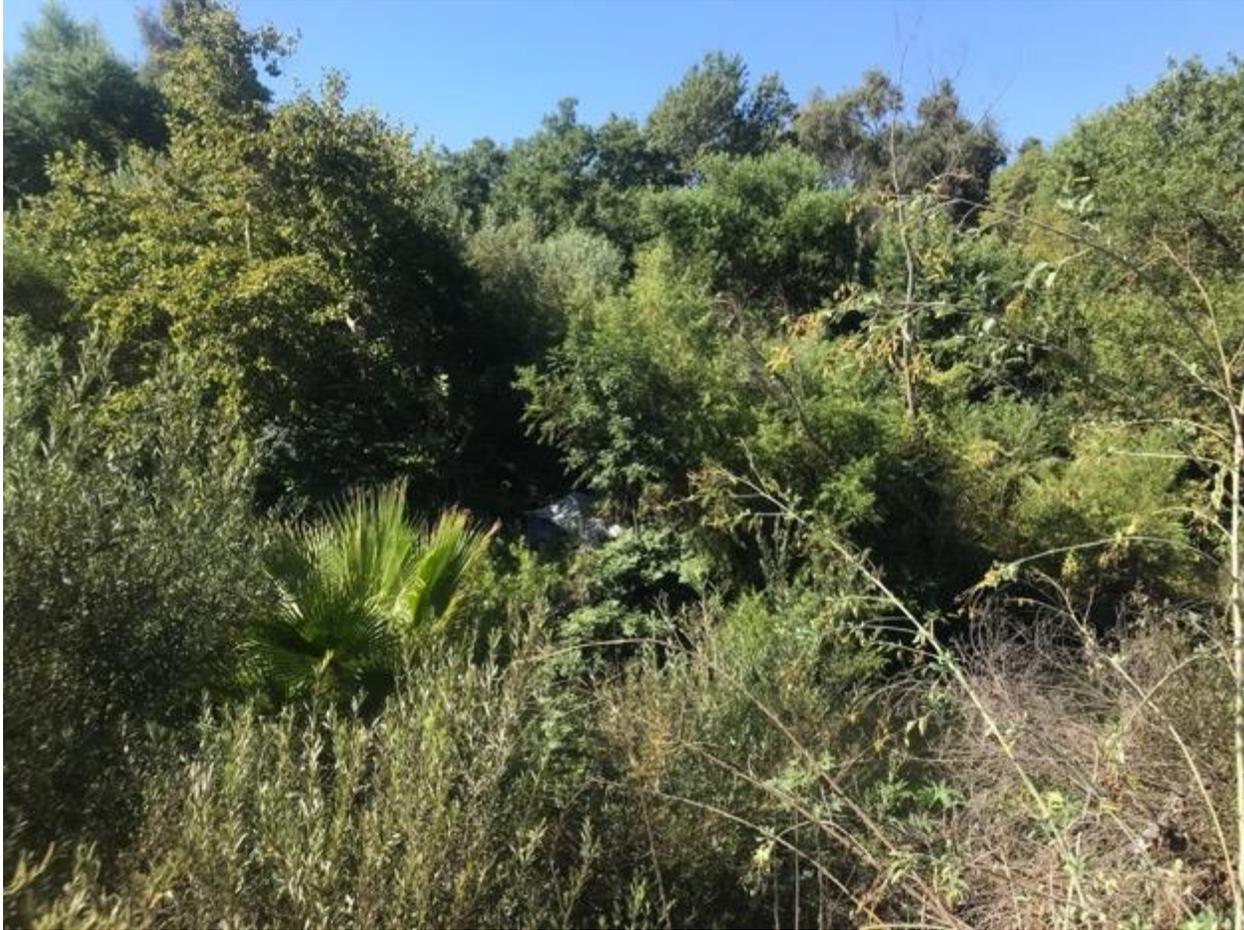
Figure 10. Riparian woodland habitat east of Balboa Blvd. showing high canopy willows (*Salix* spp.), western sycamore (*Platanus racemosa*) and walnut (*Juglans* sp.), and an understory of mulefat (*Baccharis salicifolia*) (Sepulveda Basin, 15 Oct. 2021).

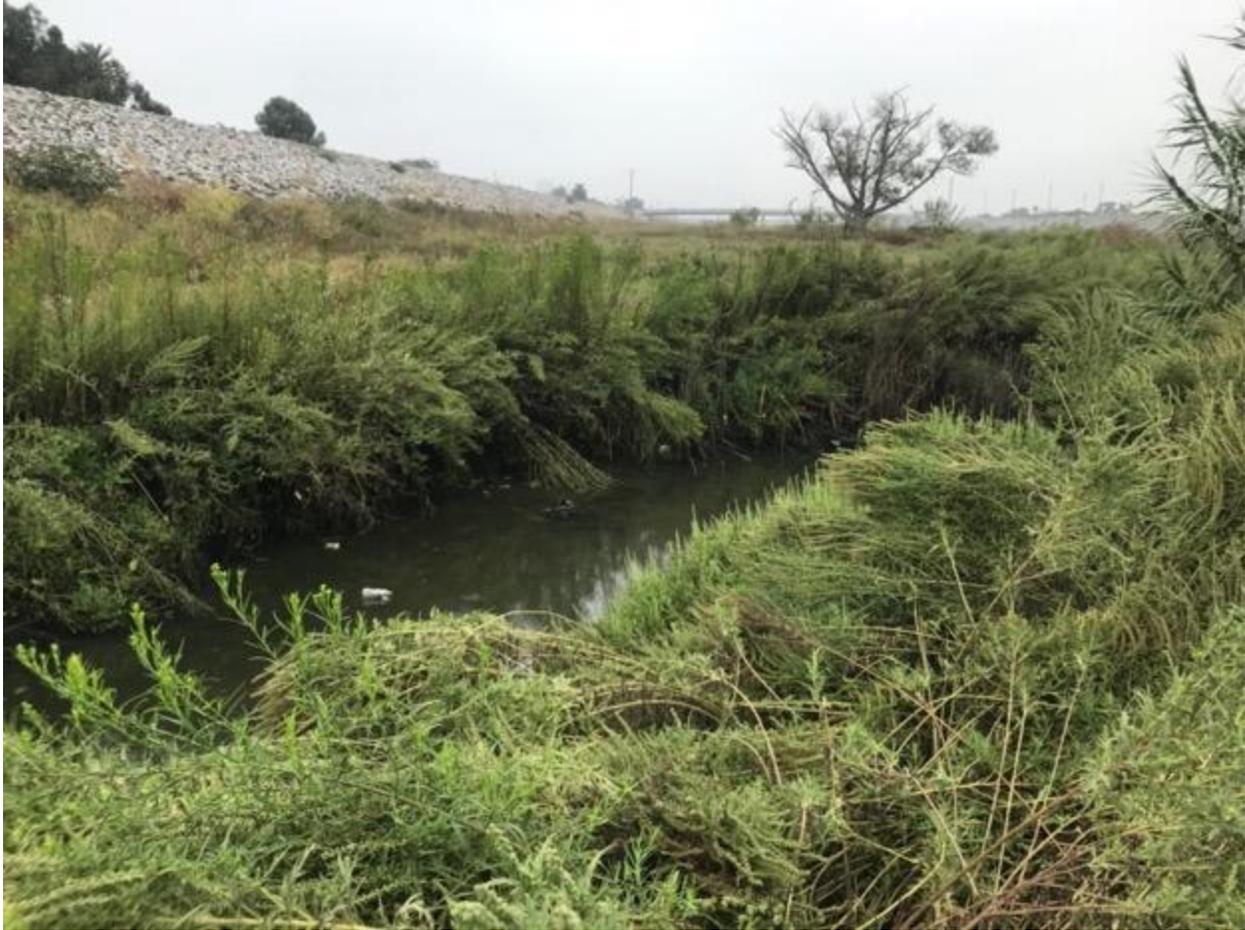
Figure 11. Transitional Herbaceous habitat, neither a riparian woodland/scrub nor a marsh, here we found it dominated by western goldenrod (*Euthamia occidentalis*) and western ragweed (*Ambrosia psilostachya*), south of Willow St., Long Beach. 8 Sept. 2021.

This complex habitat is dominated by seasonal growth, typically of winter-dormant, herbaceous species maintained by heavy disturbance (**Figure 11**). At the Willow St. site, it is apparently maintained by regular disking/bulldozing. As water flows over the habitat, either from storm flows, rainfall, or via “sub-irrigation” (near-surface groundwater), these communities quickly develop through the warmest months. Dominant plant species represent a mix of native and non-native taxa, and include western ragweed (*Ambrosia psilostachya*), creeping saltbush (*Atriplex prostrata*), Bermuda grass (*Cynodon dactylon*), rough cocklebur (*Xanthium strumarium*), annual sunflower (*Helianthus annuus*) and white sweet-clover (*Melilotus albus*). Local stands of other native species include western goldenrod (*Euthamia occidentalis*) and western saltmarsh aster (*Symphotrichum subulatum*) at Willow St., and mugwort (*Artemisia douglasiana*) at Sepulveda Basin. Areas of this habitat, if left undisturbed, would be expected to eventually transition to either Freshwater Marsh (if wet enough) or to Riparian Woodland and Scrub (if slightly drier), but some stands are likely fairly stable.

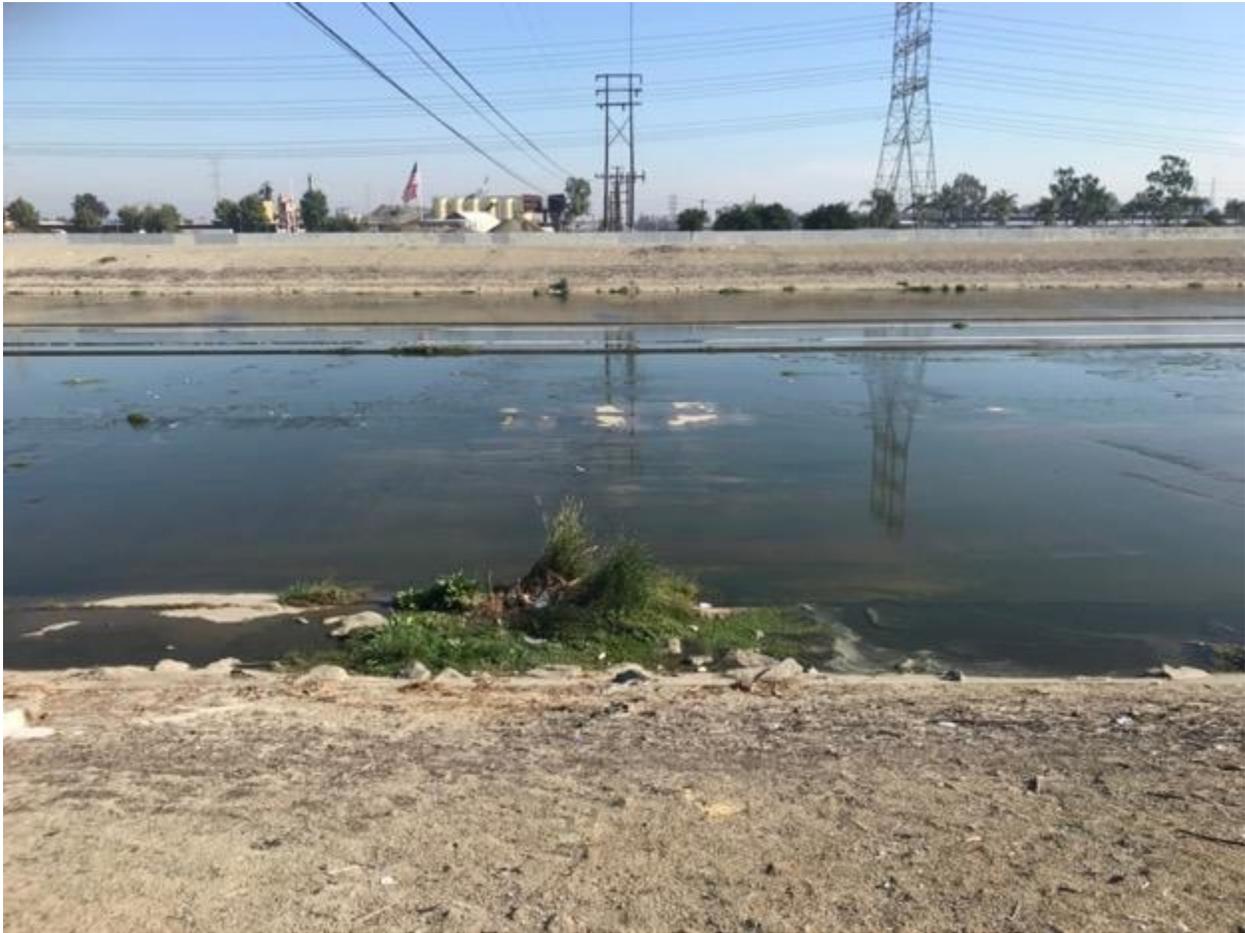
Figure 12. Wading Shorebird Habitat, showing distinctive shallow water (note concrete channel floor just barely showing through). This habitat supports thousands of shorebirds in summer and fall. Cudahy. 1 Dec. 2021.

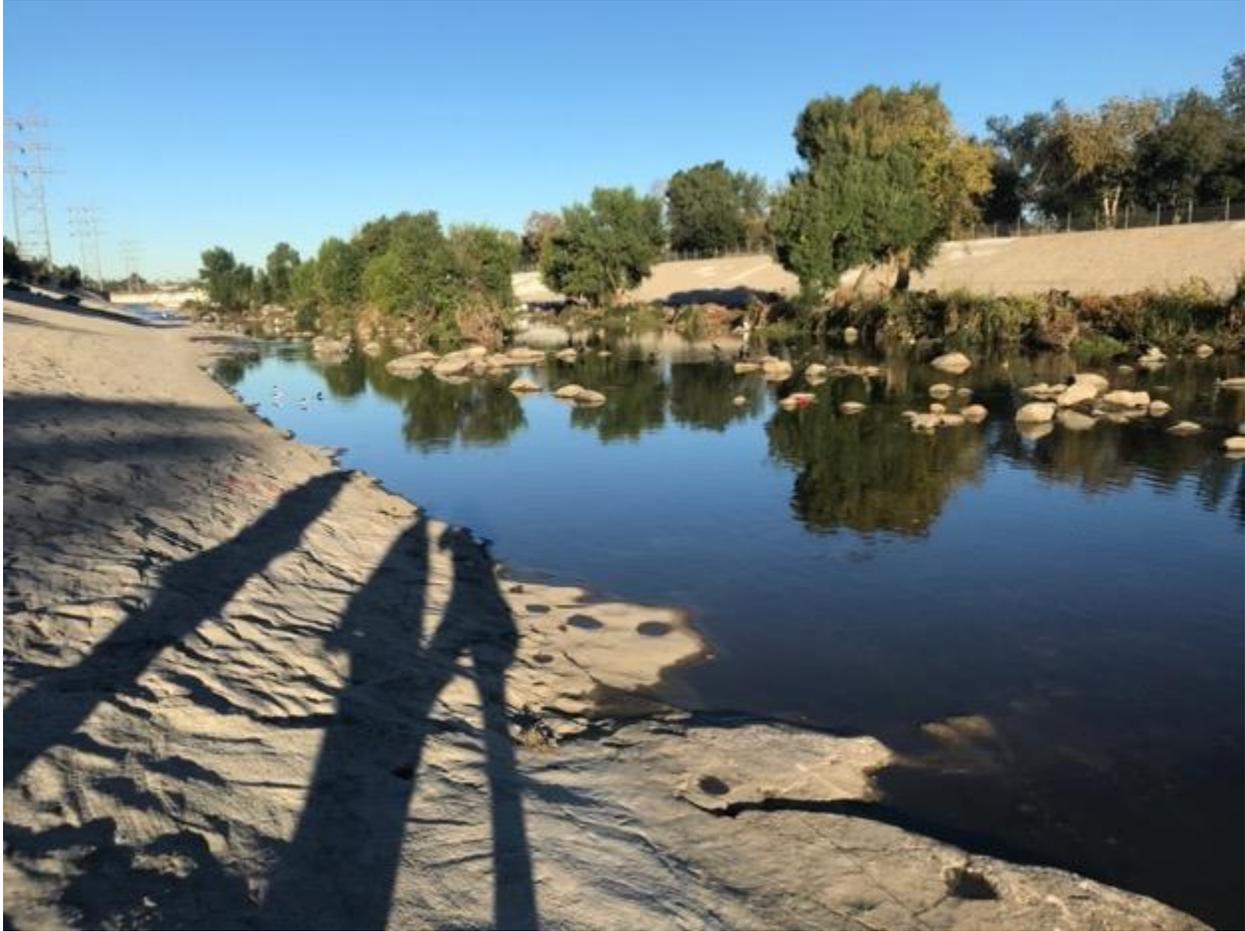
Figure 13. Warm water habitat, showing deeper pools interspersed with small boulders. This habitat type was extremely rich in birdlife and other wildlife, particularly ducks, herons/egrets and other waterbirds. Glendale Narrows. 28 Oct. 2021.

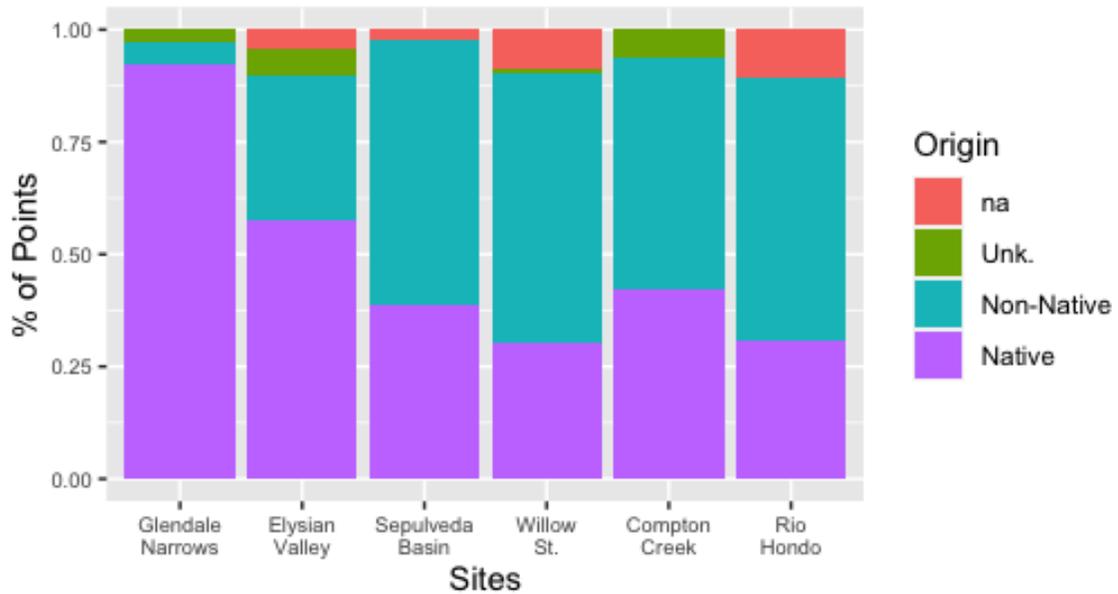
Figure 14. Percentage of line transect points with native (vs. non-native) species. “Na” denotes bare earth or rock (i.e., unvegetated areas); “Unk.” denotes taxa where native-ness is still to be determined (e.g. white-flowered nightshade *Solanum* spp.).

Site	Total points	Points with native(s)	Native proportion
Sepulveda Basin	85	33	0.388
Glendale Narrows	38	35	0.921
Elysian Valley	255	147	0.576
Willow St.	85	33	0.388
Compton Creek	131	55	0.420
Rio Hondo	140	43	0.307

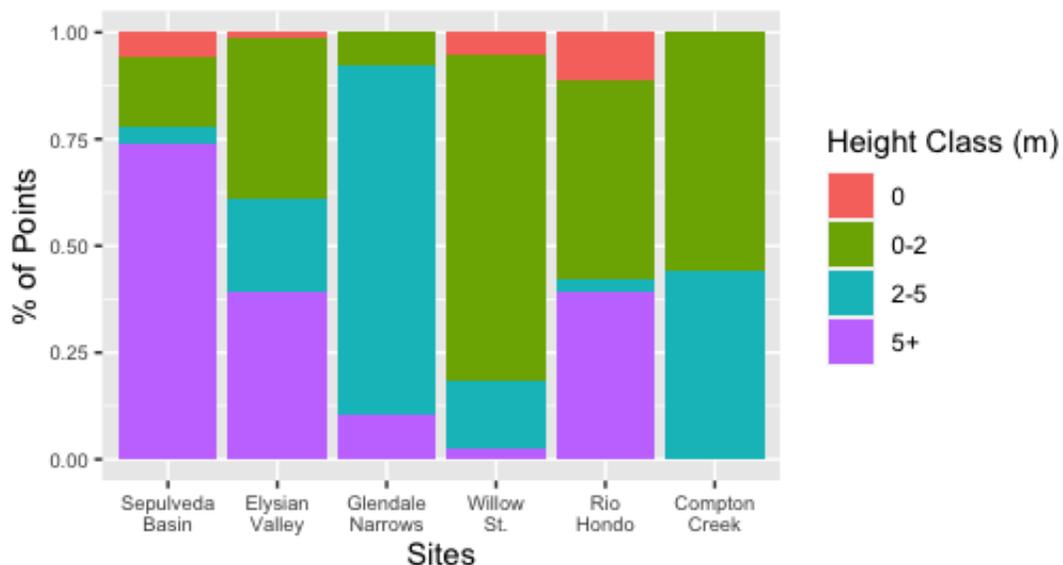
Figure 15. Vegetation height at each survey site and the two reference sites. Height class was determined by line-transect data as the maximum height at each point along the transect.

The “high shrub” layer (2-5 meters) was particularly well-developed at Glendale Narrows, while the “low shrub” layer (0-2 meters) was most prevalent at Willow St. These differences contribute to the different “feel” of the habitat at each area, with Willow St. consisting of lower, more open vegetation (including large amounts of Upland Herbaceous habitat), and Sepulveda Basin more woodland-like.

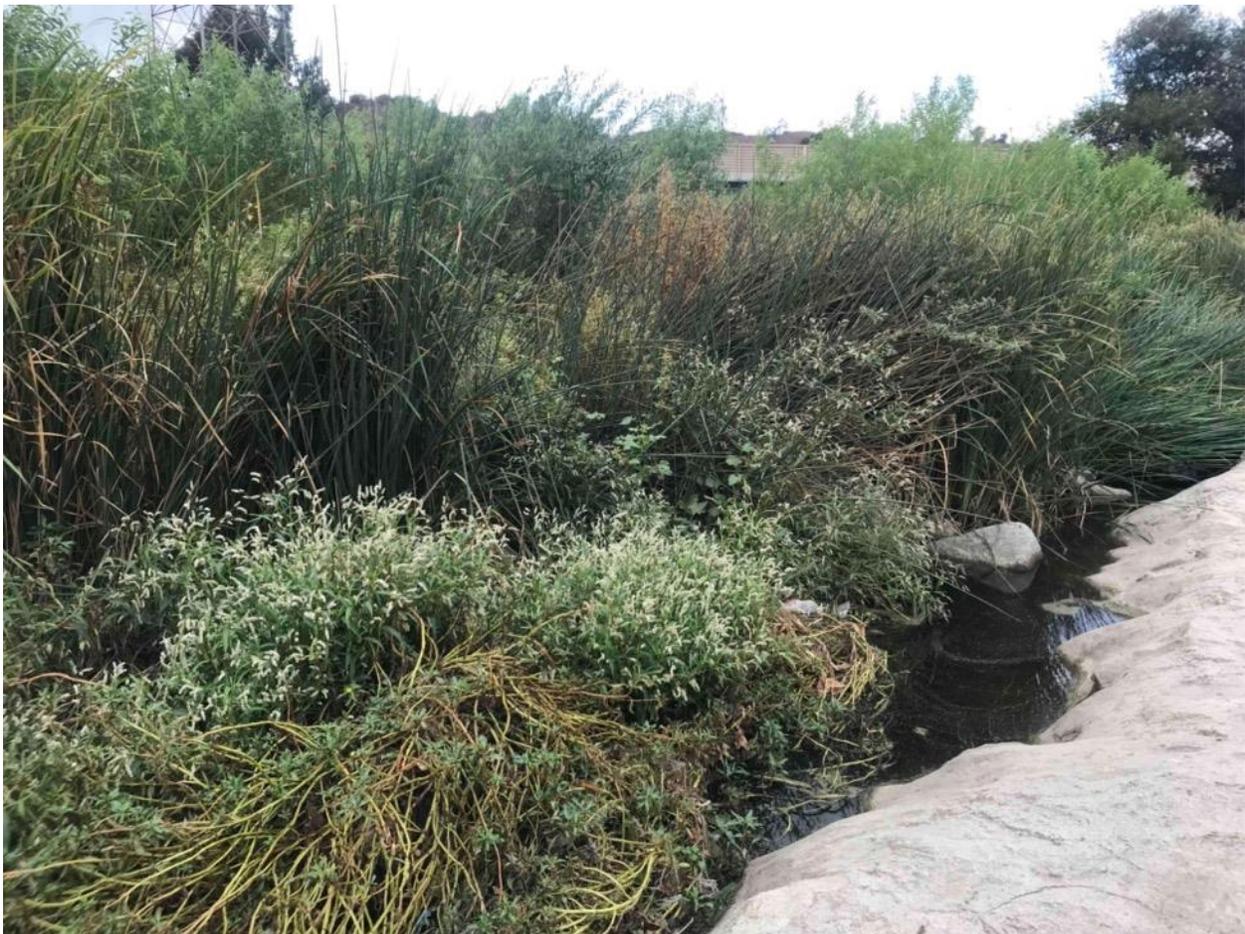
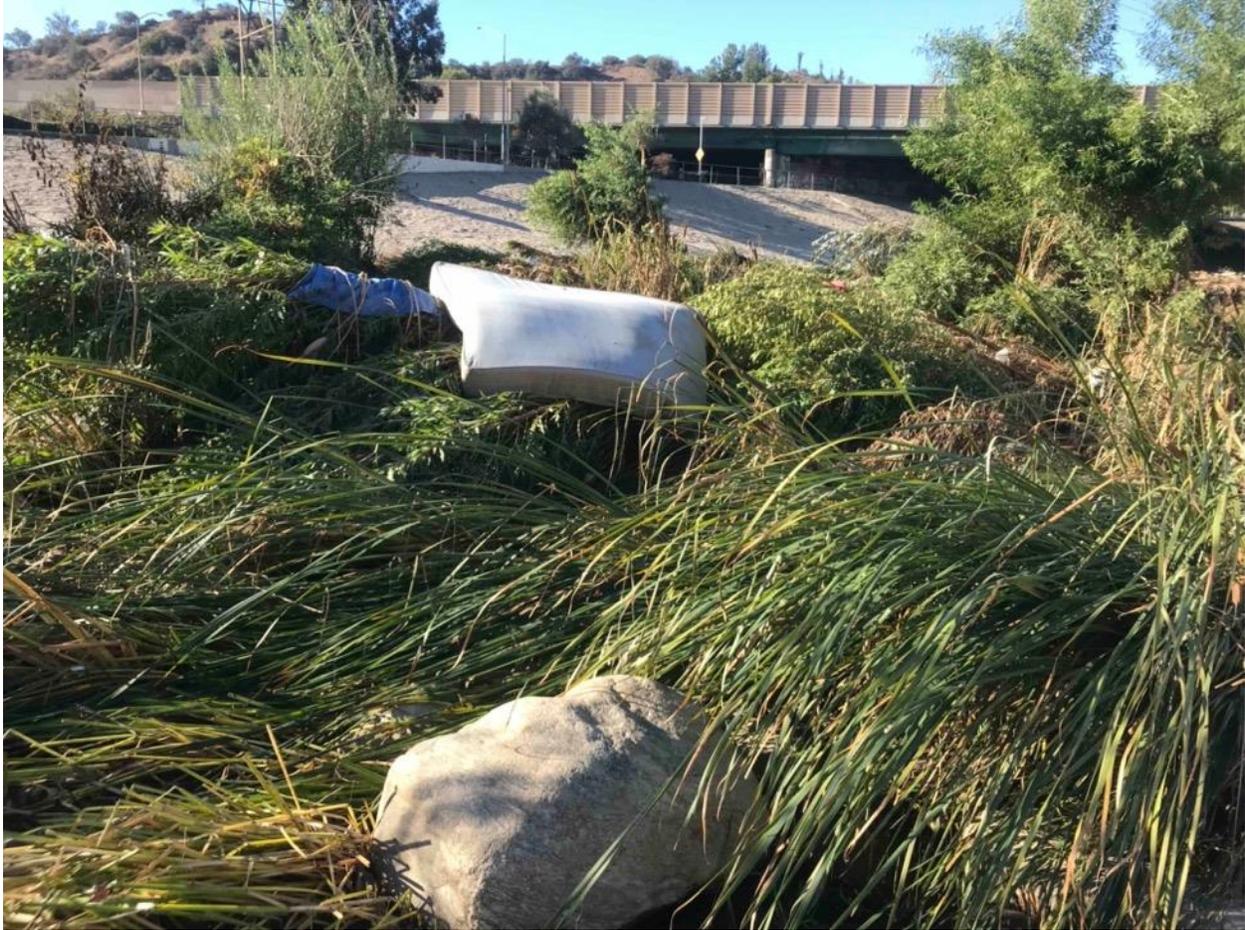
Figure 16a. Pre-rain vegetation (Oct. 20, 2022), just downstream of Riverside Dr., Glendale Narrows.

Figure 16b. Same view as in Figure 16a, post-rain vegetation (Oct. 27, 2022), just downstream of Riverside Dr., Glendale Narrows.

As with any dynamic riparian system, local areas of vegetation of the Los Angeles River channel may change dramatically from year to year, particularly after serious storm events. Heavy rains in late October 2022, for example, resulted in the vegetation at Glendale Narrows becoming essentially flattened or stripped, and covered with refuse (much of it obviously from encampments, including tents and tent poles, mattresses, luggage, folding chairs, etc.). The figures below depict this area before the rains, on October 20 (**Figure 16a**) and just following the rains on October 27 (**Figure 16b**). Notably, the more herbaceous plants such as smartweed (*Persicaria*) and *Ludwigia* were severely bent or uprooted by the flow of water, and smaller willow (*Salix*) and reeds (including *Typha* and *Schoenoplectus*) were also pushed laterally, where they were covered by refuse deposited by the receding water. These environments then take several months to recover (i.e., through the spring and summer), and may appear in somewhat different forms in terms of dominant species.

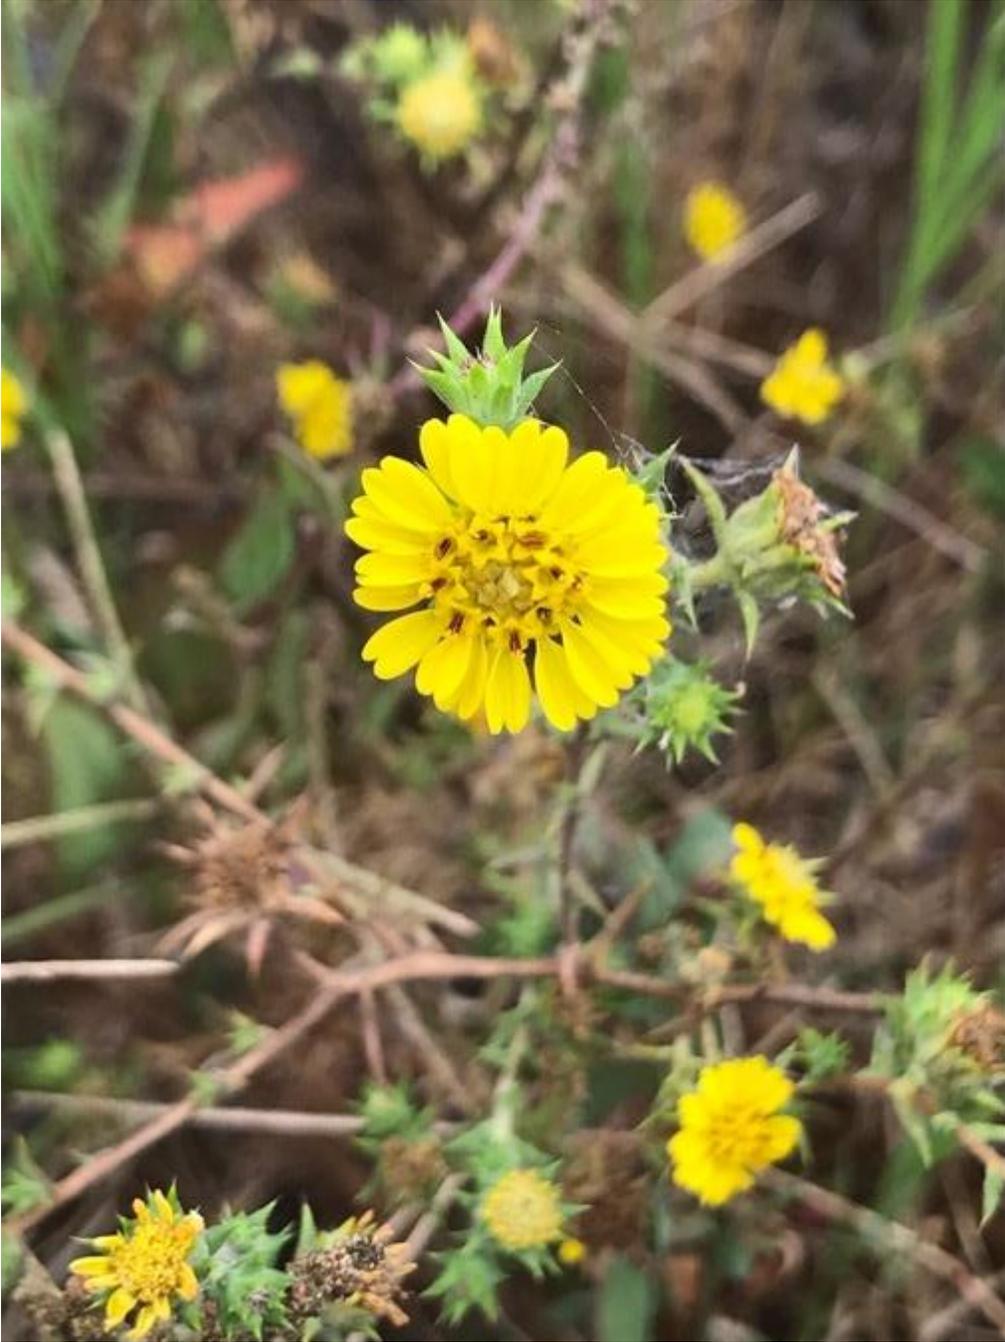
Figure 18a. Close-up of flowering southern tarplant.

Our surveys located one CNPS-ranked taxon in the Los Angeles River channel, the southern tarplant (aka southern tarweed), *Centromadia parryi* ssp. *australis* (CNPS Rank 1B.1). A population of several hundred plants were observed growing at the base of the eastern levee, roughly halfway between Willow St. and Pacific Coast Highway (see **Figure 17**). Plants appeared robust and healthy, with many seedlings and mature plants noted (**Figure 18a**, **Figure 18b**), but most plants were smallish, likely the result of recent (2020) discing of the site, visible on Google Earth.
