Biological Resources Survey and Report for “Baseline Dry Season In-Channel Vegetation Mapping”

Los Angeles River (and selected reference sites)

Date: February 28, 2022

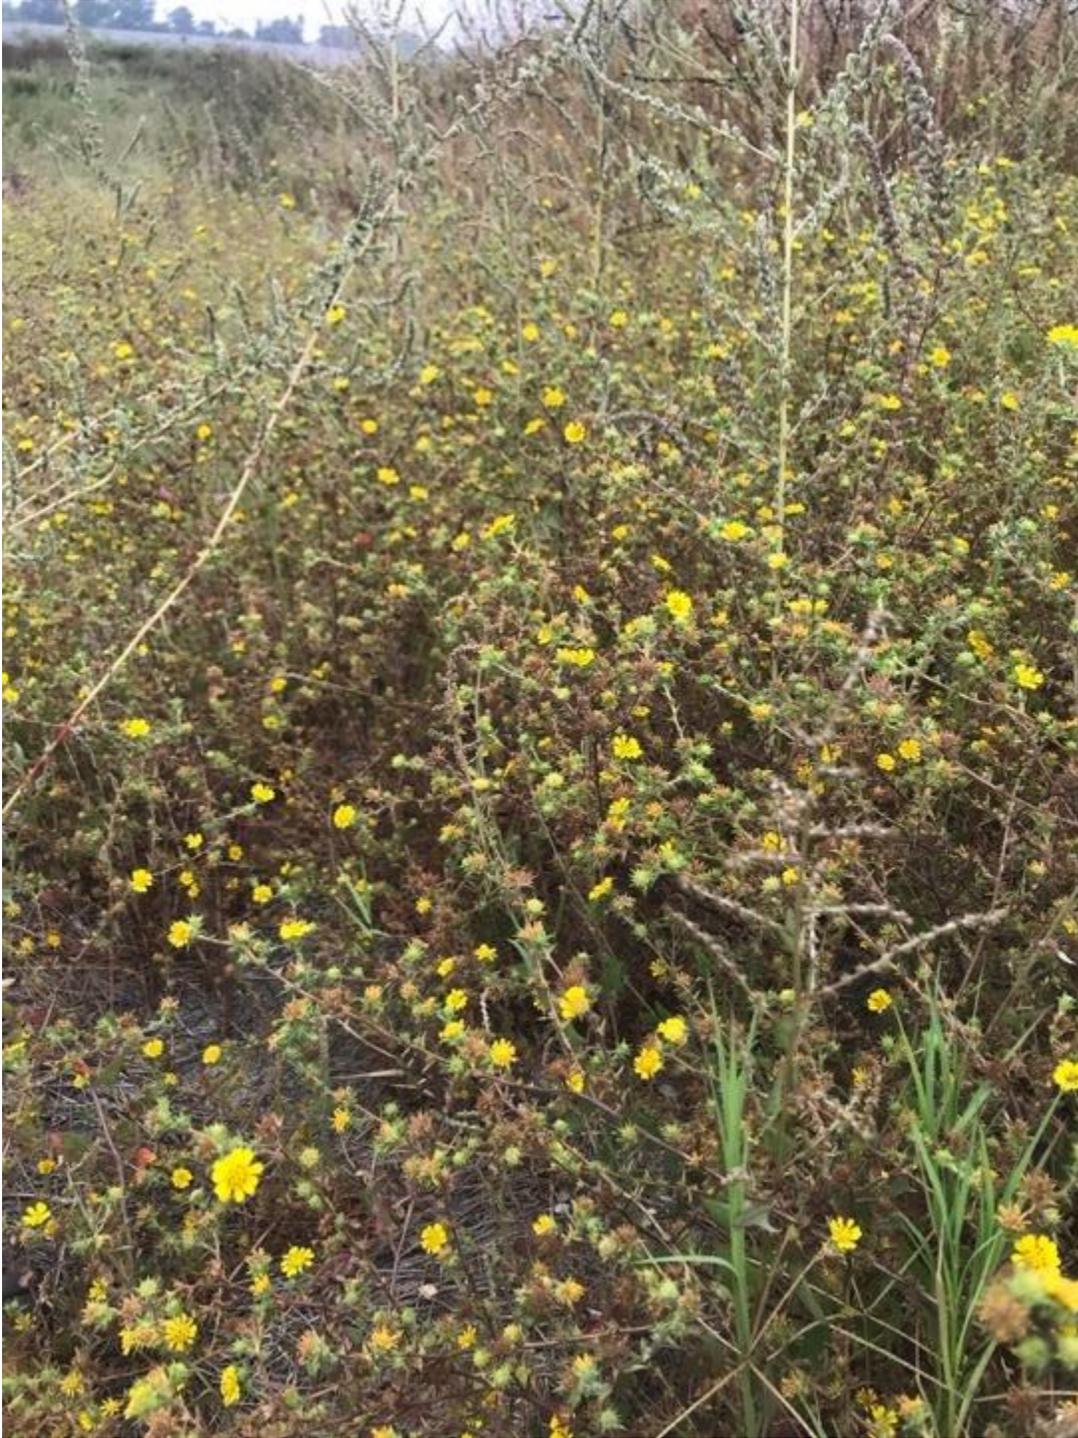
Figure 18b. Southern tarplant growing *in situ*, growing within the “Transitional Herbaceous” habitat community. Other species in the photo include *Chenopodium* sp. (either *C. album* or *C. berlandieri*), *Atriplex prostrata* (lower left), and an unidentified grass (Poaceae).

Our surveys located one CNPS-ranked taxon in the Los Angeles River channel, the southern tarplant (aka southern tarweed), *Centromadia parryi* ssp. *australis* (CNPS Rank 1B.1). A population of several hundred plants were observed growing at the base of the eastern levee, roughly halfway between Willow St. and Pacific Coast Highway (see **Figure 17**). Plants appeared robust and healthy, with many seedlings and mature plants noted (**Figure 18a**, **Figure 18b**), but most plants were smallish, likely the result of recent (2020) discing of the site, visible on Google Earth.

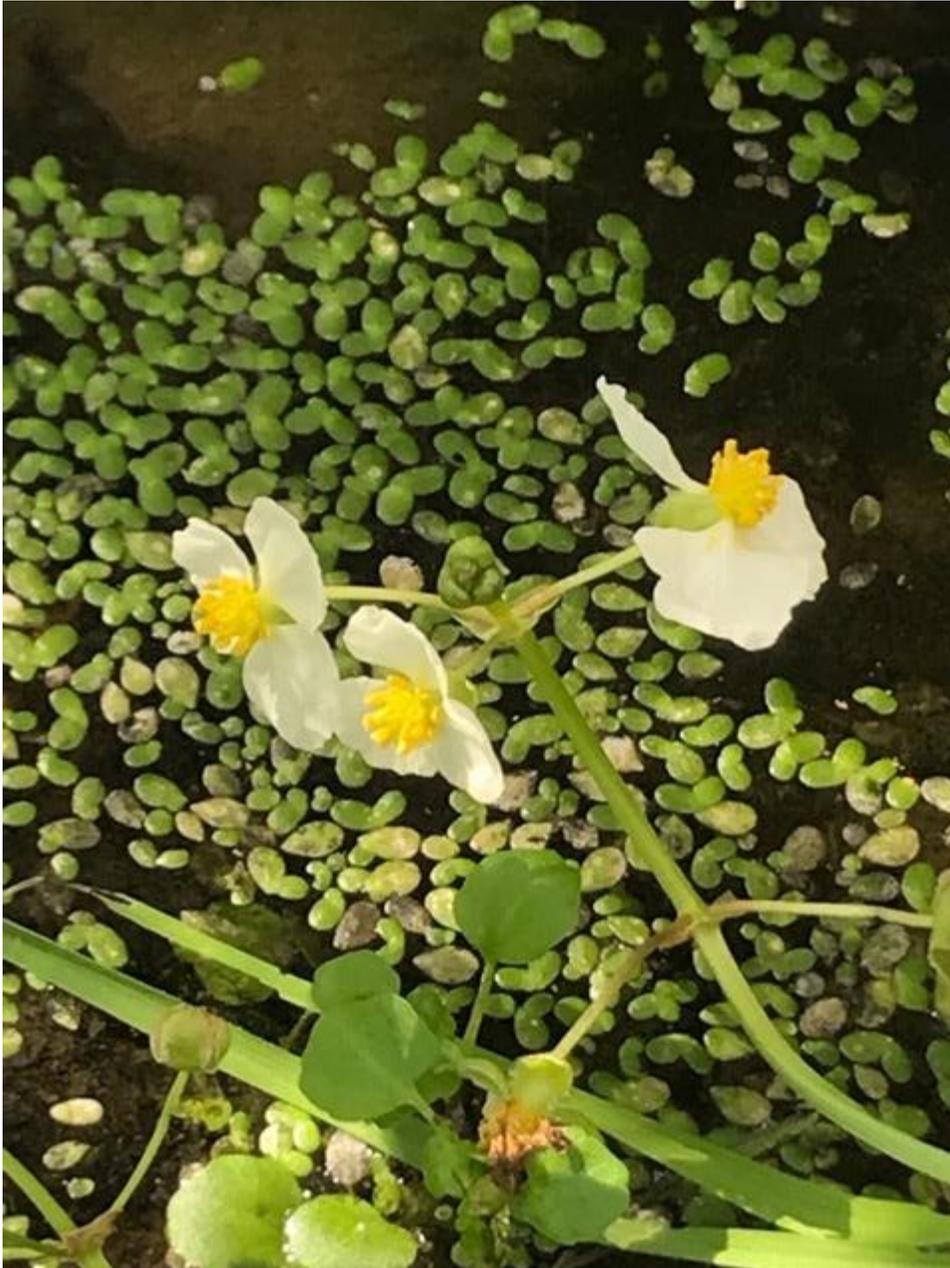
Figure 19. An aquatic plant likely Sanford's arrowleaf (*Sagittaria sanfordii*) discovered just east of Balboa Blvd. in the Sepulveda Basin. Smaller floating bits of vegetation are leaves of duckweed (*Lemna* sp).

Most surprising was a tiny population of what appeared to be Sanford’s arrowleaf (*Sagittaria sanfordii*), a CNPS Rank 1B.2 species (**Figure 19**). Fewer than five individuals were growing along the north

side of the river channel roughly 100 meters east of the Balboa Blvd. bridge, in an area with large cobbles/small boulders and an abundance of native marsh and wetland vegetation (**Figure 20a**, **Figure 20b**). It is possible that the species we found represents a poorly-known, perhaps tropical species that was released from an aquarium, or something else entirely (*vide* A.C. Sanders, UCR Herbarium). Positive identification will hopefully be made soon (material deposited in UCR Herbarium).

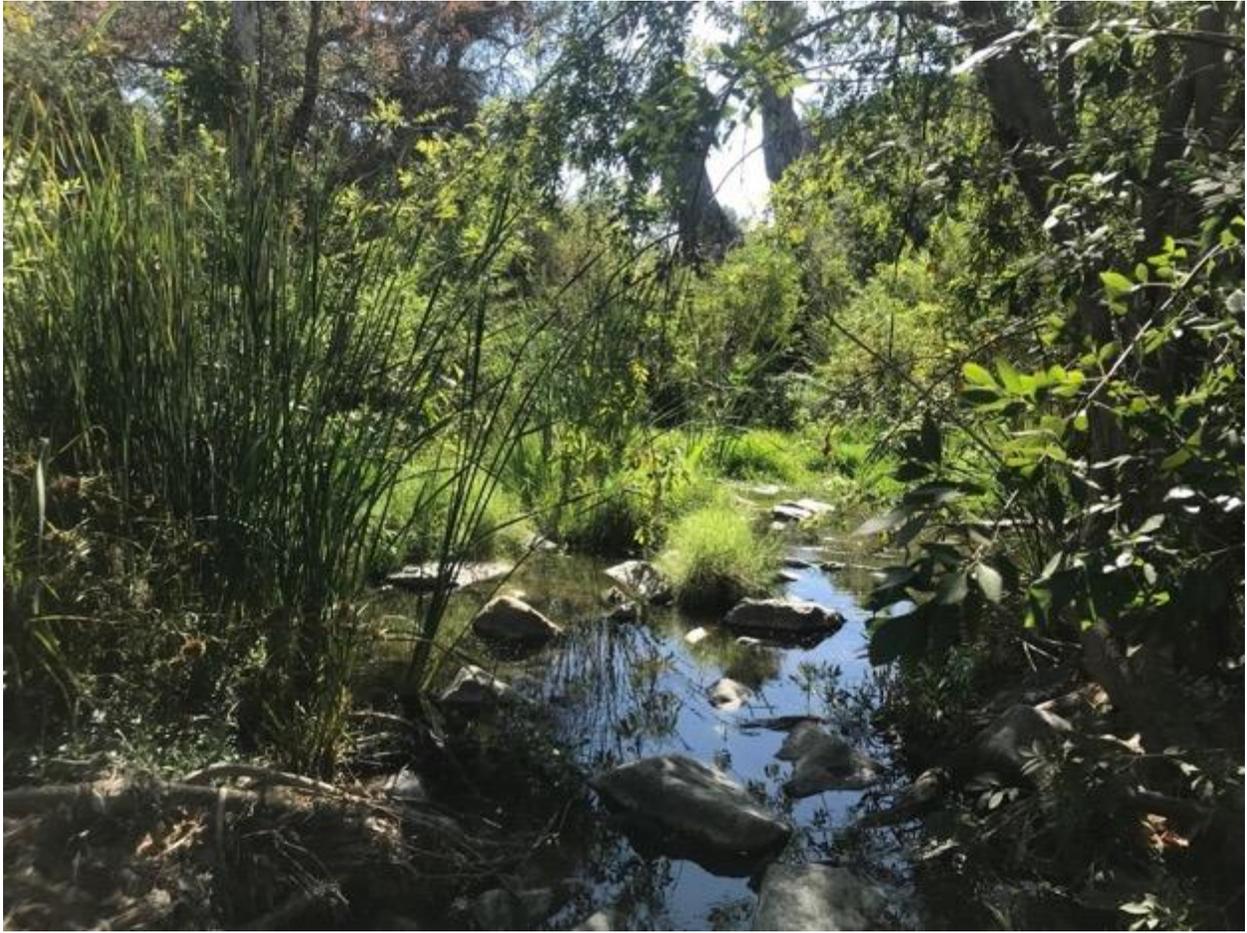
Figure 20a. Understory of riparian woodland and shallow water south of Lake Balboa, showing diversity of herbaceous understory (including southern cattail *Typha domingensis* at left, and spikerush *Eleocharis* sp. in middle ground). The middle-story here consists of both native willows (esp. black willow *Salix gooddingii*) and Shamel ash (*Fraxinus udbei*). This area is where we located what may be a CNPS-ranked plant, Sanford's arrowleaf (*Sagittaria sanfordii*). 21 Sept. 2021.

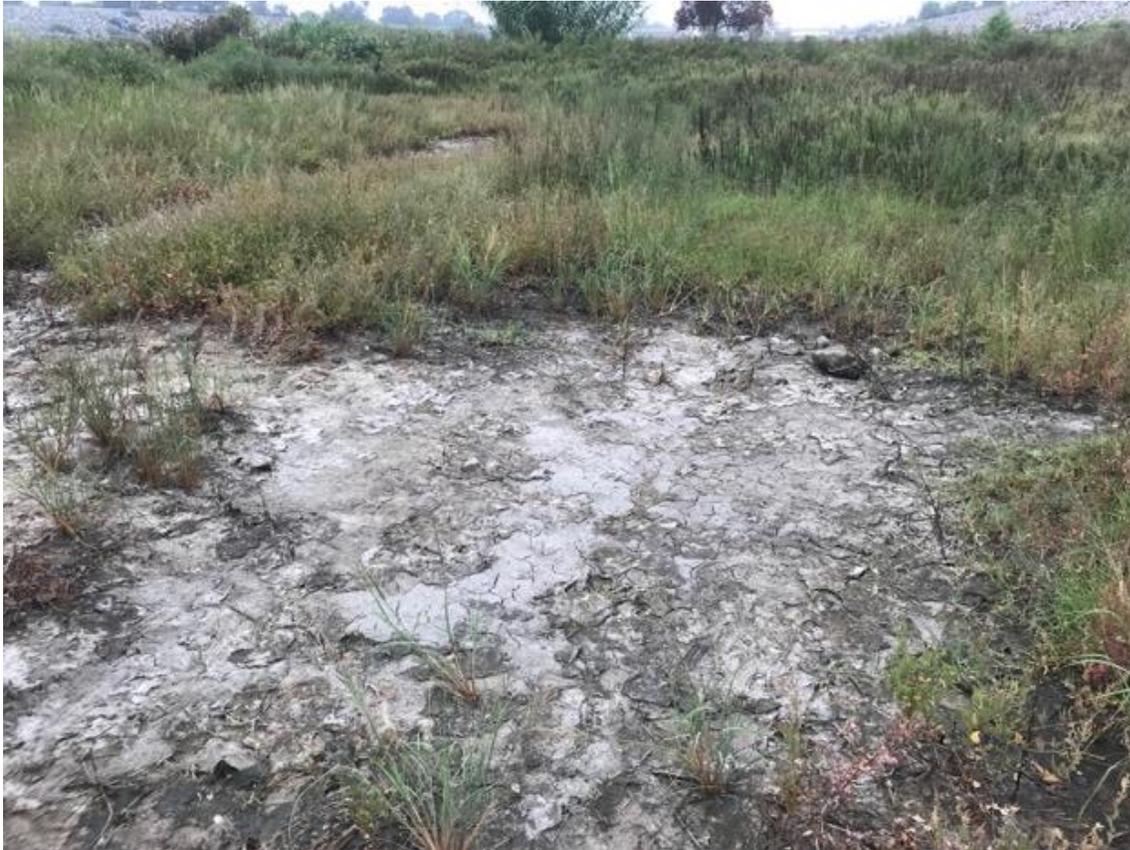
Figure 21. Seasonal wetlands south of Willow St. mimic alkali vernal pools, and were found to support the rare southern tarplant (*Centromadia parryi* ssp. *australis*).

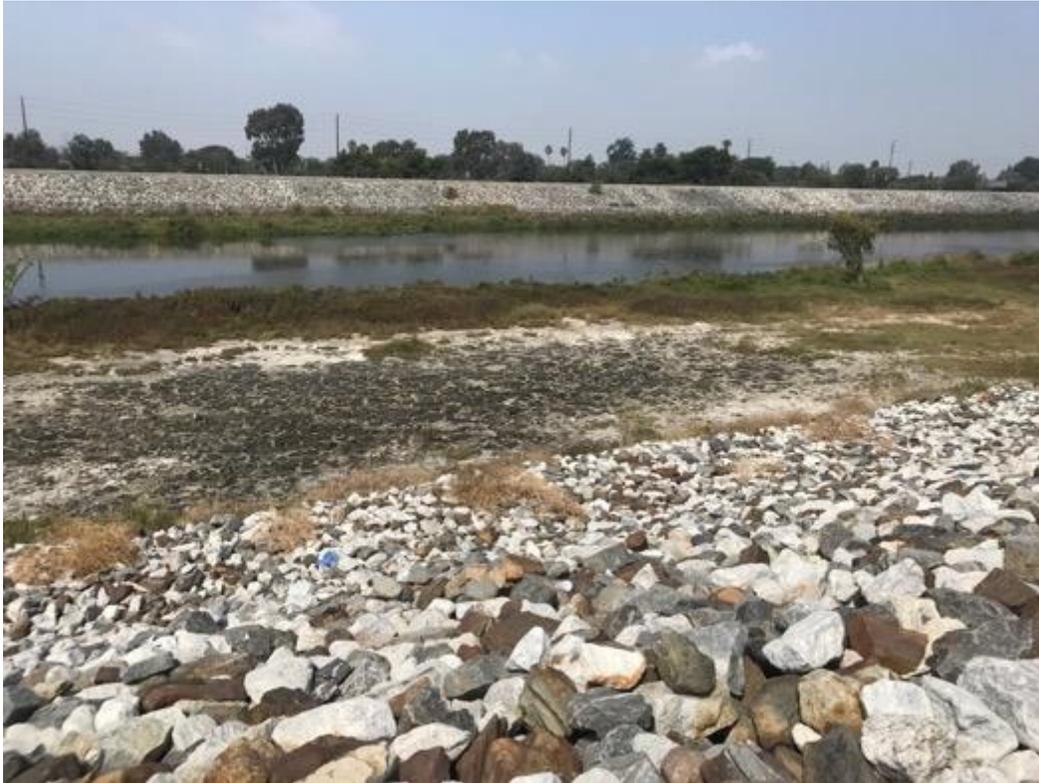
Figure 22a. Unusual mudflat habitat south of Willow St., presumably formed by deeper brackish water pooling for an extended period of time. This habitat was found to support the wetsalts tiger-beetle (*Cicindela haemorrhagica*), a native arthropod found in salt marshes and alkali lakes around the West (but unexpected in an active flood control channel in Long Beach!). 8 Sept. 2021.

Just south of the tarplant area (and perhaps co-occurring with it in some years) we found an area of dried algal mat east of the main channel unlike any other habitat we encountered in the study (**Figure 22a**). We map this area in **Figure 22b**. In it, we found no distinctive vegetation, but did locate a population of tiger beetle called the wetsalts tiger beetle (*Cicindela haemorrhagica*) (**Figure 23**). The wetsalts tiger beetle had been photographed in this same area in 2020 (www.inaturalist.org/observations/53225607). While not “listed” by any resource agency, it is part

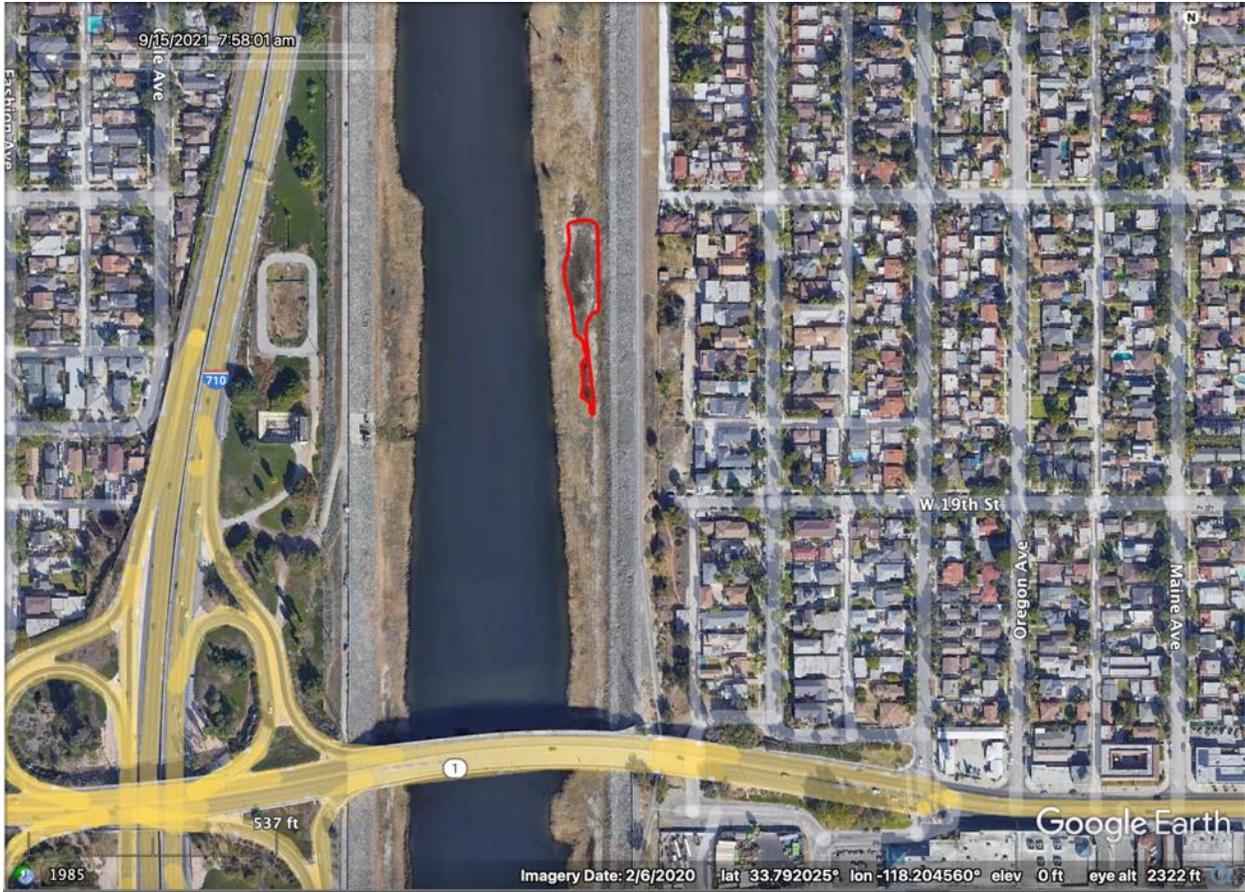
Figure 22b. Location of algal mat habitat where we located wetsalts tiger beetle (red outline).

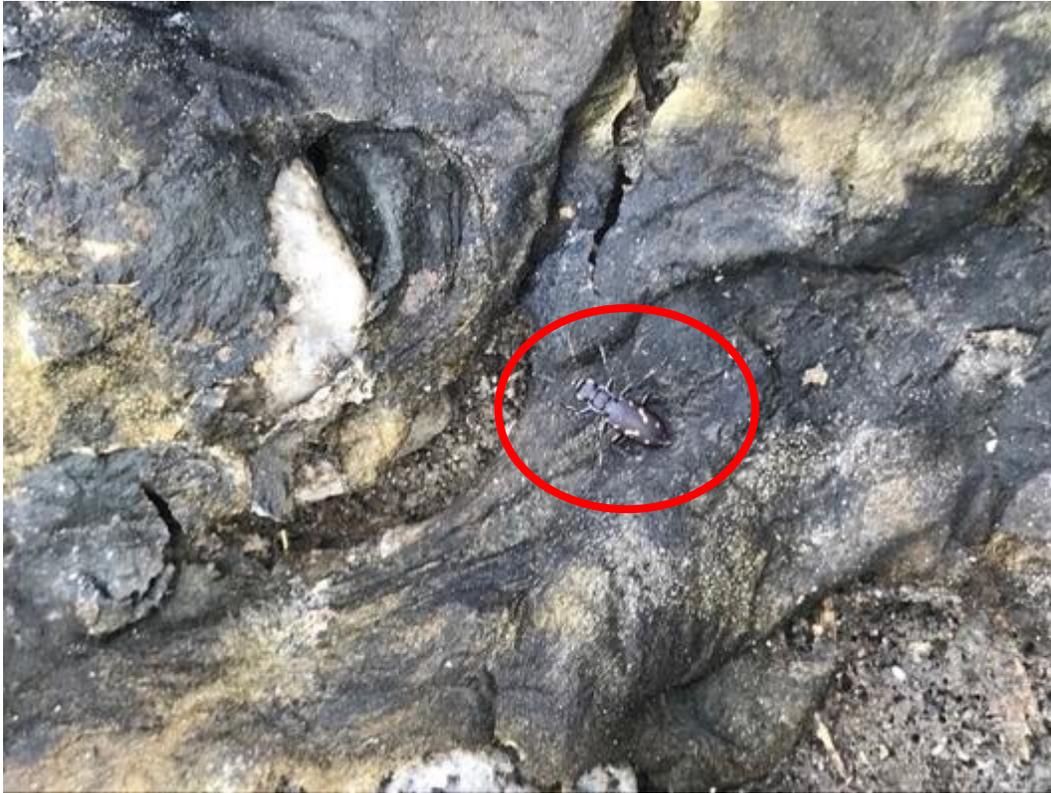
Figure 23. Wetsalts tiger beetle (*Cicindela haemorrhagica*) on the algal crust shown in **Figure 22.** 8 Sept. 2021.

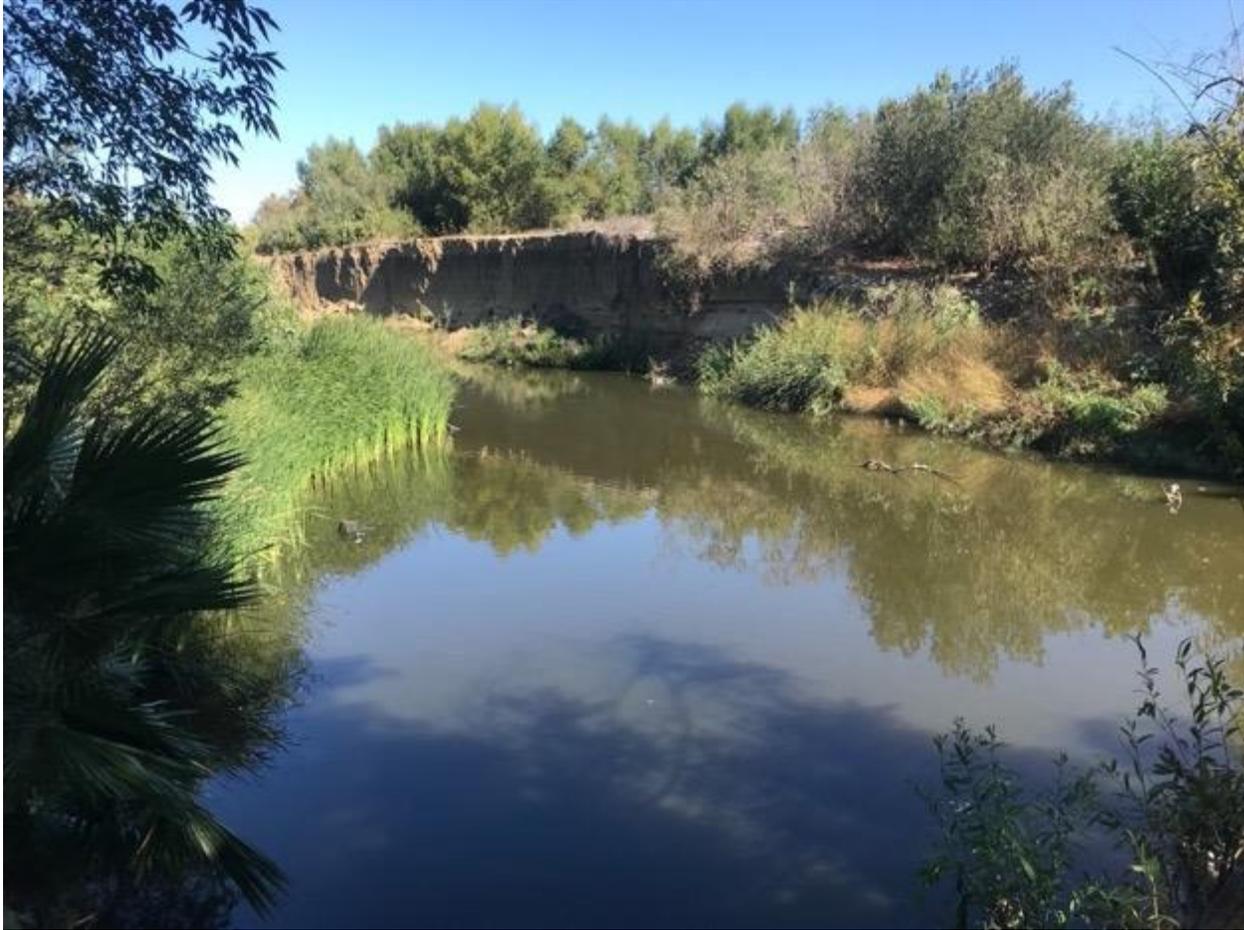
Figure 24. Natural river cut south of Woodley Golf Course formed by river erosion. This stretch had both natural floor and natural bank, and supported a very high diversity of native plants, including many not found elsewhere along the river channel. 13 Oct. 2021.

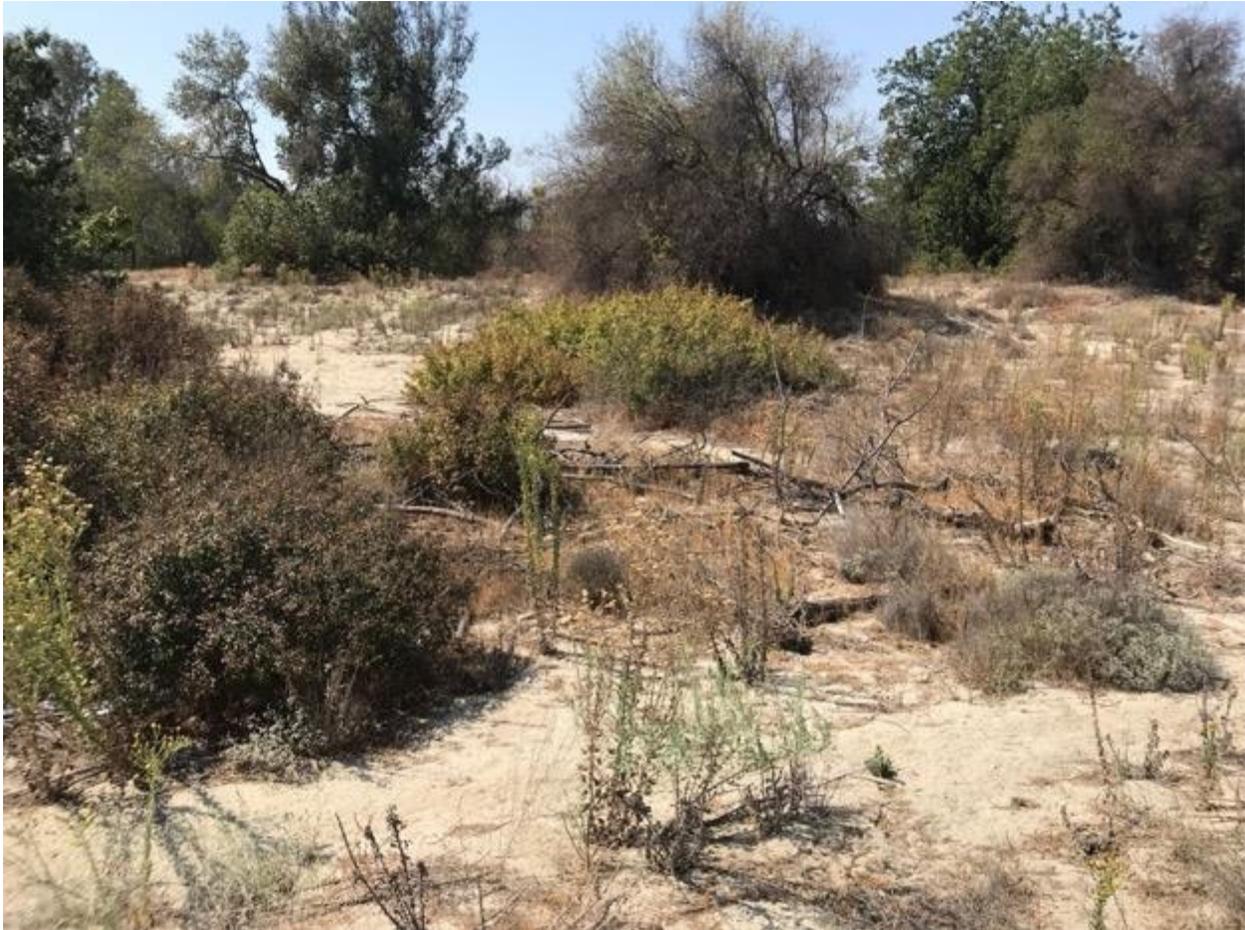
Figure 25. Alluvial fan scrub, a rare microhabitat, east of Rio Hondo channel north of 60 Fwy, showing a high diversity of scrub plants with large patches of bare sand (a natural condition). 25 Sept. 2021.

This rare habitat type is characterized by widely-spaced scrub species and stunted riparian trees on sand or fine gravel soil²⁹. Components of this habitat were observed along the channel at Sepulveda Basin (including stands of branching phacelia *Phacelia ramosissima* and patches of California buckwheat *Eriogonum fasciculatum* and California sagebrush *Artemisia californica*), but given the highly modified nature of these communities, and the fact that they are well-integrated into the larger riparian system here, we have elected to treat them as part of the Riparian woodland and scrub mapping category. Perhaps the finest example of little-disturbed river-associated habitat we encountered was located adjacent to our Rio Hondo reference site, within the Whittier Narrows Recreation Area (see **Figure 25**). This area was located off the main channel (to the east), but prior to channelization, would have occurred within the channel itself (which would have been much broader). Here, a patch of alluvial fan scrub on fine sandy soil with a different assortment of plants

as was found anywhere else in the study area (including at Sepulveda Basin, at least not in a natural/non-planted state). Here we found lemonadeberry (*Rhus integrifolia*), coastal pricklypear (*Opuntia littoralis*), California spurge (*Croton californica*), golden currant (*Ribes aureum*), and showy penstemon (*Penstemon spectabilis*), as well as a stand of native bunchgrass that appears to be foothill needlegrass (*Nassella lepida*), or some other native bunchgrass. A handful of species in the wet riparian zone were also not found at the other sites (including western virgin's-bower *Clematis ligusticifolia* and black cottonwood *Populus trichocarpa*), but the alluvial scrub was an entirely unique (for the study area) community, and one that has been essentially lost elsewhere in the study area.

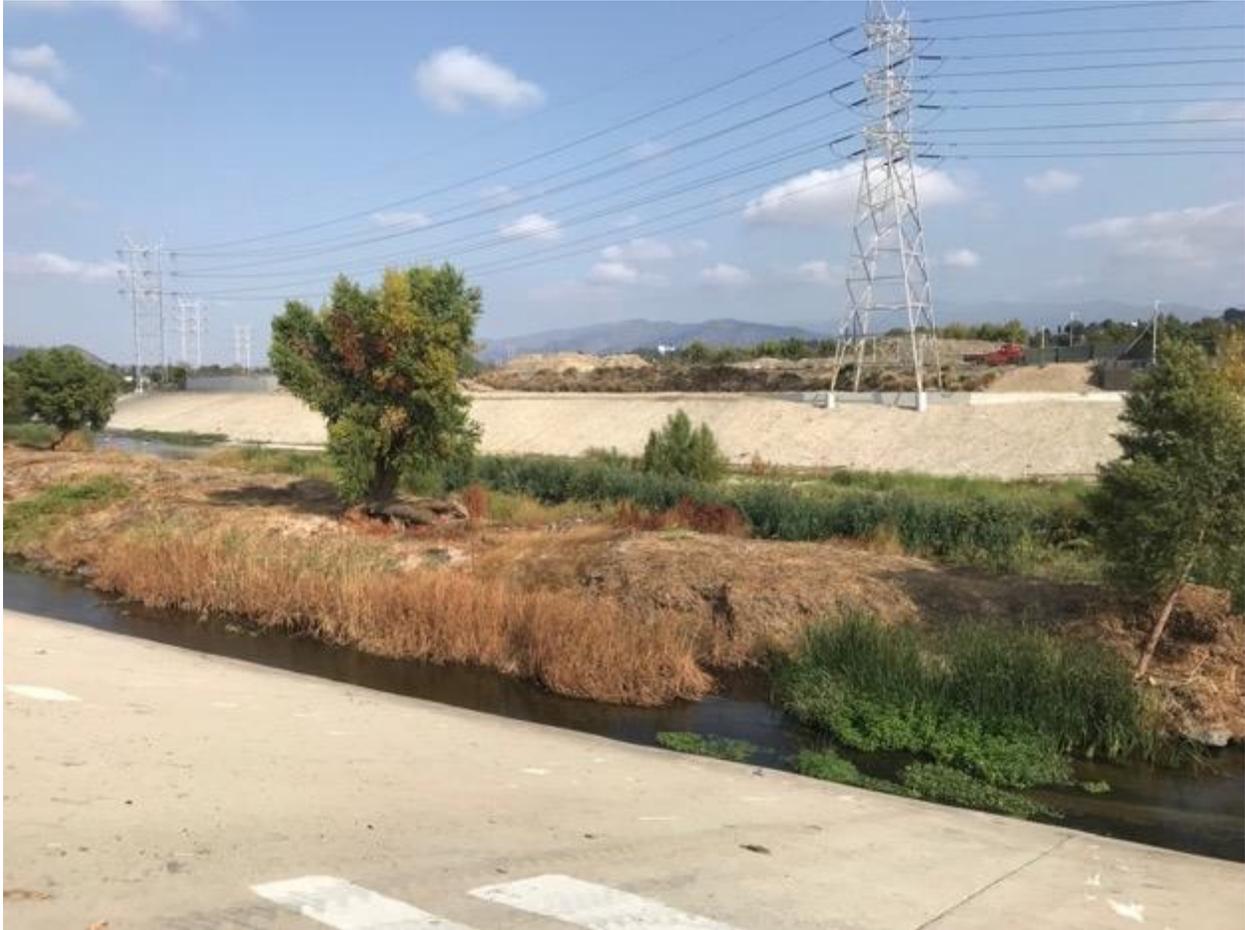
Figure 29. Giant cane (*Arundo donax*) removal area south of Fletcher Ave., Elysian Valley. 29 Sept. 2021.

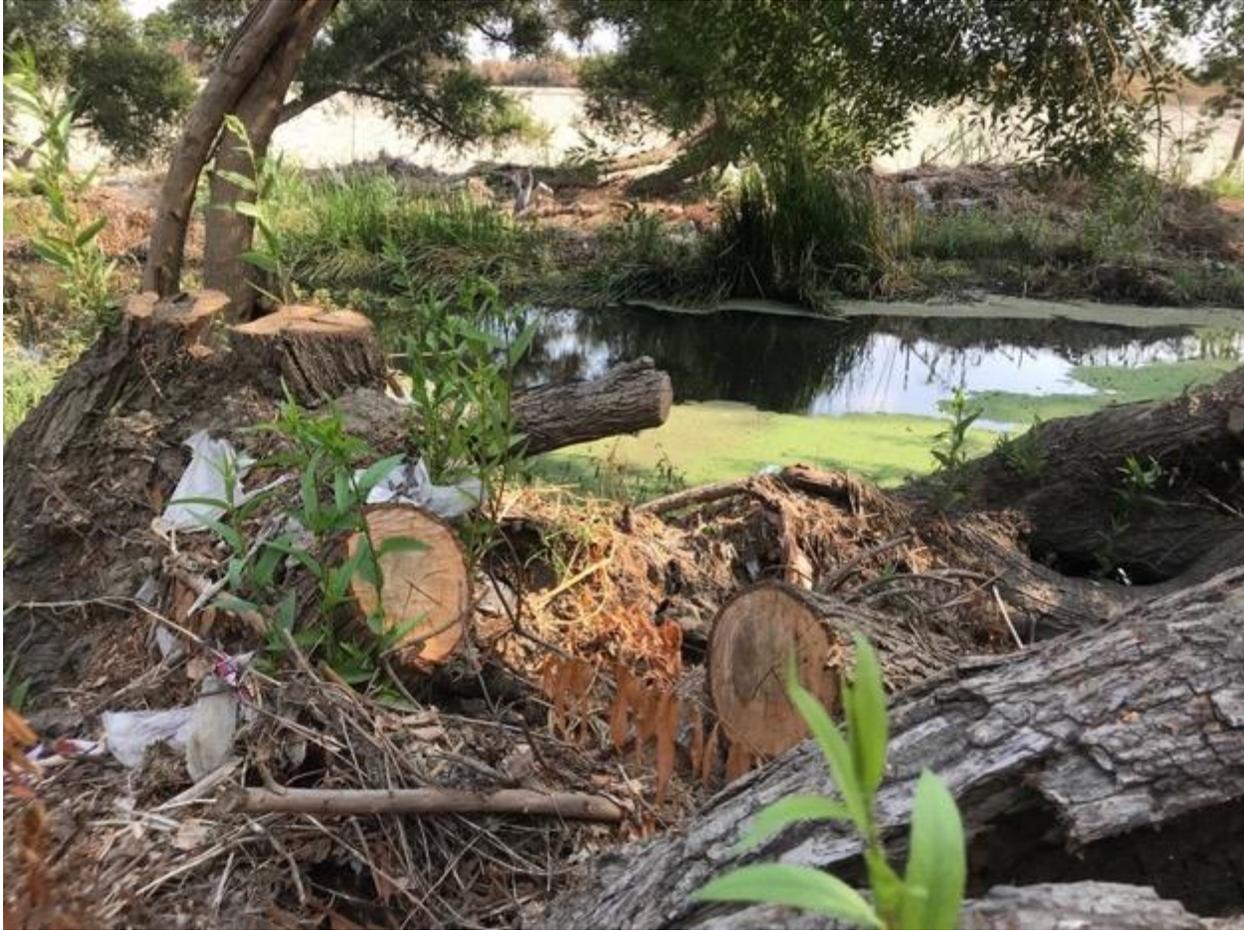
Figure 30. Cut willow stumps (unknown reason) in giant cane removal area, Elysian Valley. 2 Oct. 2021.

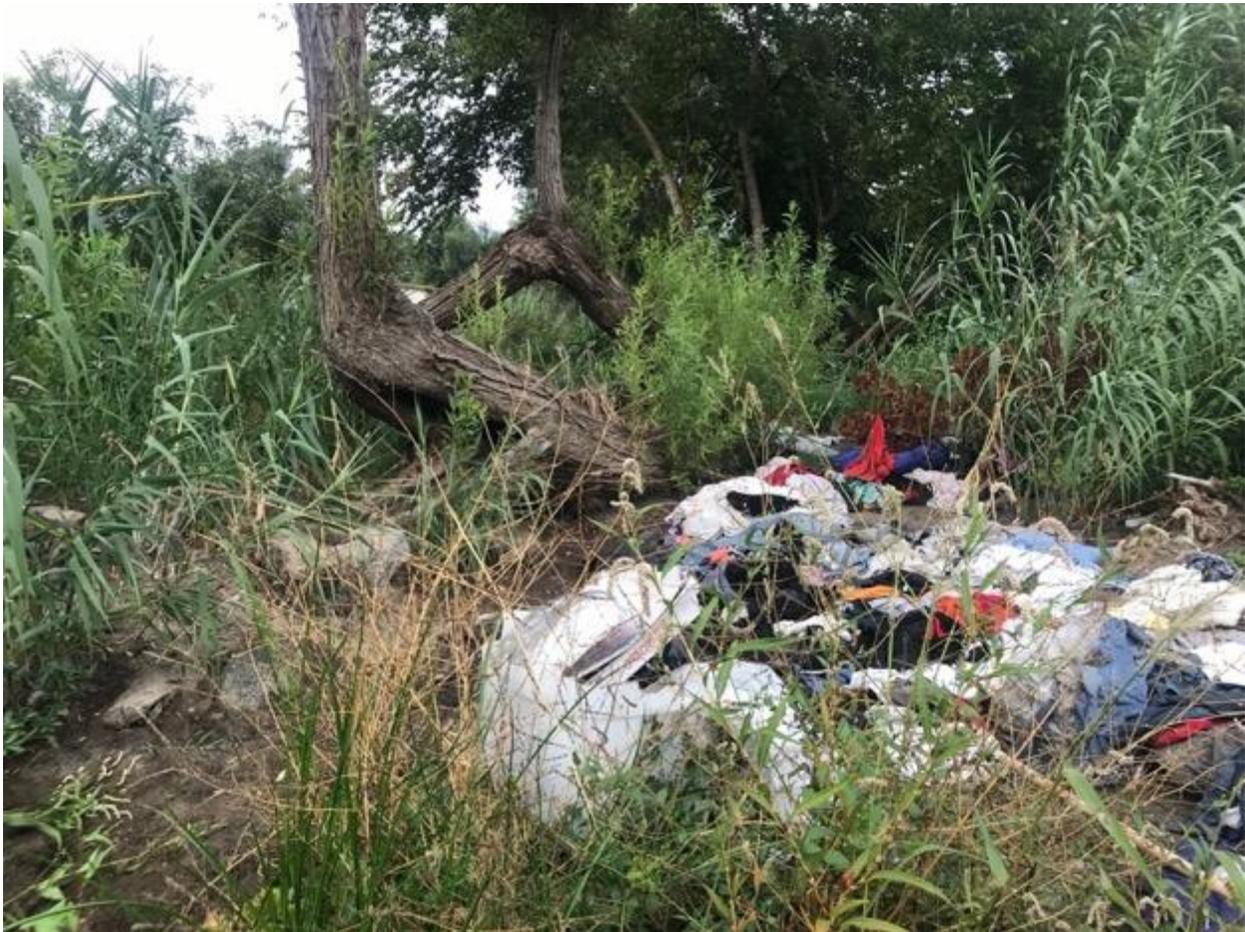
Figure 31. Typical encampment refuse, river island near Sunnynook footbridge, Elysian Valley. Piles of this garbage is washed downstream during each rain event. 2 Oct. 2021.

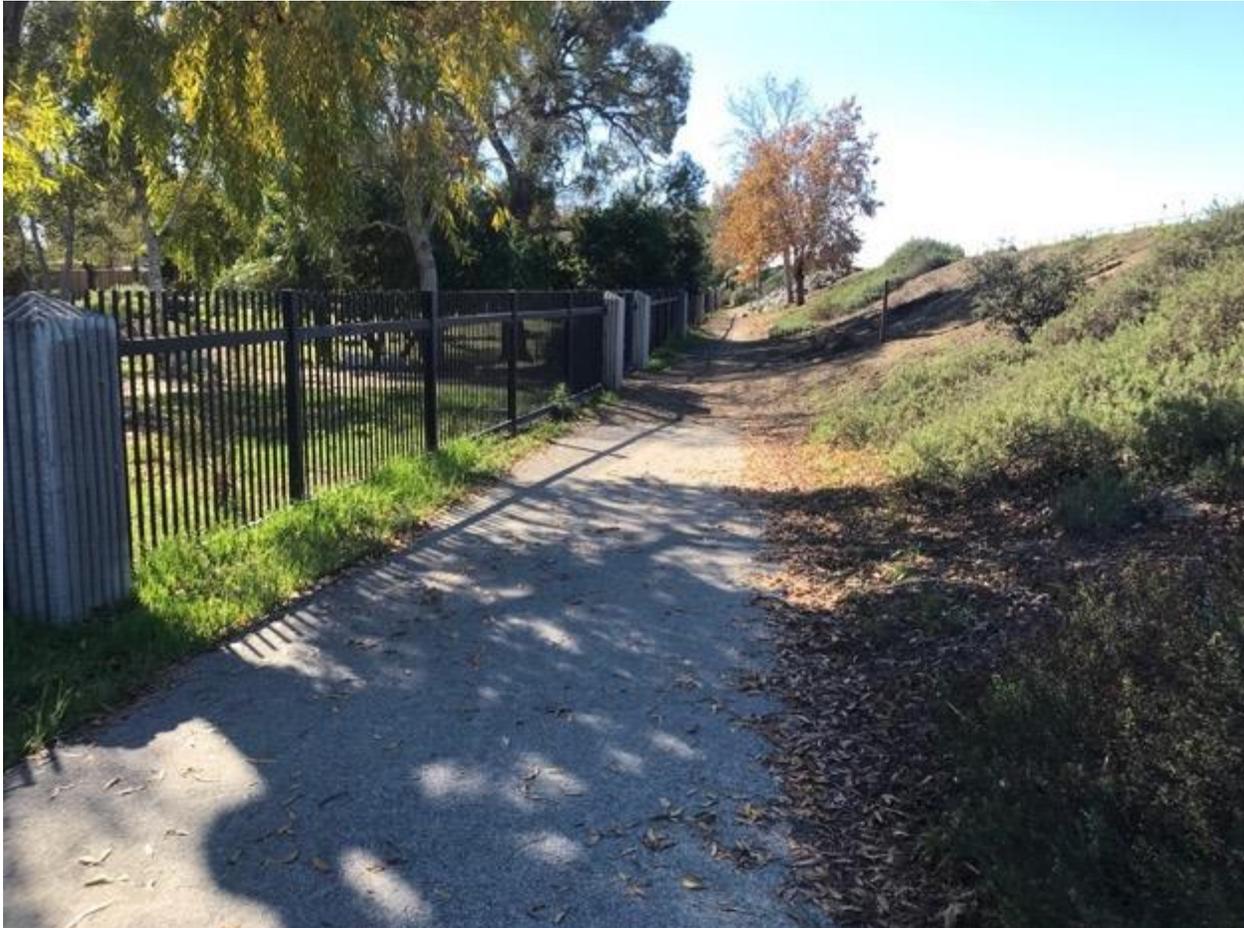
Figure 32. Extensive, mostly-native plantings at Ralph Dills Park, city of Paramount (left), adjacent to levee of Los Angeles River channel (right), which is also landscaped in part with native vegetation. 9 Jan. 2022.

We observed native shrub species planted as ornamental landscaping directly onto the levees (outside slope; i.e., away from the river channel) in several areas, but most consistently in the “southeastern cities” of Los Angeles County, such as South Gate, Paramount, and Long Beach, presumably as part of U.S. Army Corps of Engineers “improvement” projects dating to the 1990s (**Figure 32**; see also photos in **Appendix G**). Commonly-observed species included cultivars of

sages (*Salvia*), coyotebush (*Baccharis pilularis*), and buckwheat (*Eriogonum cf. fasciculatum*). As our focus for this report was in-channel restoration, we did not investigate the composition of these plantings, nor their use by wildlife. However, it is likely that these plantings support at least some native species, which are then able to move up and down the river more easily (e.g., lizards and small mammals).

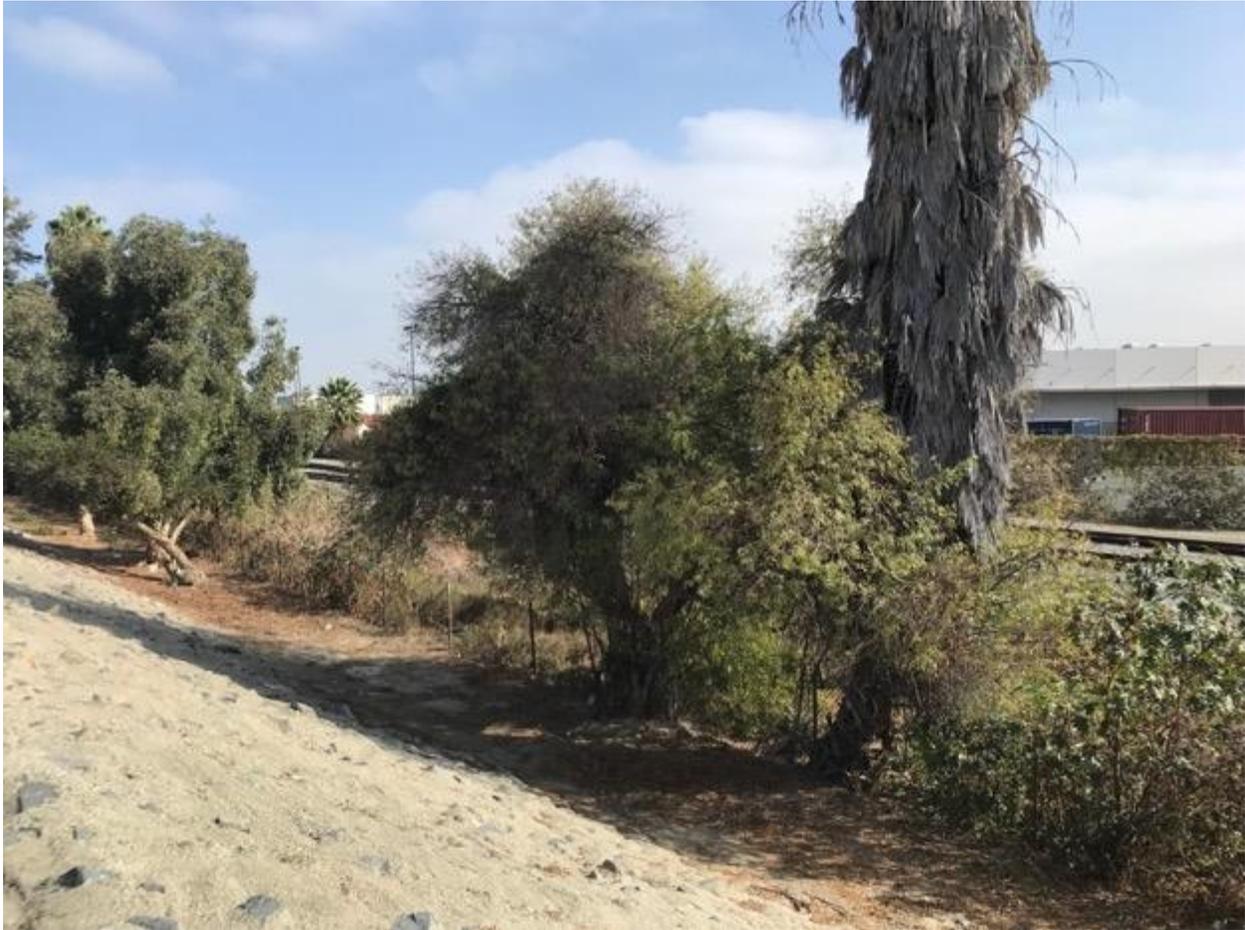
Figure 33. Relict stands of blue elderberry (*Sambucus caerulea*) were observed widely, including these along the fenceline just outside the Compton Creek levee (north of Del Amo Blvd.). These can serve as “keystone species” in an otherwise heavily-urbanized/industrial zones through which the river flows. If these levee-adjacent sites were to be protected and managed (a large encampment was recently cleared here following several publicized murders of unhoused residents), these elderberries could serve to anchor the native plantings here, and provide habitat if the non-natives were removed. A fan palm (*Washingtonia* sp.) is visible, and castor bean (*Ricinus communis*). 15 Sept. 2021.

Many areas of river-adjacent land, including those many miles from large blocks of native habitat (such as along Compton Creek) still support relict riparian species such as blue elderberry, Fremont cottonwood (*Populus fremontii*), and willows (*Salix* spp.) (**Figure 33**). These areas have never been formally mapped, and yet represent a major source of actually native flora and fauna along the river channel, which must be recognized, protected, and promoted during any development (including restoration).
