# Mountain Hawk Park and Salt Creek Recreational Center Pedestrian Audit

Address: 1475 Lake Crest Dr, Chula Vista, CA 91915

Date: July 15, 2026

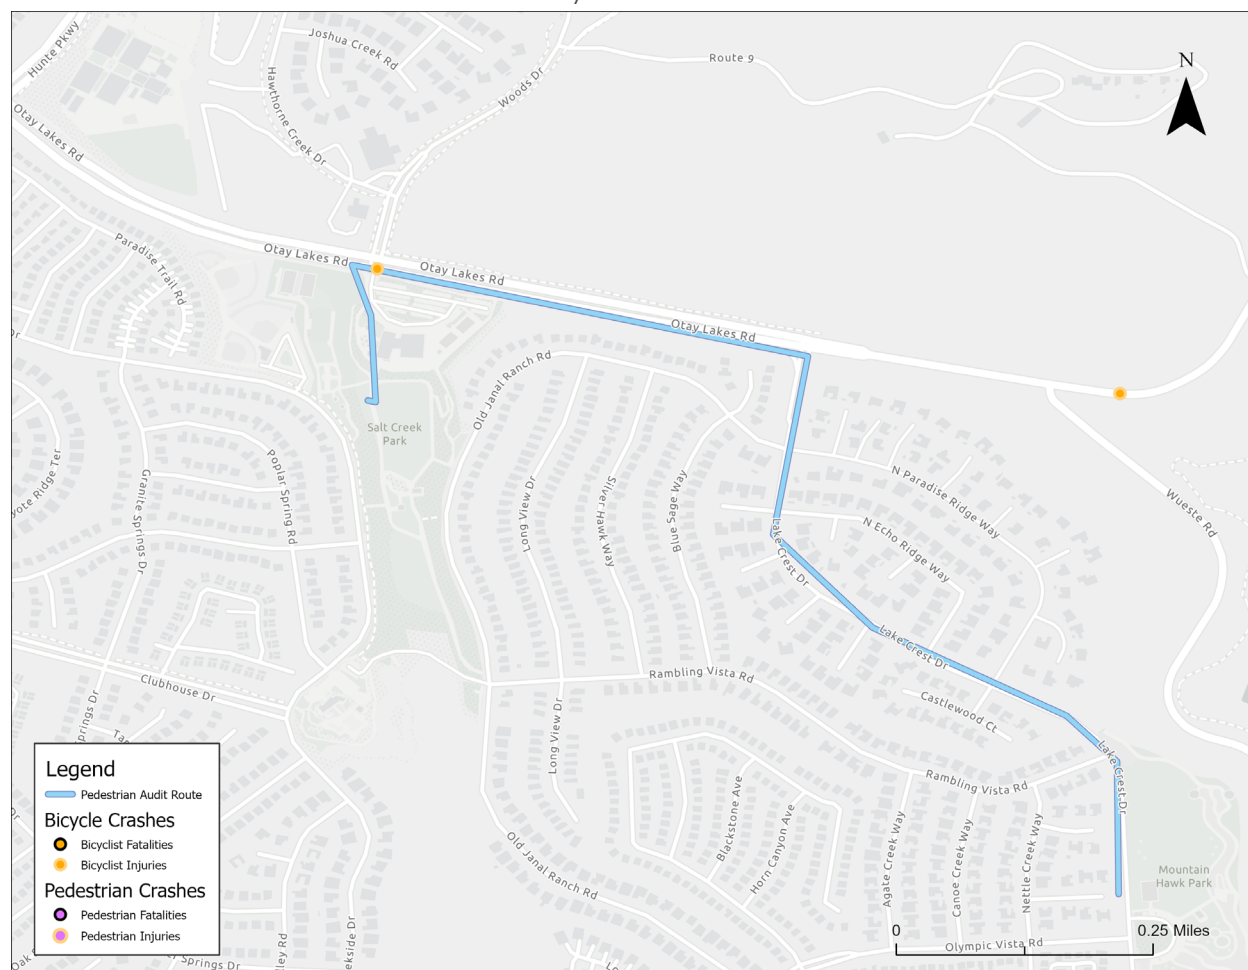
The pedestrian audit was attended by Circulate Planning & Policy, Salt Creek staff, and Salt Creek campers. This audit took place along Otay Lakes Road and Lake Crest Drive. Between 2020 and 2024, there were 2 bicyclists injured within a quarter mile of the route (see Figure 1). On May 27, 2023, a three-year-old pedestrian was struck and killed by a driver in the parking lot of the Eastlake Village Marketplace, located near Otay Lakes Road and Fenton Street. On February 8, 2024, a 14-year-old cyclist was struck by a driver making a right turn while the cyclist crossed the street at the intersection of Otay Lakes Road and Fenton Street.

FIGURE 1. PEDESTRIAN AND BICYCLE FATALITIES AND INJURIES PROXIMATE TO SALT CREEK AND MOUNTAIN HAWK PARKS (2020-2024)
