Walking Field Trip #1: San Diego Housing Federation

Address: 25th St / Commercial Station, San Diego, CA 92113

Date: March 27, 2023

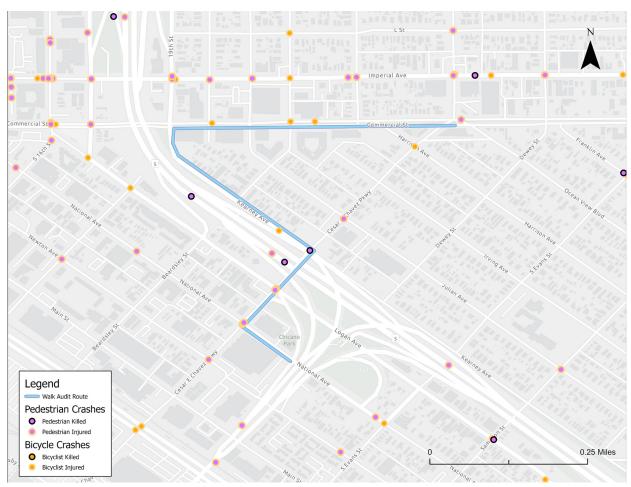
The walking route was situated on two high-injury corridors: Commercial Street and Cesar Chavez Parkway. Between 2017-2022, there were 6 pedestrian fatalities, 61 pedestrian injuries, and 36 bicycle injuries within a quarter mile of the walking route (see Figure 1).

FIGURE 1. PEDESTRIAN AND BICYCLE FATALITIES AND INJURIES PROXIMATE TO THE SAN DIEGO HOUSING FEDERATION WALKING FIELD TRIP (2017-2022)
