Pedestrian Field Trip# 1: 30th Street

Address: 4044 Idaho St, San Diego, CA 92104

Date: February 21st, 2025

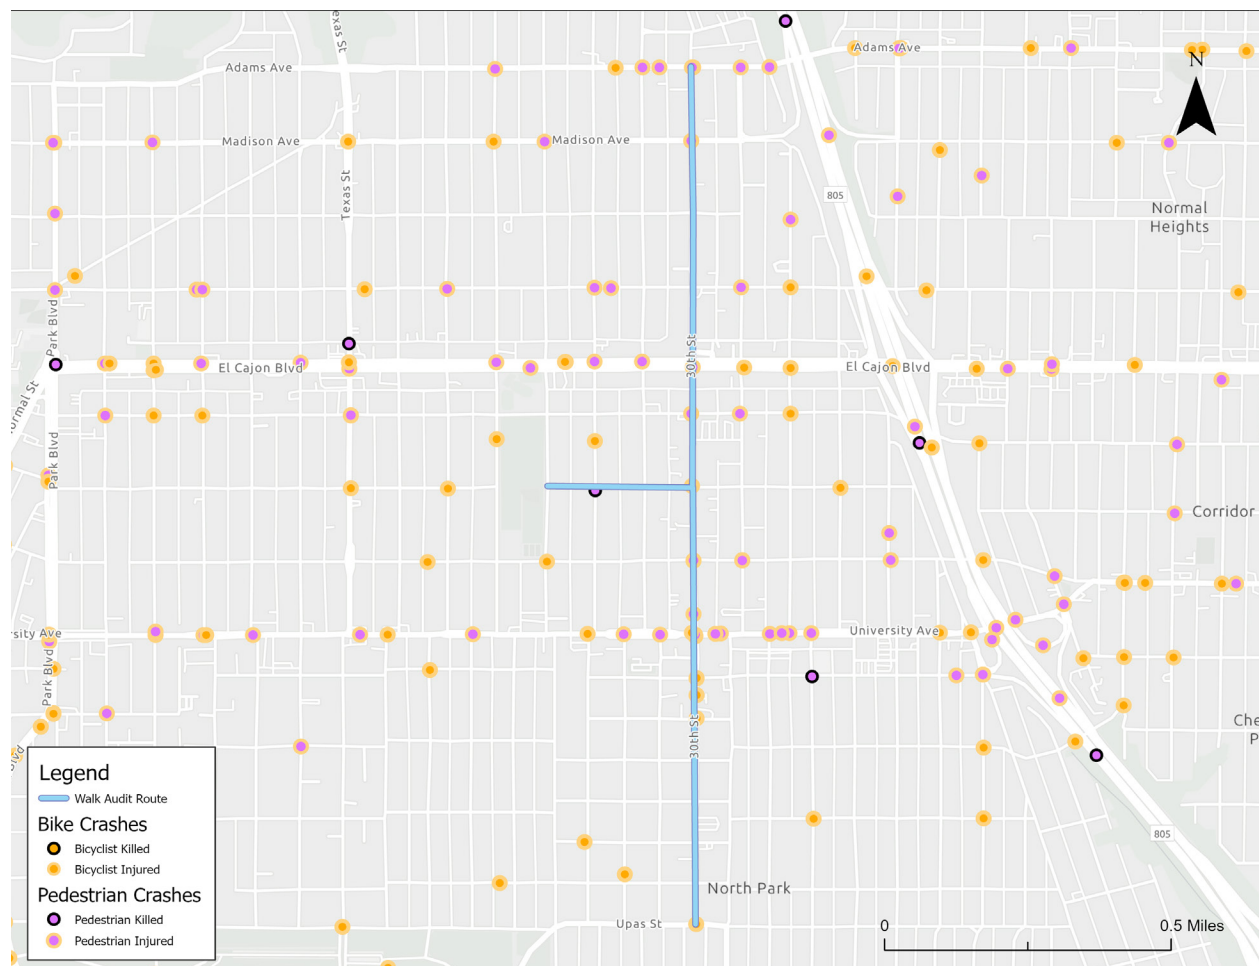
This pedestrian audit took place along Polk Avenue, 30th Street, Upas Street, and Adams Avenue. Between 2019-2023, there were 3 pedestrians killed, 51 pedestrians injured, and 24 bicyclists injured within one quarter-mile of the walking route (see Figure 1). On November 21st, 2023 42-year-old Stephen Debow was killed by a hit-and-run driver at the intersection of Polk Avenue and Utah Street.

FIGURE 1. PEDESTRIAN AND BICYCLE FATALITIES AND INJURIES PROXIMATE TO 30TH STREET (2019-2023)

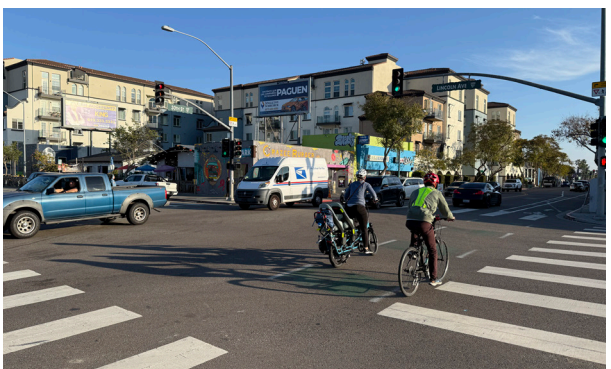
FIGURE 10: 30TH STREET IS A BUSY, SHARED SPACE, AND EVERYONE WHO USES IT DESERVES TO FEEL SAFE.
