AUGUST 10, 2023 FLOOD INVESTIGATION REPORT

DRAFT SUMMARY REPORT WARD 8

Infrastructure and Water Services

December 14, 2023

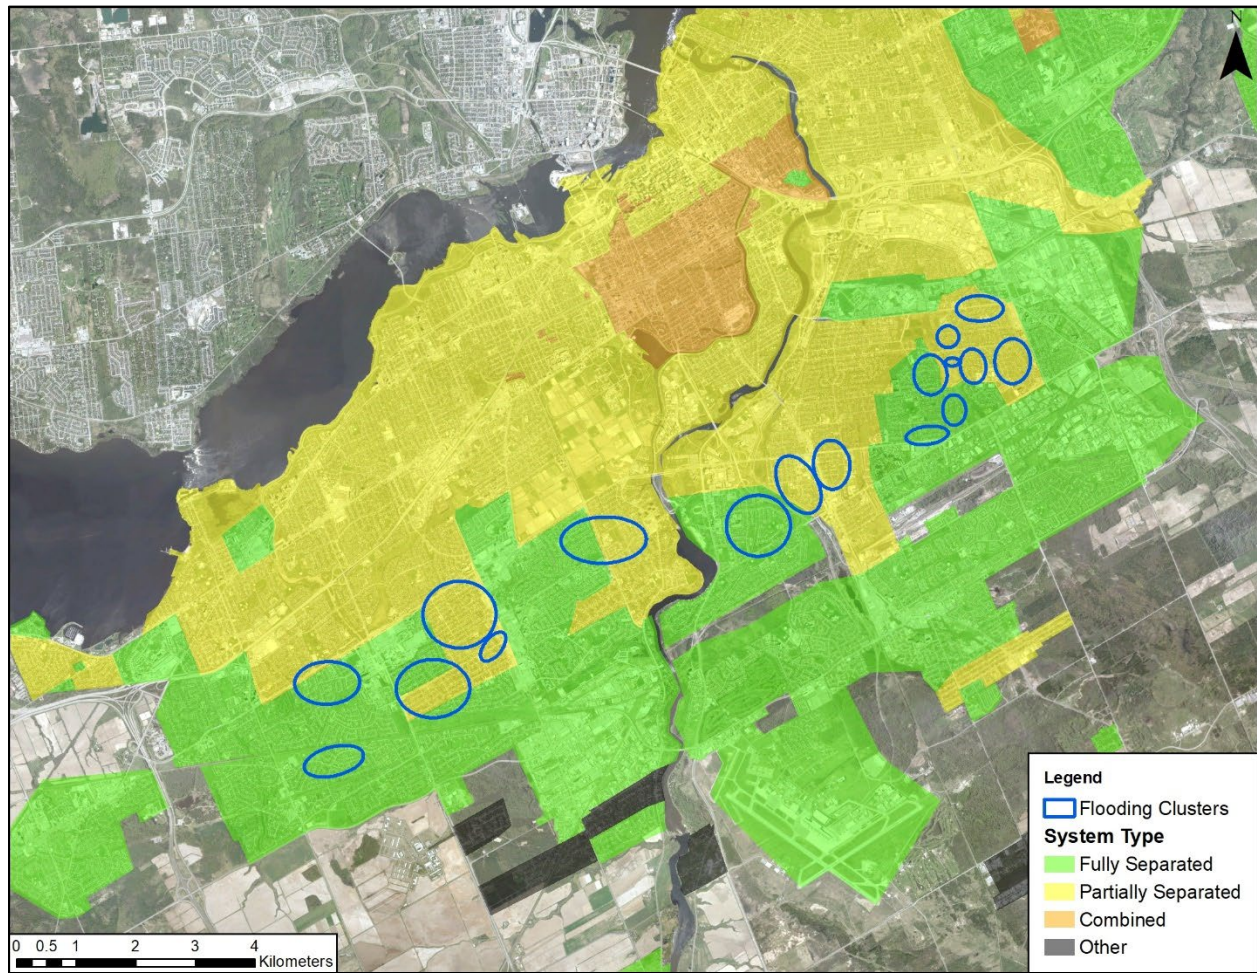
Figure 1 – System Type and Flooding Clusters

In 1961 the City of Ottawa passed a bylaw that required that all new sewer systems be fully separated. In other words, a sanitary sewer system would be designed for domestic flow only and a deeper storm system would capture surface runoff and foundation drain flow. The City even proceeded to separate sewers in some of the combined areas, however due to outlet restrictions, the storm sewers were shallow and foundation drains remained connected to the sanitary sewers. Also, in many areas where ditch drainage existed, the City constructed storm sewers, but again due to various drainage conditions or limitations the sewers were shallow and foundation drains remained connected to the sanitary system. ***All areas that have foundation drains connected to the sanitary sewers are referred to as partially separated. Figure 1.0 below, shows an approximate outline of the partially separated systems (in yellow) and fully separated systems (in red) in the southern portion of the City core, which was most affected by the storm.***

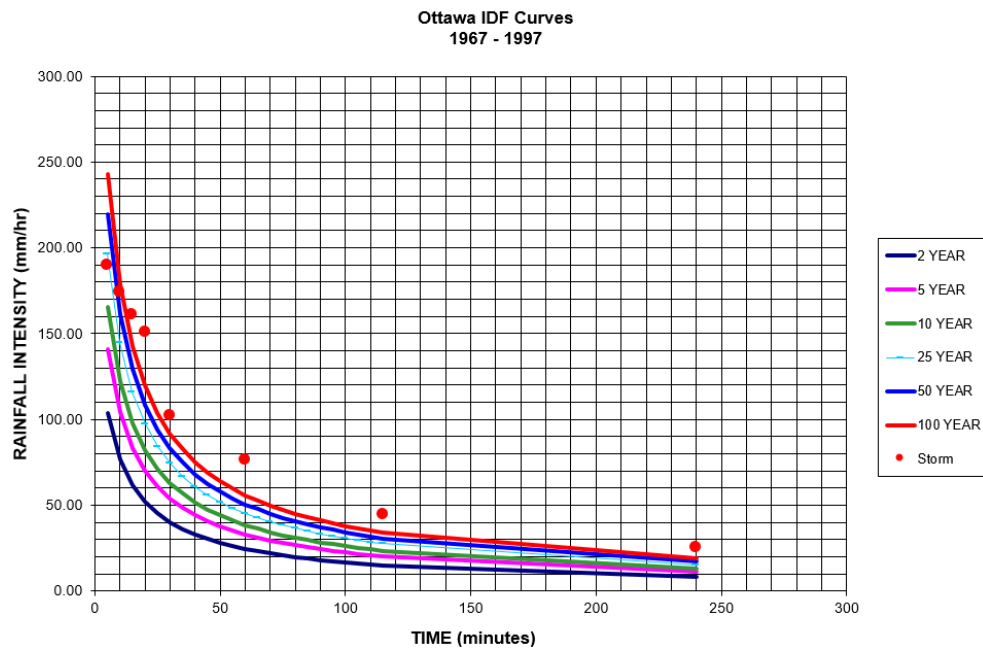
Figure 2 - Colonnade Road Rain Gauge

The average rainfall in the partially separated area was 60 mm with a peak recorded volume of 107 mm. The peak intensity of the event reached 190 mm/hr at the Colonnade rain gauge. Although the event did not reach the peak 100 year peak intensity of 243 mm/hr, it lasted longer than a typical storm, therefore the sustained intensity created an effect similar to a 100 year storm. Figures 2 and 3 below show the Intensity Duration Frequency (IDF) curves for the event at the Colonnade and Mooney's Bay rain gauges. It is apparent from the graphs that as the storm progressed, the curve moved into the 100 year range due to the sustained intensity over a long period of time.
