Powder Wood at Landmark HOA

Level 1 Reserve Study

Report Period – 01/01/2024 – 12/31/2024

Executive Summary – Powder Wood at Landmark HOA – ID # 10228

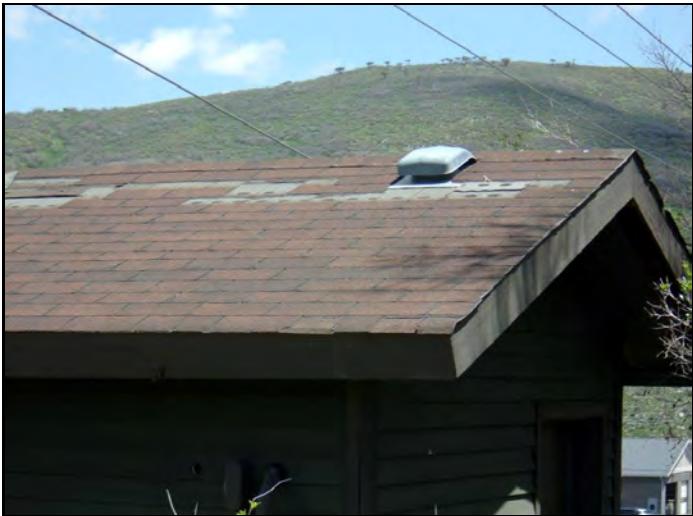
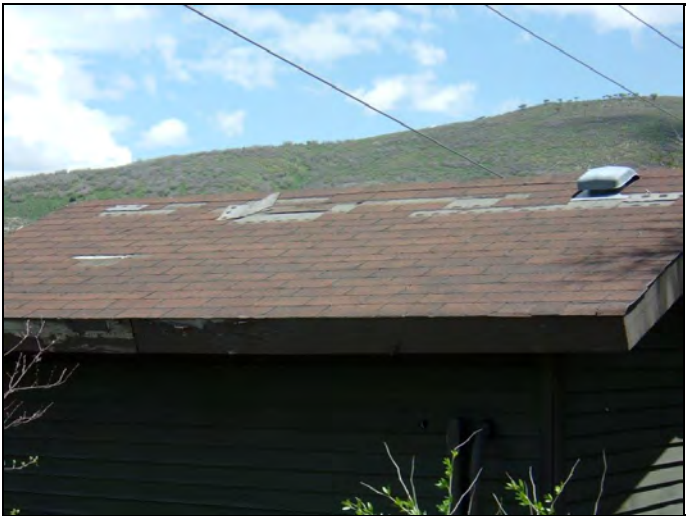
Comp #: 106 Roofs - Storage - Replace

Location: **Storage Building**

Quantity: **Approx. 260 SF**

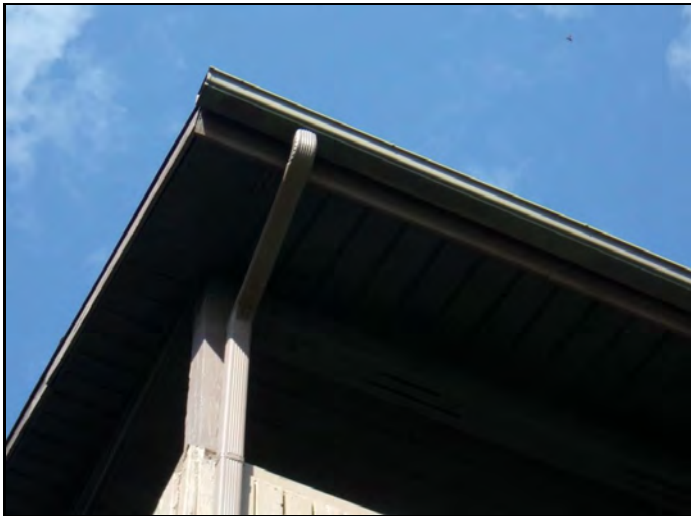
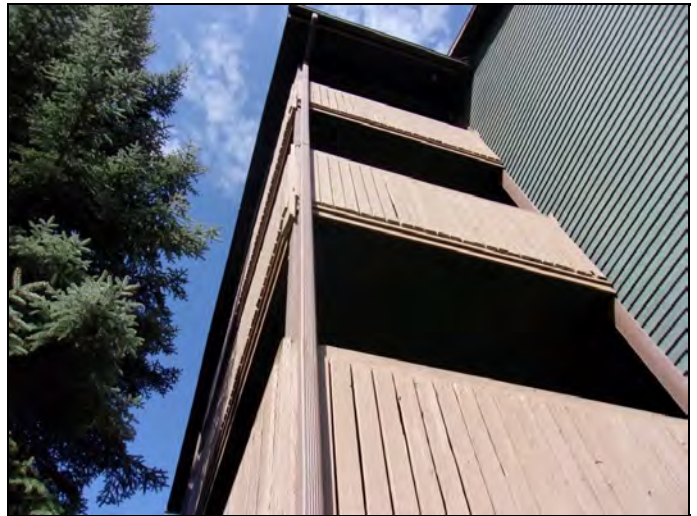
Comp #: 120 Rain Gutters/Downspouts - Replace

Location: **Building Exteriors**

Quantity: **Approx. 2,390 LF**

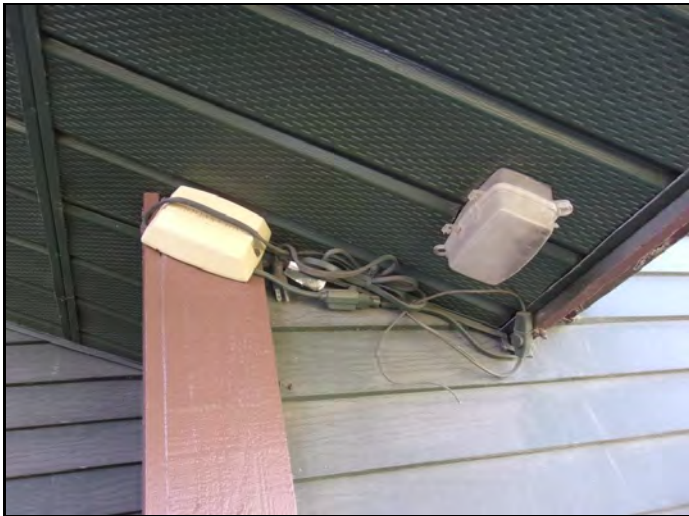
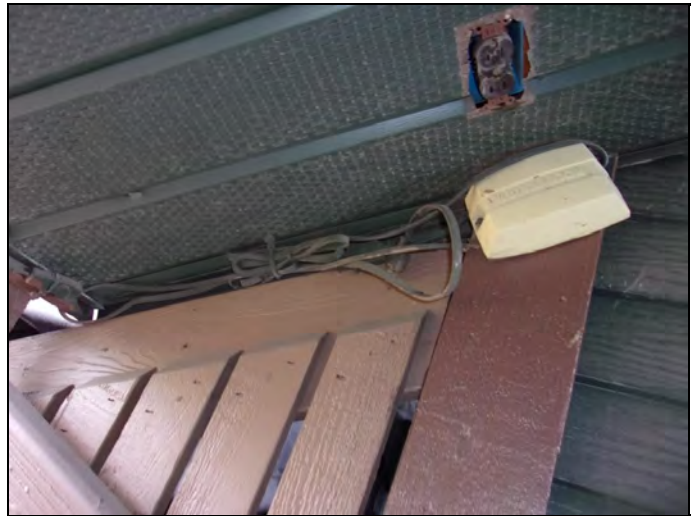
Comp #: 121 Heat Tape - Replace

Location: **Building Exteriors**

Quantity: **(14) Buildings**

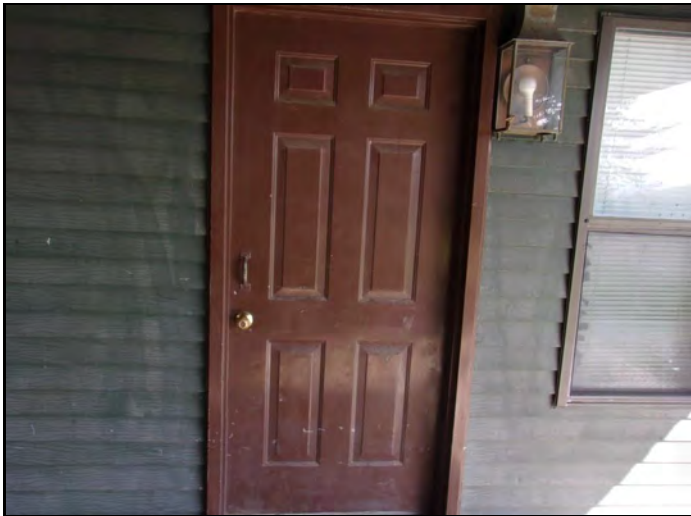
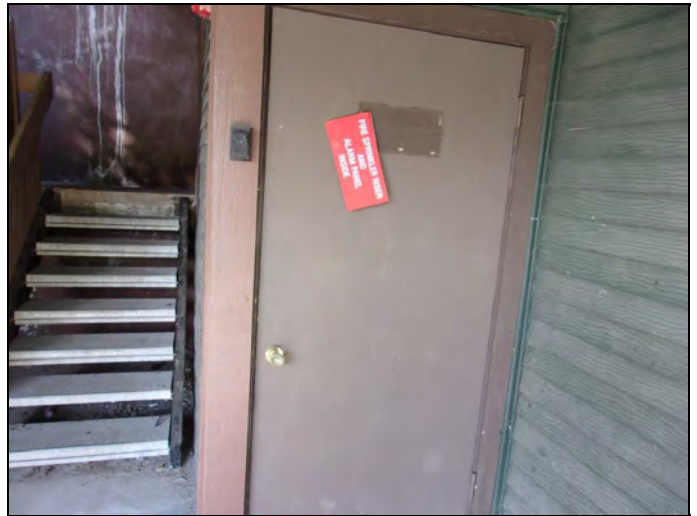
Comp #: 204 Doors - Repaint

Location: **Building Exteriors**

Quantity: **(290) Doors**

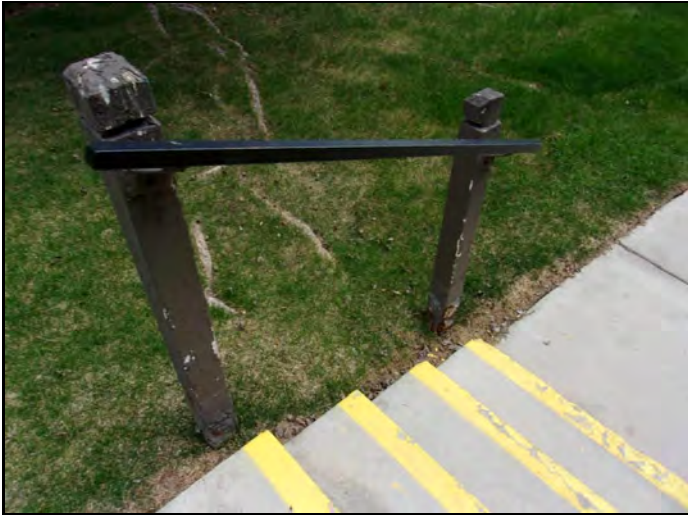
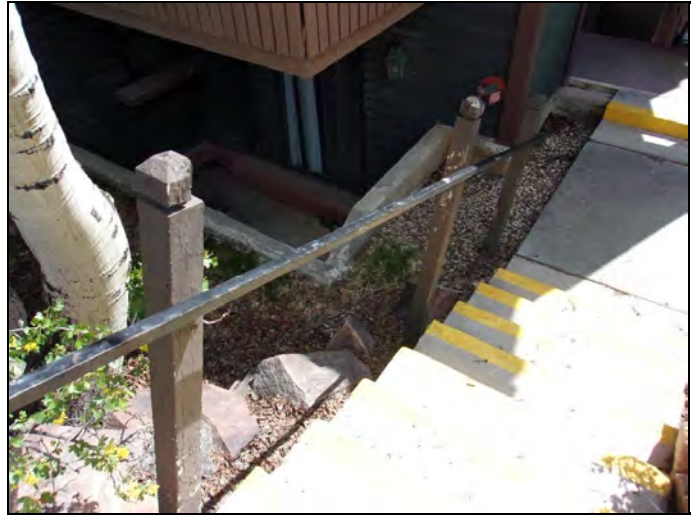
Comp #: 212 Metal Railing - Repaint

Location: **Common Area**

Quantity: **Approx. 255 LF**

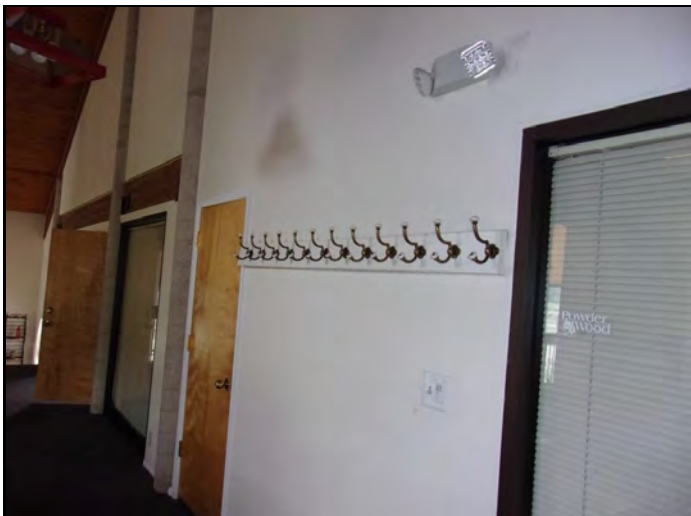
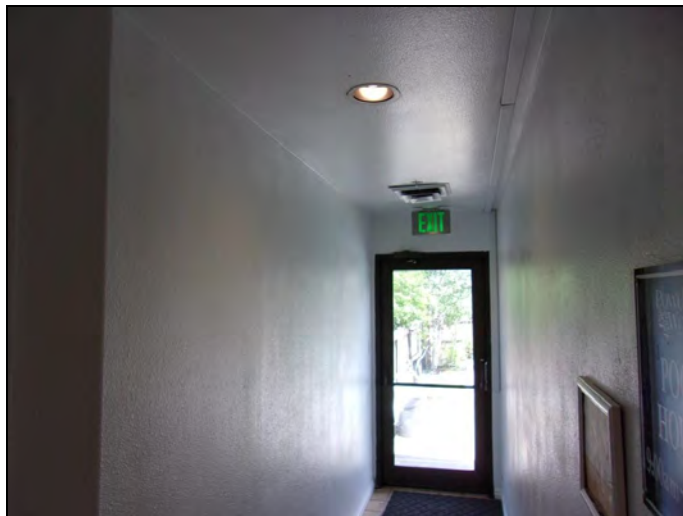
Comp #: 216 Interior Surfaces - Repaint

Location: Clubhouse

Quantity: Approx. 5,030 SF

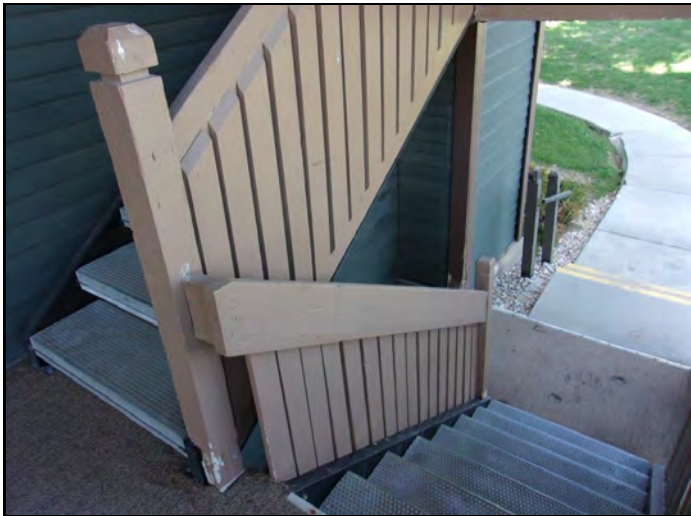
Comp #: 217 Wood Surfaces - Repair/Repaint

Location: **Building Exteriors**

Quantity: **Approx. 108,795 SF**

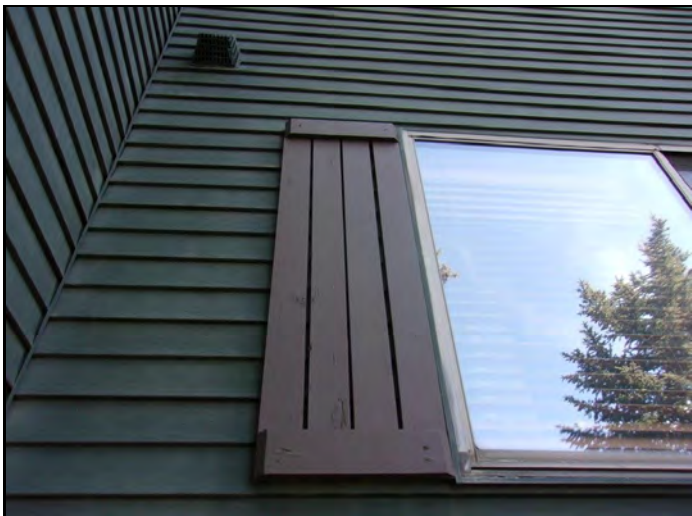
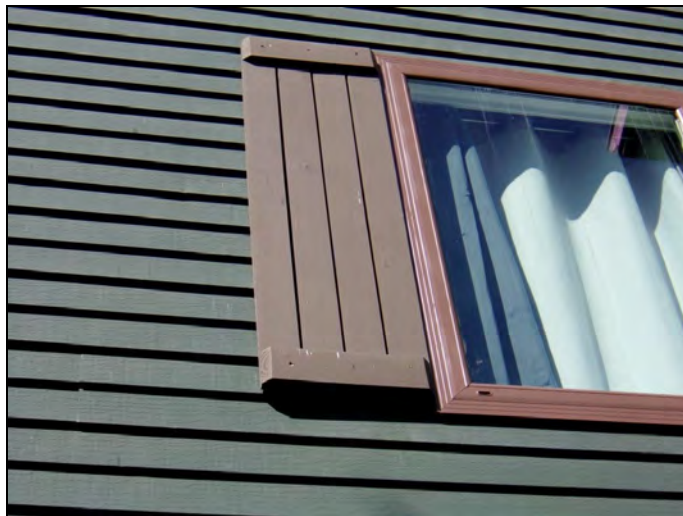
Comp #: 219 Shutters - Repaint

Location: **Building Exteriors**

Quantity: **(456) Shutters**

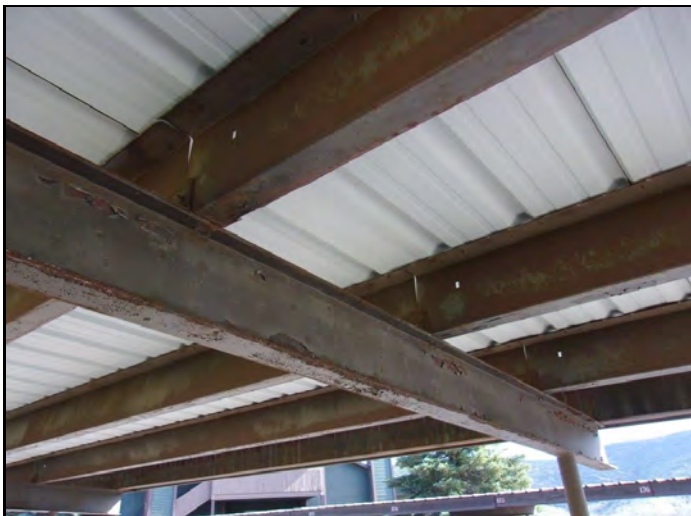
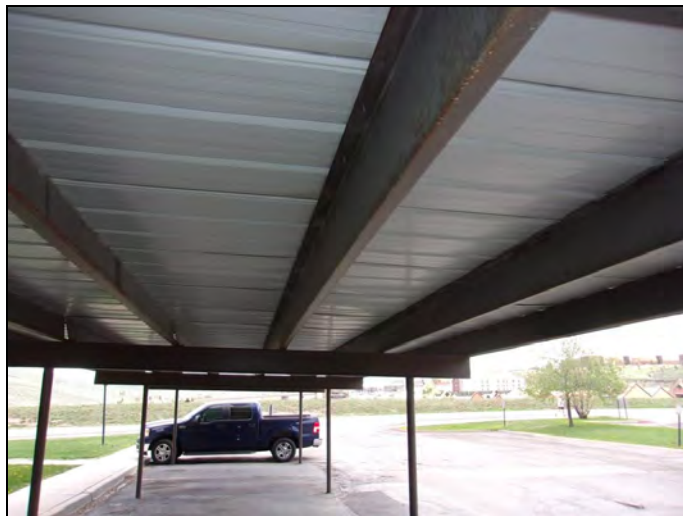
Comp #: 223 Carports - Repaint

Location: **Common Area**

Quantity: **(32) Carports**

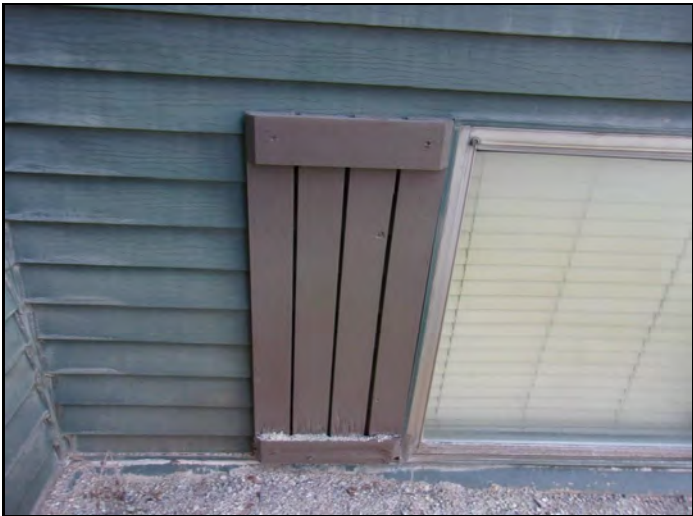
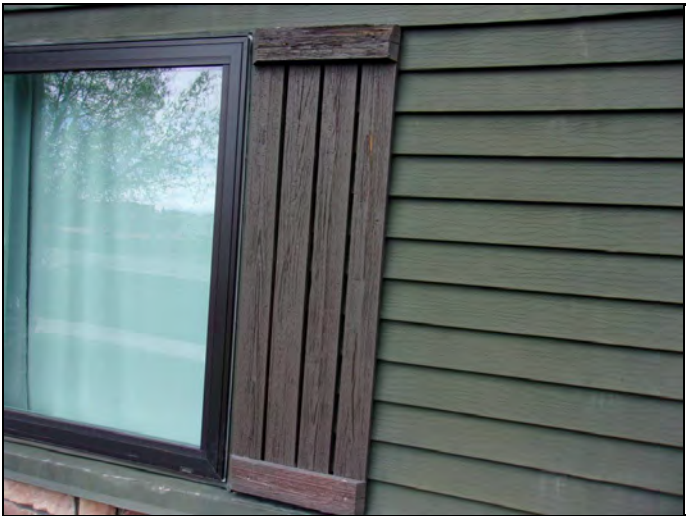
Comp #: 303 Wood Shutters - Replace

Location: Building Exteriors

Quantity: (456) Shutters

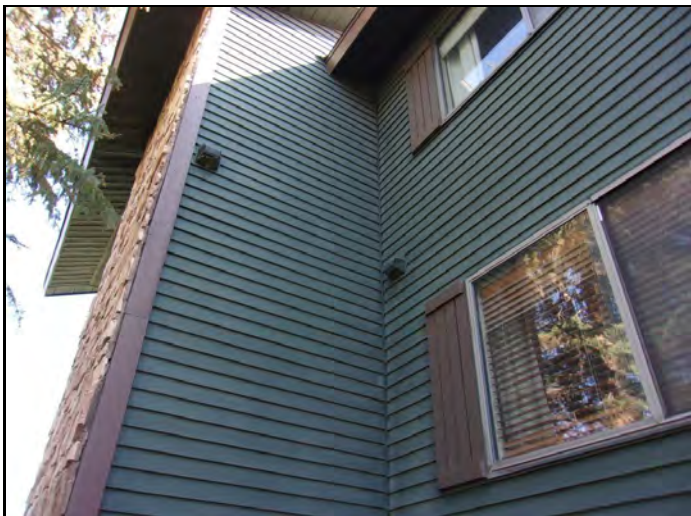
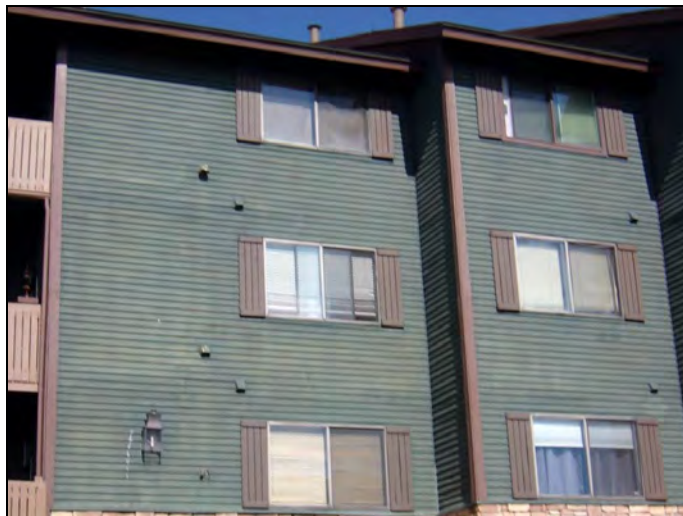
Comp #: 304 Metal Siding - Replace

Location: **Building Exteriors**

Quantity: **Approx. 194,070 SF**

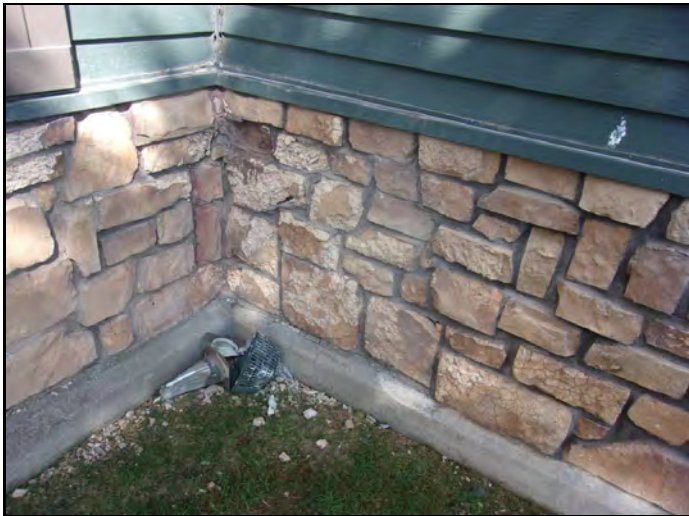
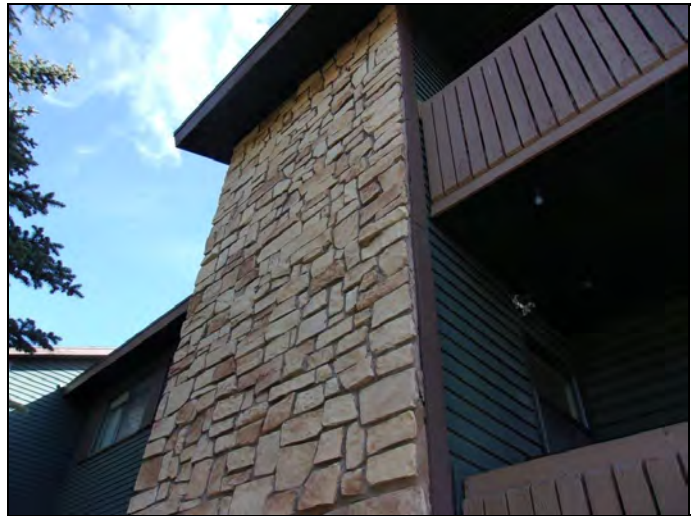
Comp #: 390 Stone Façade - Repair/Replace

Location: **Building Exteriors**

Quantity: **(14) Buildings**

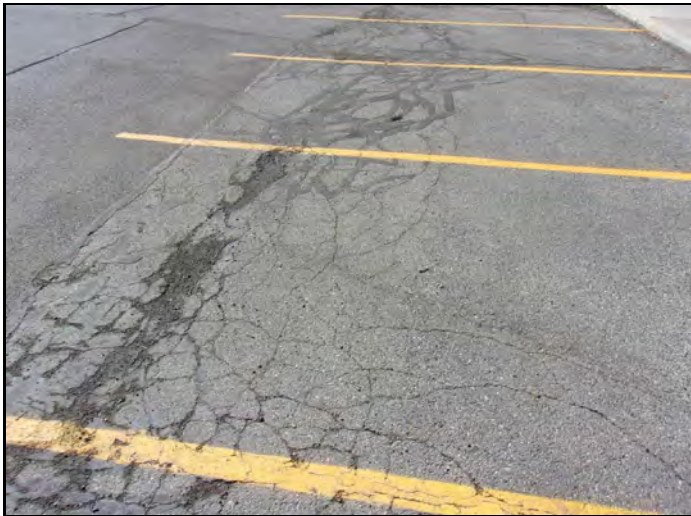
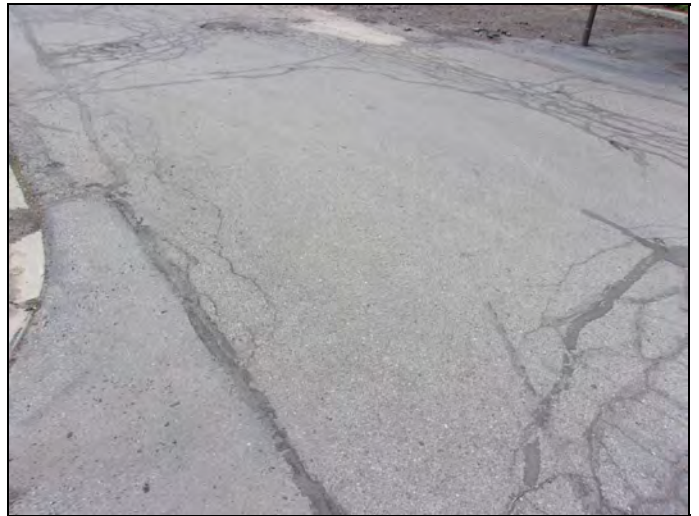
Comp #: 401 Asphalt - 2024 - Major Rehab

Location: **Community Streets**

Quantity: **Approx. 53,000 SF**

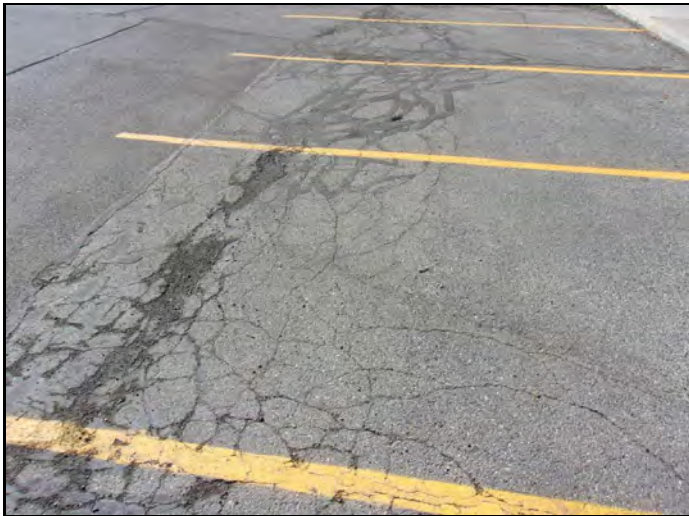
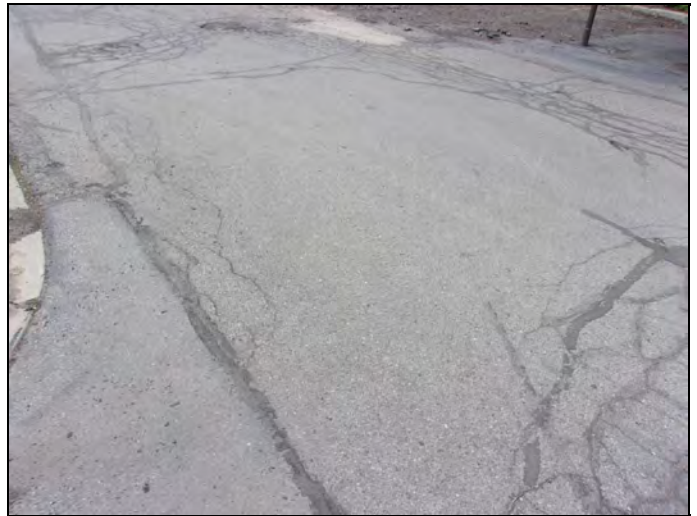
Comp #: 401 Asphalt - 2030 - Major Rehab

Location: **Community Streets**

Quantity: **Approx. 56,000 SF**

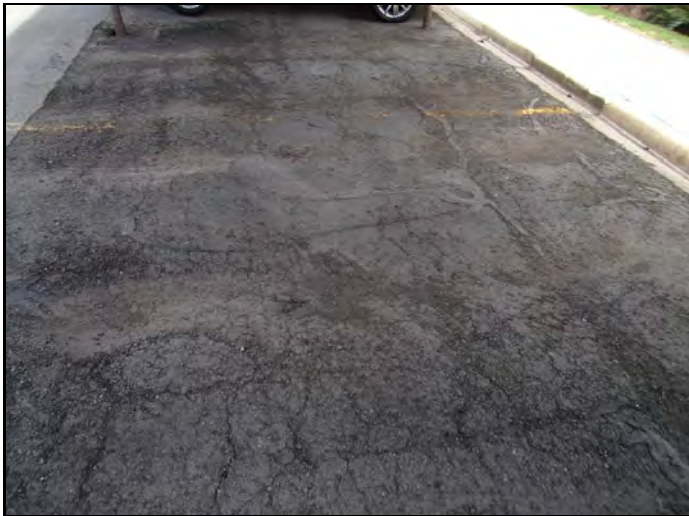
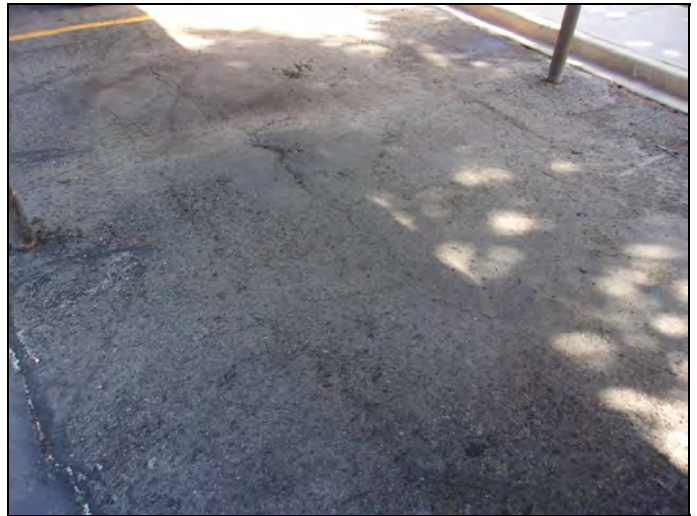
Comp #: 402 Asphalt - 2024 - Seal Coat

Location: **Community Streets**

Quantity: **Approx. 53,000 SF**

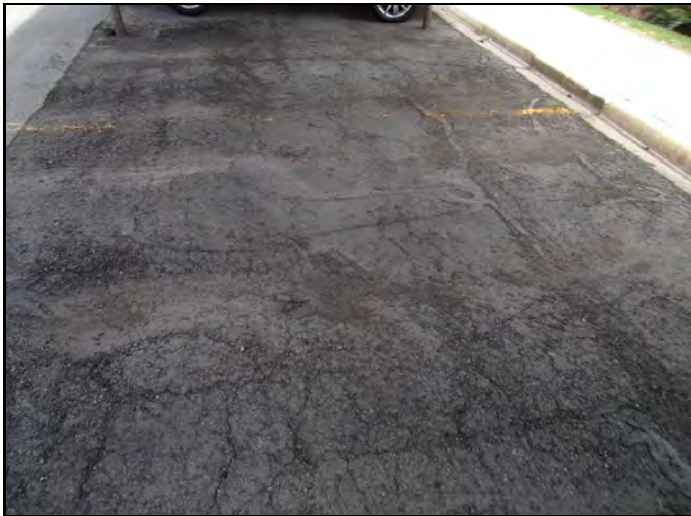
Comp #: 402 Asphalt - 2030 - Seal Coat

Location: **Community Streets**

Quantity: **Approx. 56,000 SF**

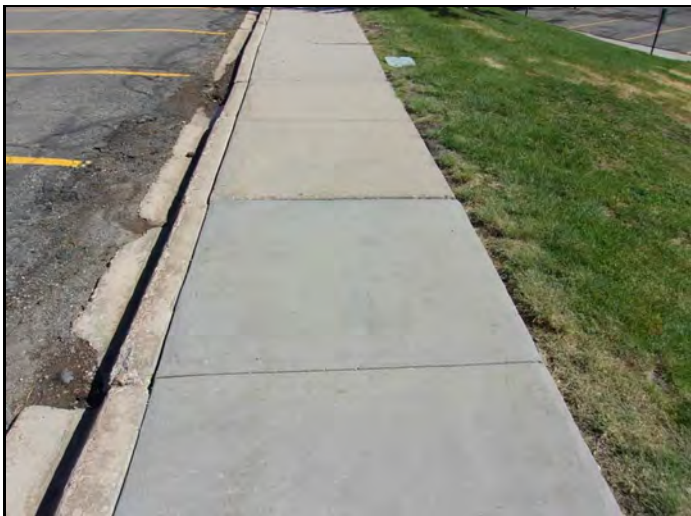
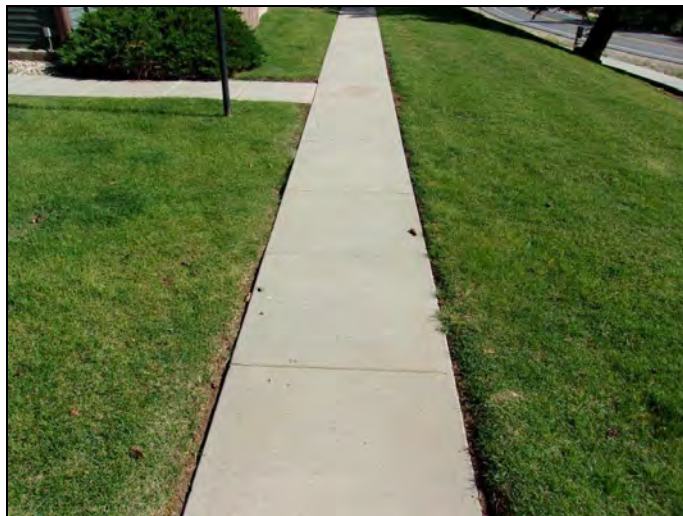
Comp #: 403 Concrete - Partial Repair/Replace

Location: **Common Area**

Quantity: **Moderate SF**

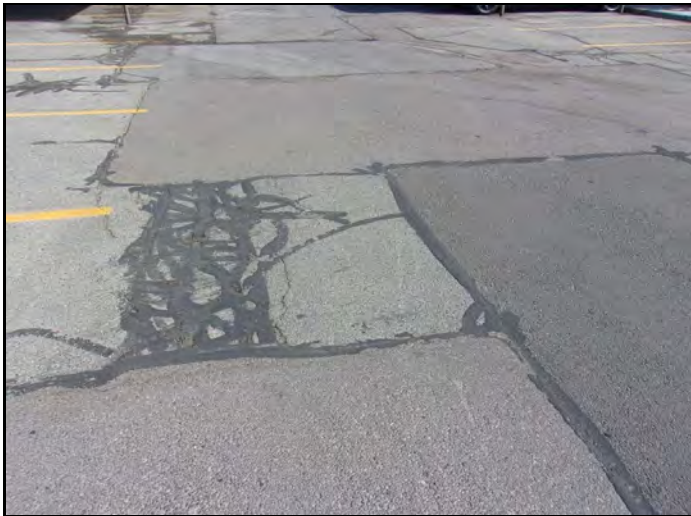
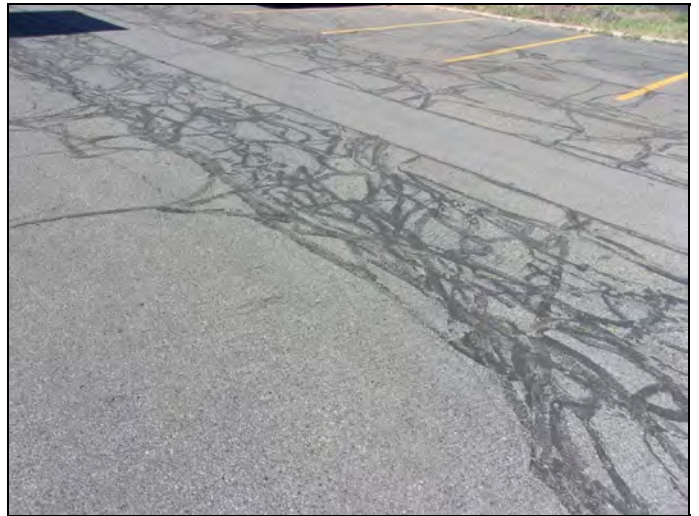
Comp #: 406 Asphalt - 2024 - Repairs

Location: **Community Streets**

Quantity: **Approx. 112,000 SF**

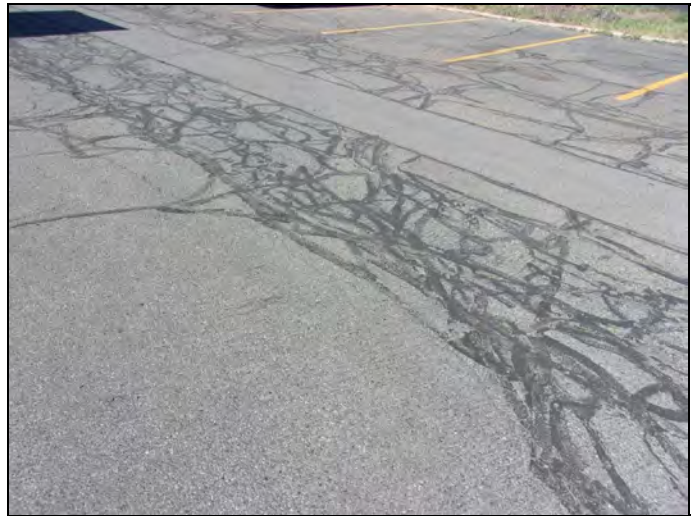
Comp #: 406 Asphalt - 2026 - Repairs

Research with the client reveals this component is repaired yearly.

Allowance for repairs

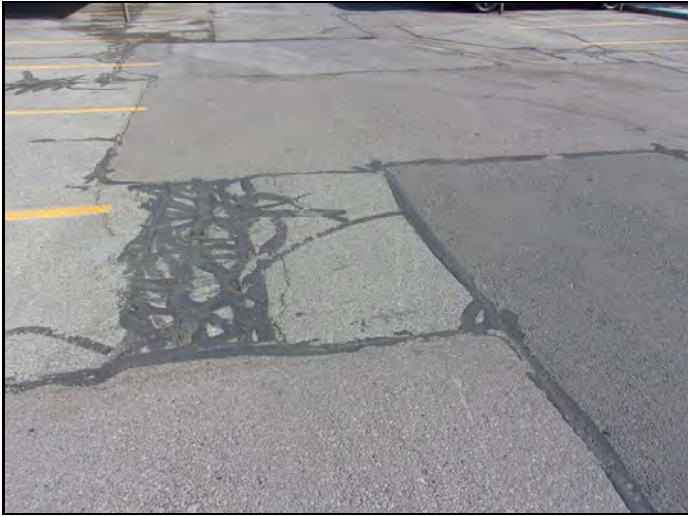
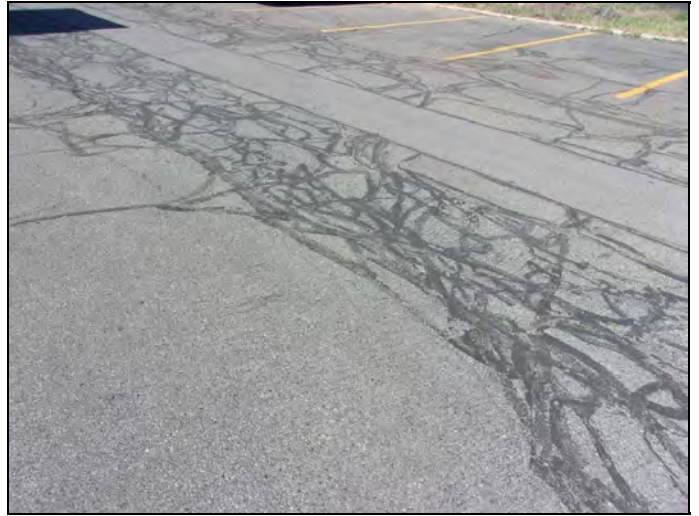
Comp #: 406 Asphalt - 2031 - Repairs

Research with the client reveals this component is repaired yearly.

Allowance for repairs

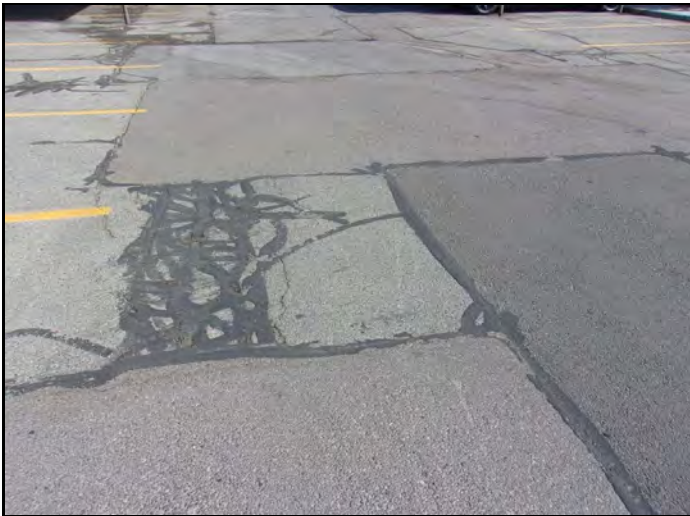
Comp #: 406 Asphalt - 2033 - Repairs

Research with the client reveals this component is repaired yearly.

Allowance for repairs

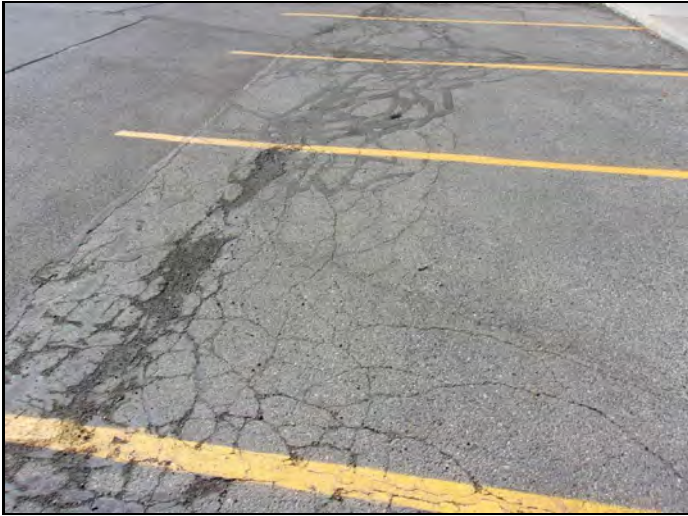
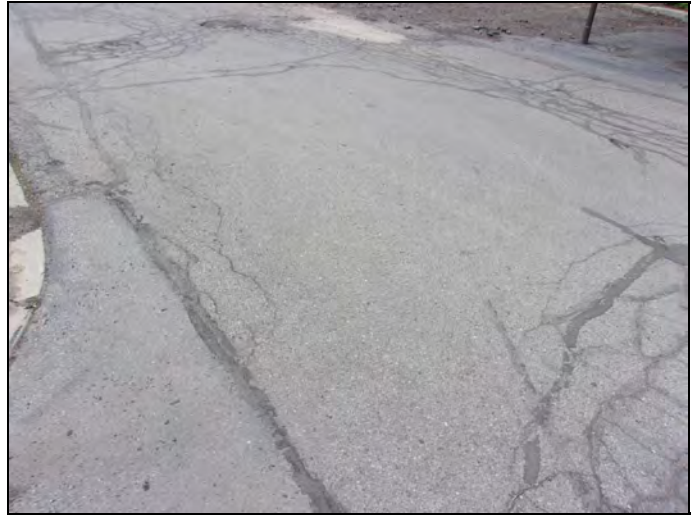
Comp #: 490 Asphalt - 2024 - Replace

The asphalt surface is generally in fair to poor condition. We recommend funding to replace this component in sections. This is one section. This is a one-time component.

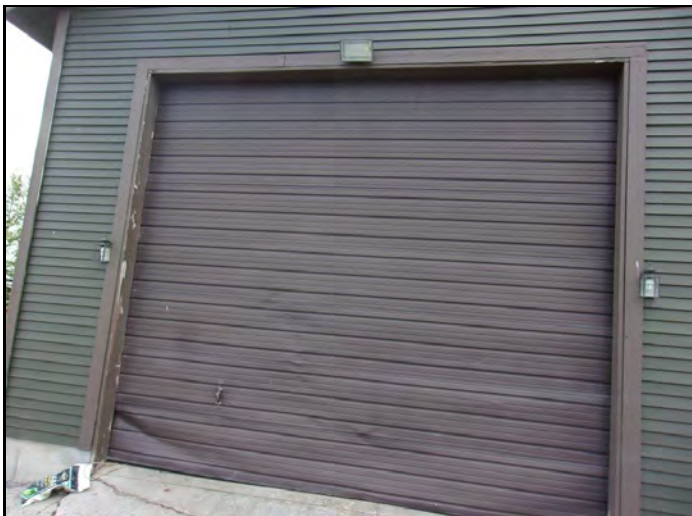
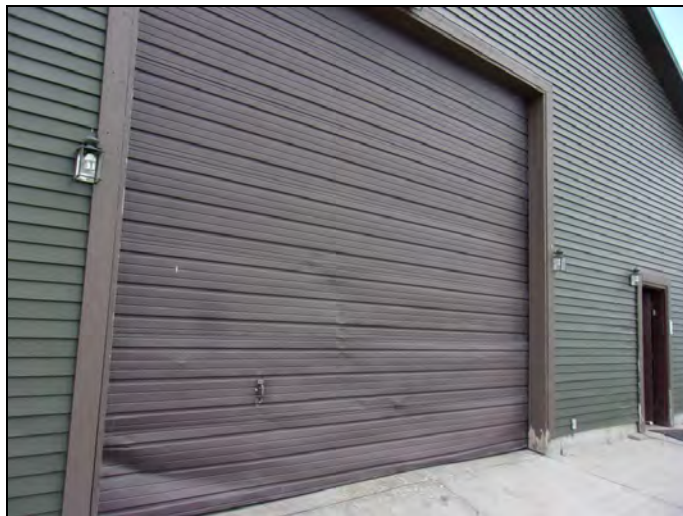
Comp #: 502 Garage Door - Replace

The garage door is in fair condition. We recommend funding to replace this component approximately every 20 years. Remaining life based on current age and condition.

Estimate to replace

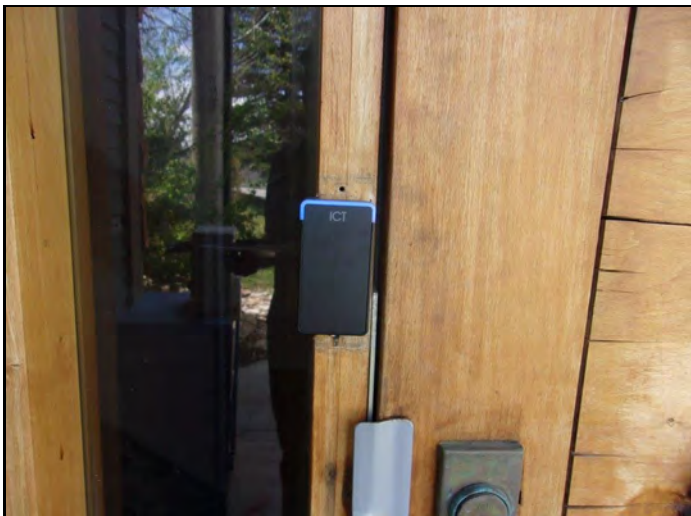
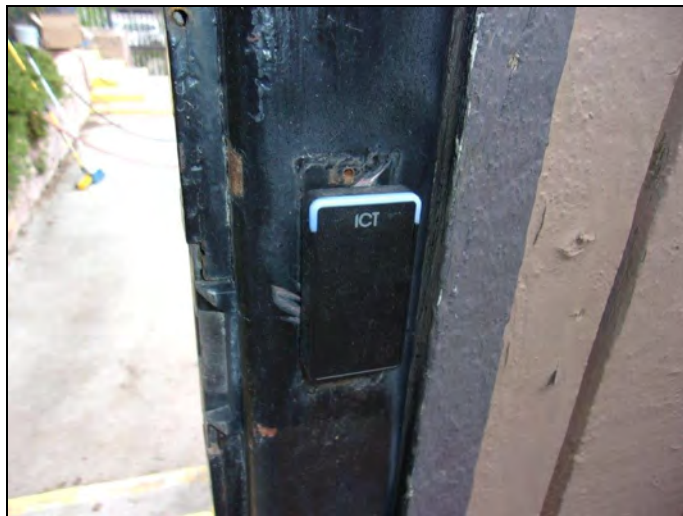
Comp #: 508 Access Control System - Replace

The access control system is in working condition. We recommend funding to replace this component approximately every 10 - 12 years. Remaining life based on current age.

Estimate to replace

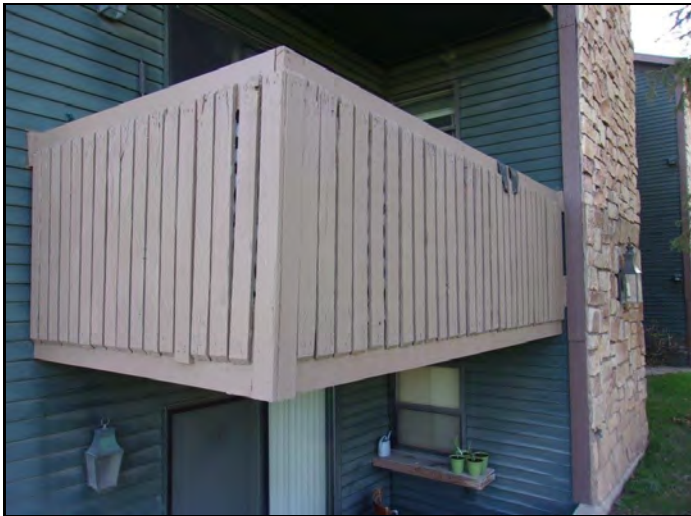
Comp #: 603 Balcony Decks - Resurface

Unable to inspect this component at the time of the site visit. We recommend funding to resurface this component approximately every 15 - 20 years. Remaining life based on current age.

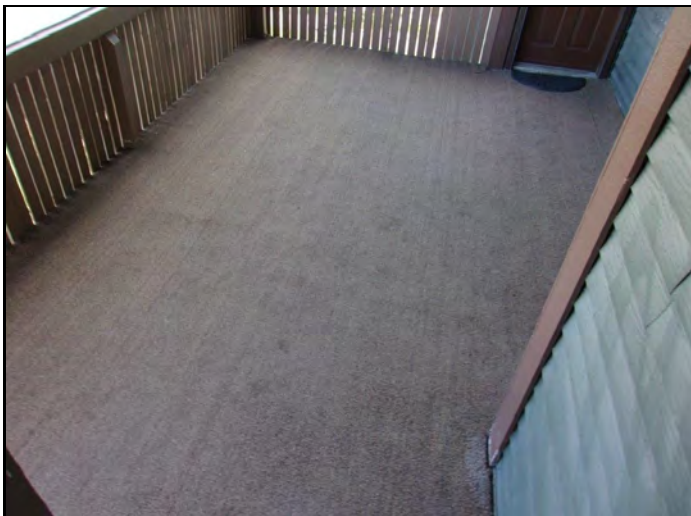
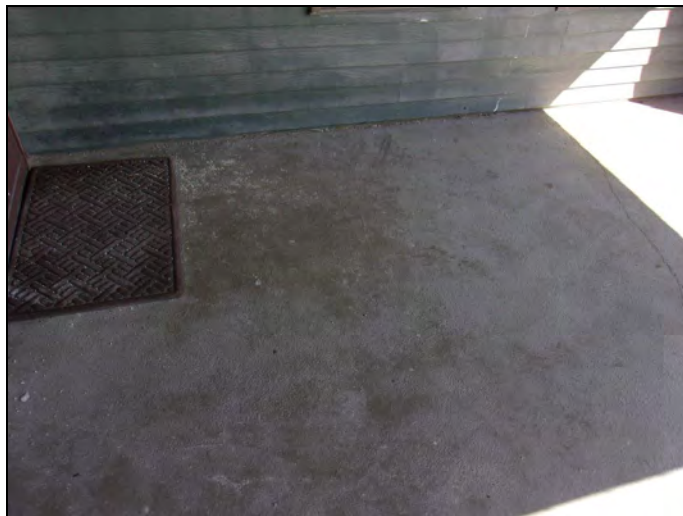
Comp #: 604 Breezeway & Stair Landings - Resurface

The landings are in fair to poor condition. We recommend funding to resurface this component approximately every 15 - 20 years. Remaining life based on current age and condition.

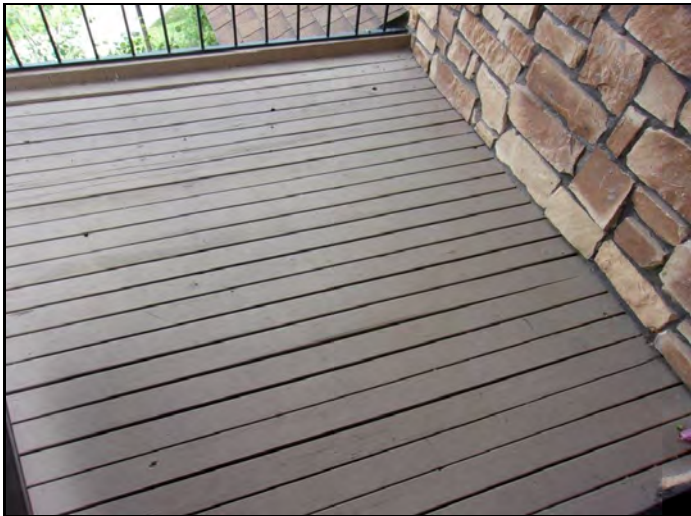
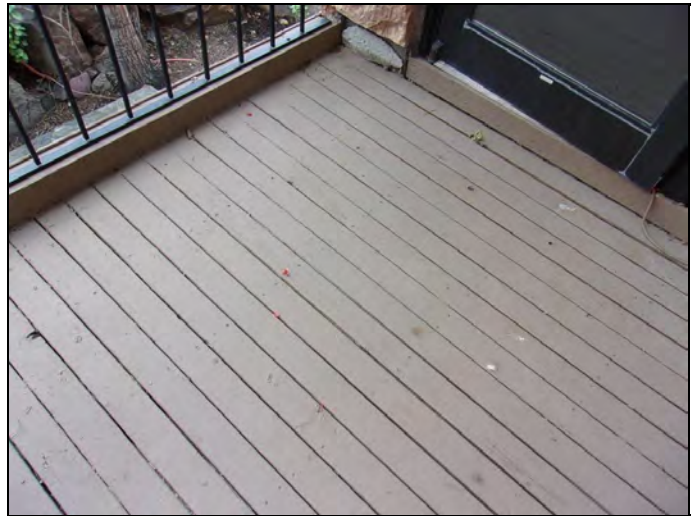
Comp #: 607 Wood Decks - Replace

Research with the client reveals this component is replaced as necessary as an operating expense.

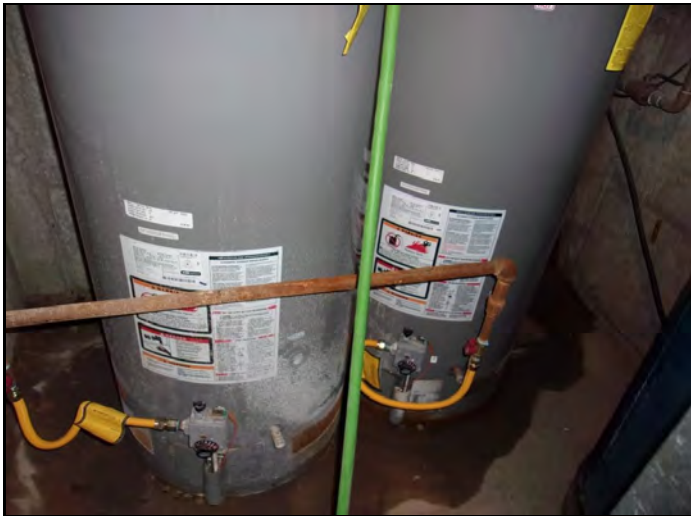
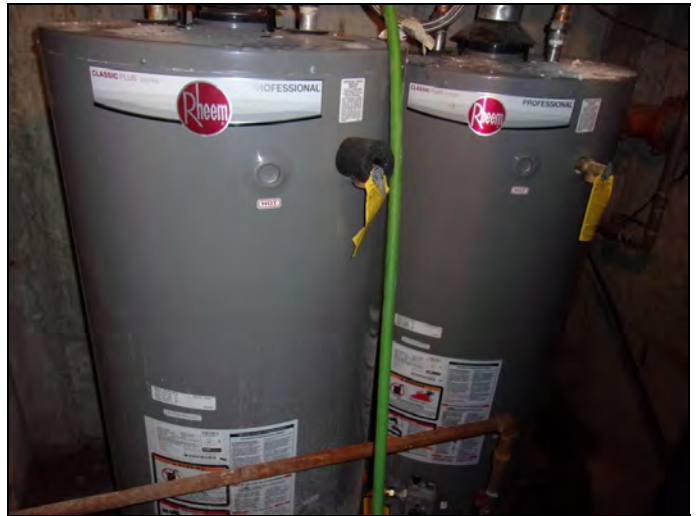
Comp #: 703 Water Heaters - Replace

The water heaters are in working condition. We recommend funding to replace this component approximately every 12 years. Remaining life based on current age.

Estimate to replace

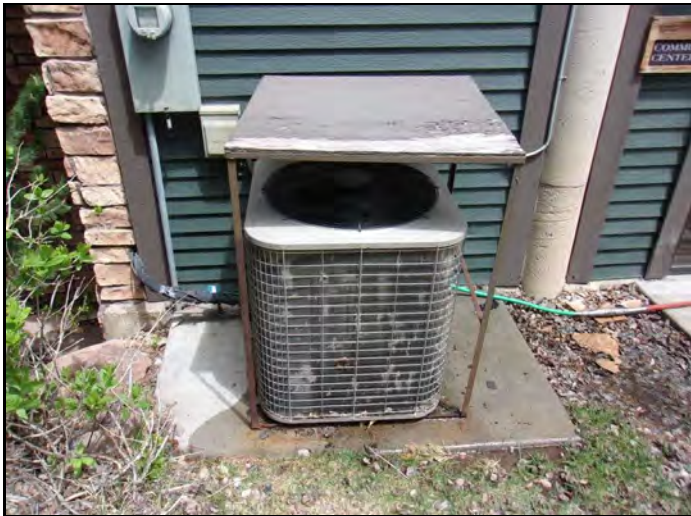
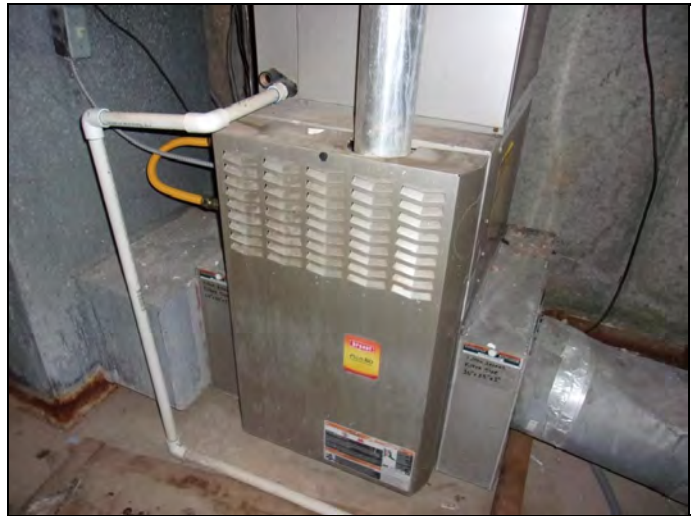
Comp #: 706 HVAC Systems - Replace

The HVAC systems are in working condition. We recommend funding to replace this component approximately every 20 years. Remaining life based on current age and condition.

Estimate to replace

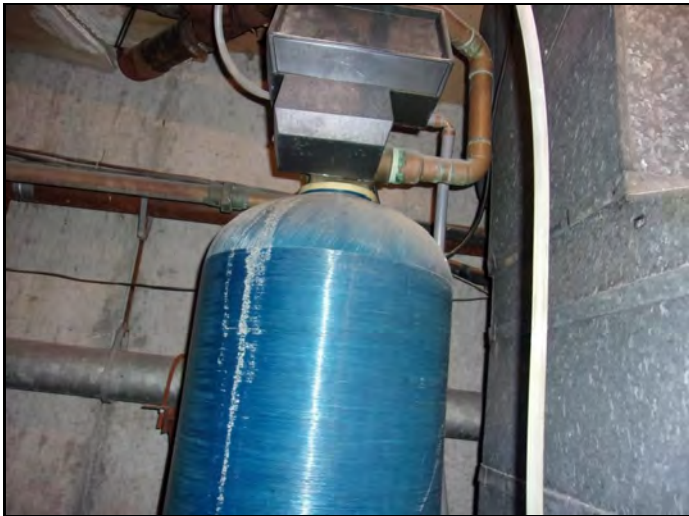
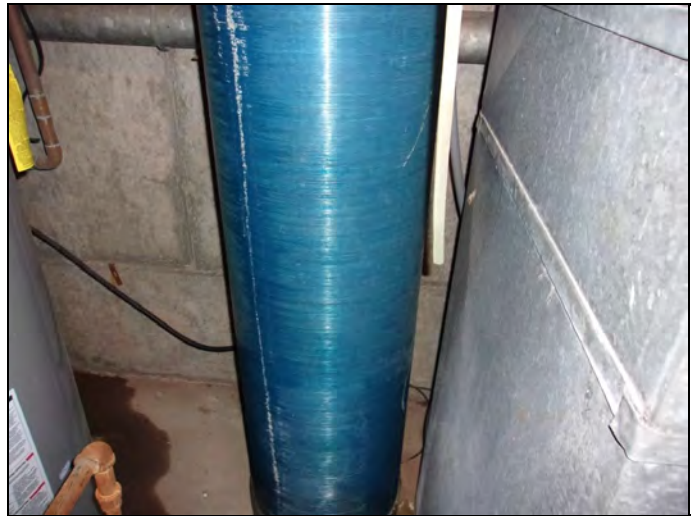
Comp #: 790 Water Softener System - Replace

The water softener system is in working condition. We recommend funding to replace this component approximately every 15 - 20 years. Remaining life based on current age and condition.

Estimate to replace

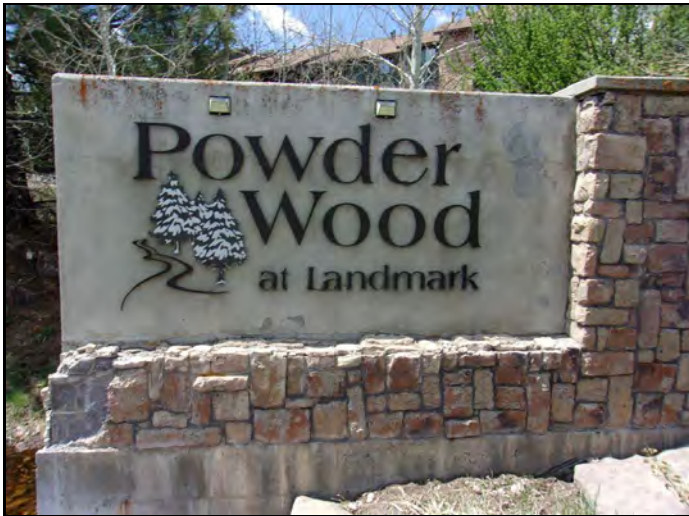
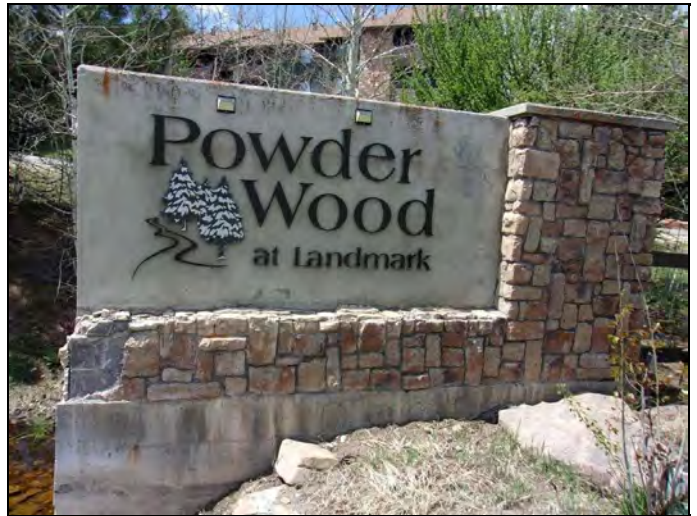
Comp #: 801 Monument Sign - Refurbish

The monument sign is in fair condition. We recommend funding to refurbish this component approximately every 15 - 20 years. Remaining life is based on current age.

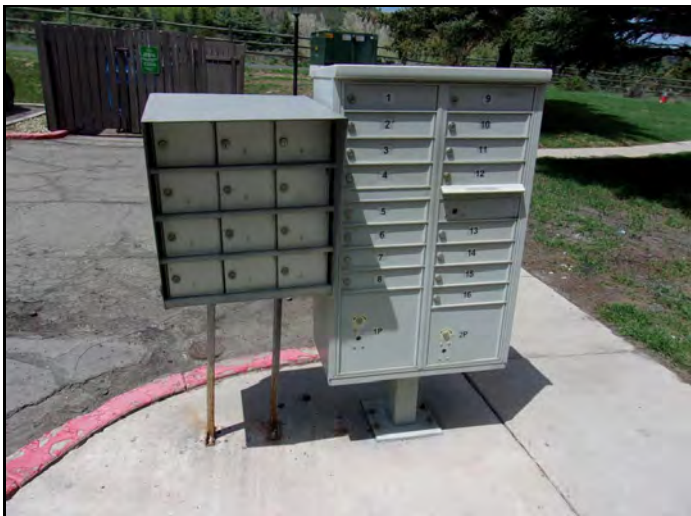
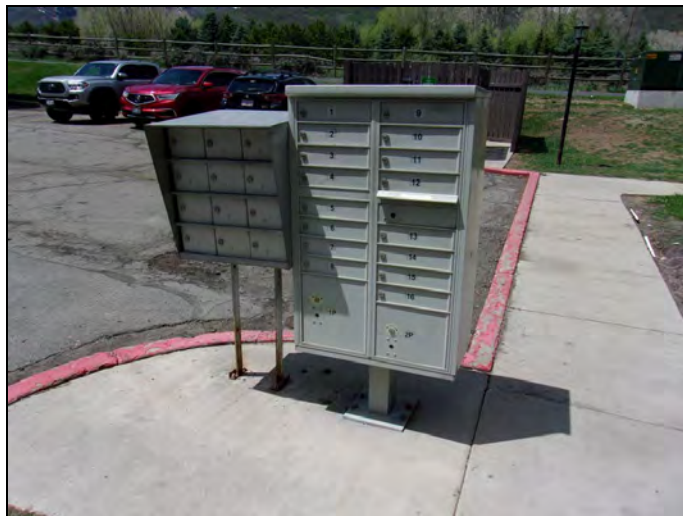
Comp #: 803 Mailboxes - Newer - Replace

The mailboxes are in fair condition. We recommend funding to replace this component approximately every 20 - 25 years. Remaining life based on current age and condition.

Estimate to replace

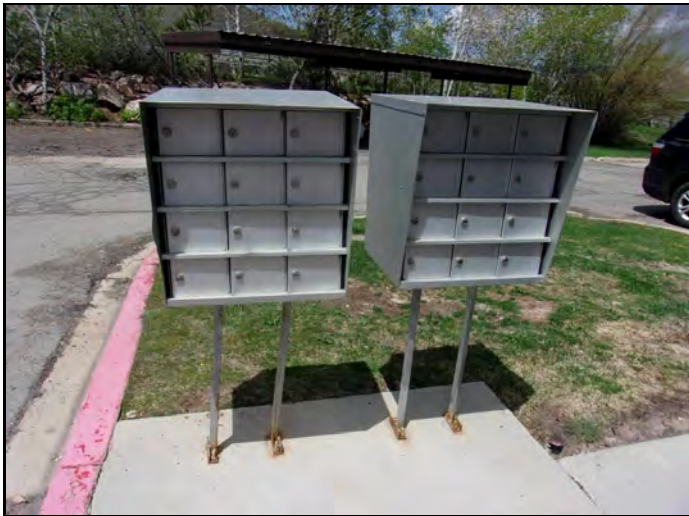
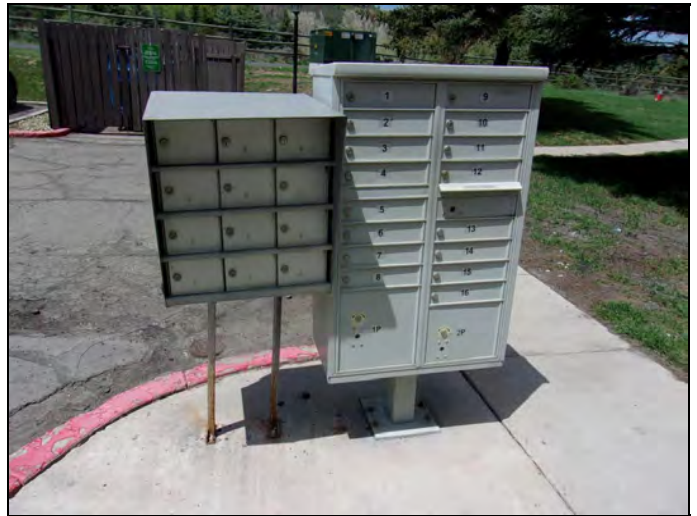
Comp #: 803 Mailboxes - Older - Replace

The mailboxes are in fair condition. We recommend funding to replace this component approximately every 20 - 25 years. Remaining life based on current age and condition.

Estimate to replace
