Powder Wood at Landmark HOA

Level 1 Reserve Study

Report Period – 01/01/2024 – 12/31/2024

Executive Summary – Powder Wood at Landmark HOA – ID # 10228

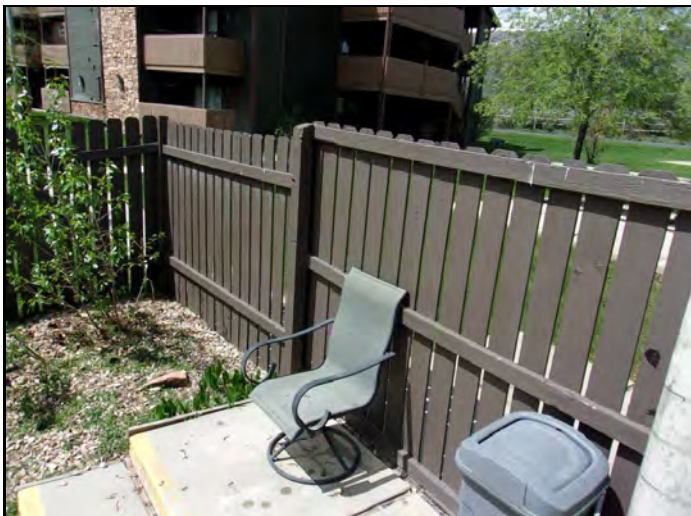
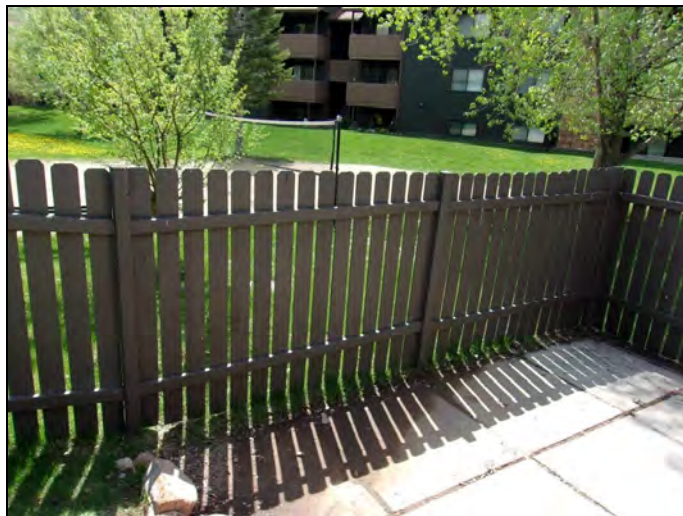
Comp #: 1001 Spa Wood Fencing - Replace

The wood fencing is in good to fair condition. We recommend funding to replace this component approximately every 25 - 30 years. Remaining life based on current condition.

Estimate to replace

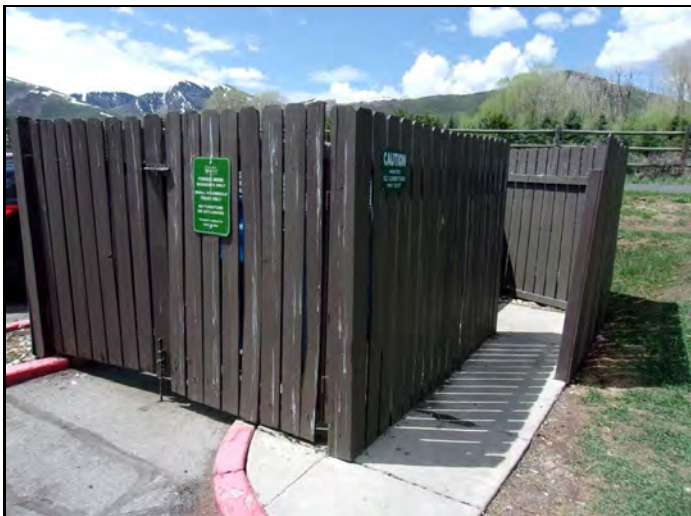
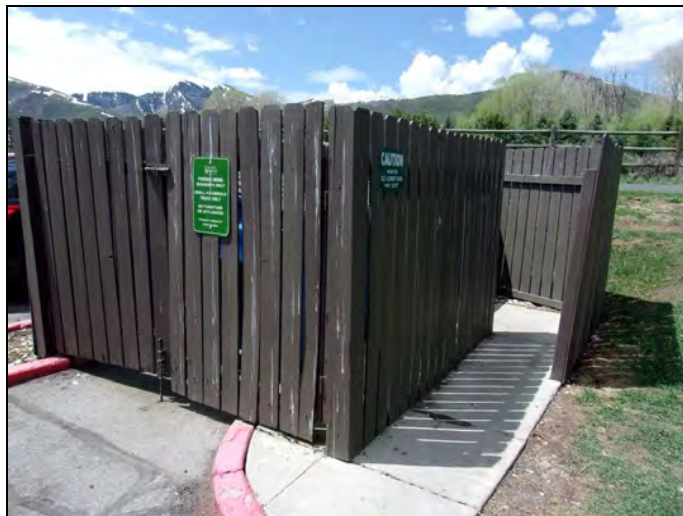
Comp #: 1010 Dumpster Enclosures - Replace

The wood fencing is in fair condition. We recommend funding to replace this component approximately every 25 - 30 years. Remaining life based on current condition.

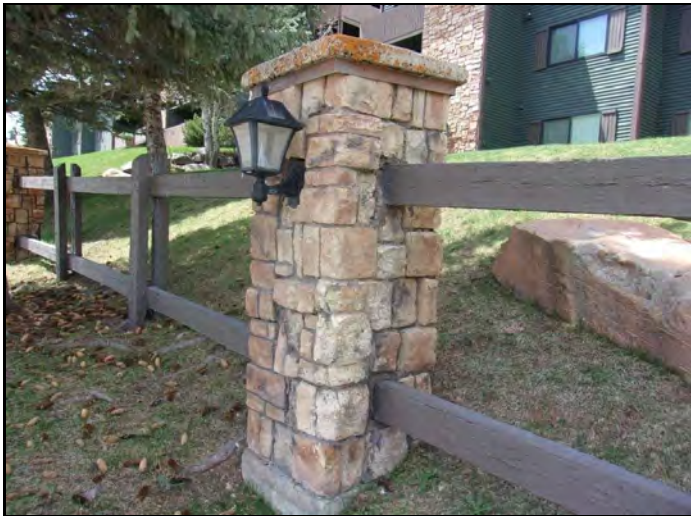
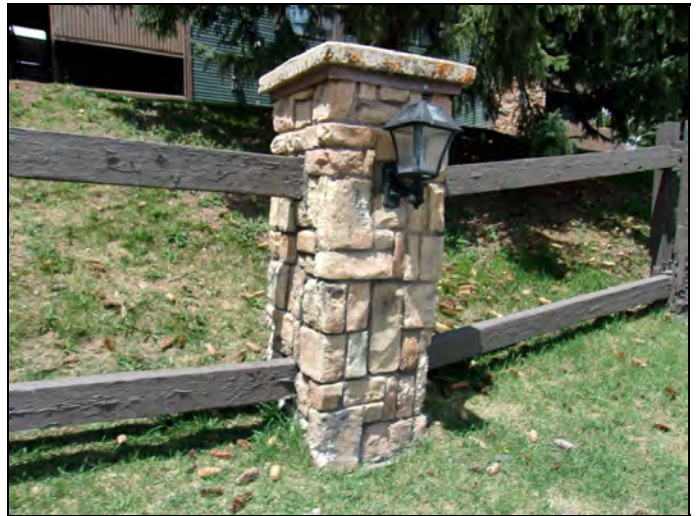
Comp #: 1090 Fence Columns - Replace

Research with the client reveals this component is replace as necessary as an operating expense.

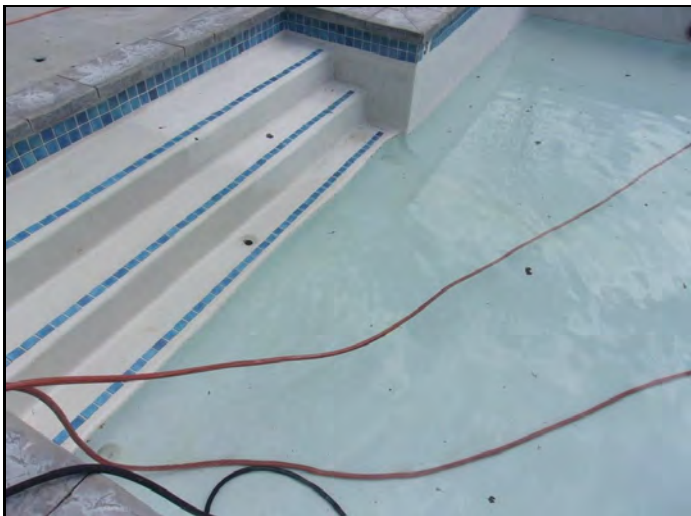
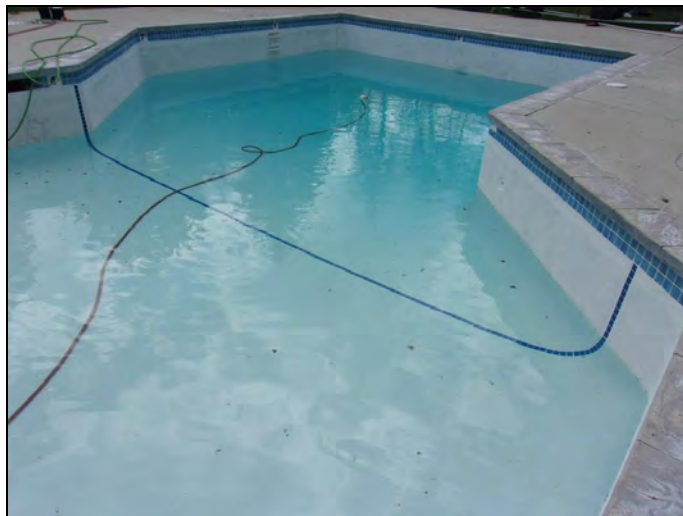
Comp #: 1101 Pool - Resurface

The pool surface is in good condition. We recommend funding to resurface this component every 10 - 12 years. Remaining life based on current age.

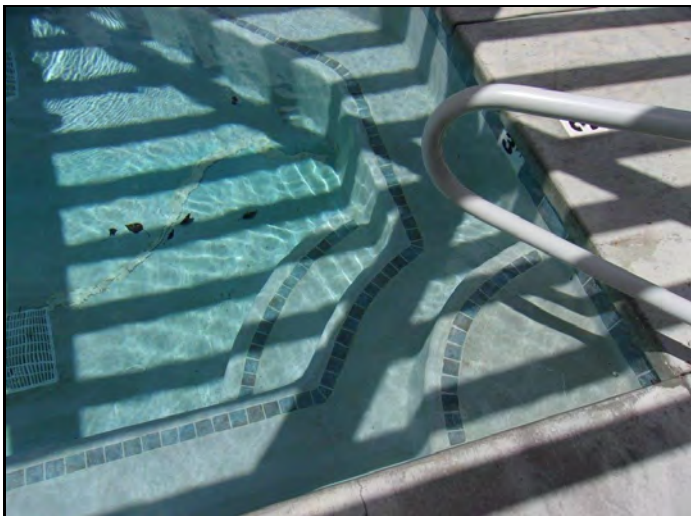
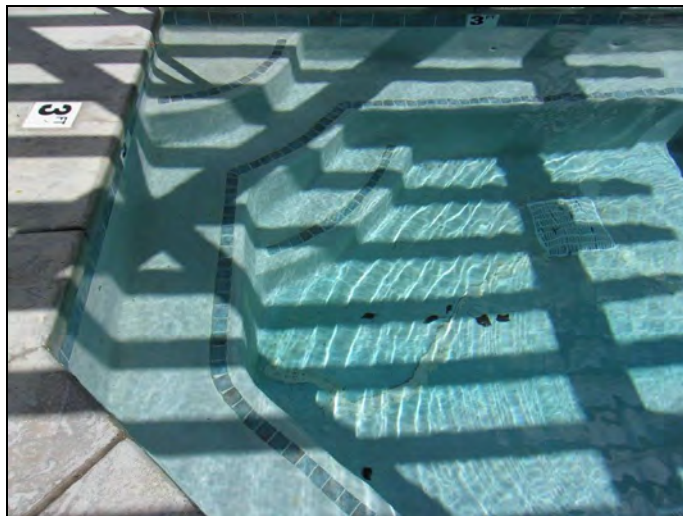
Comp #: 1102 Spa - Resurface

The spa surface is in fair to poor condition. We recommend funding to resurface this component approximately every 10 - 12 years. Remaining life based on current age and condition.

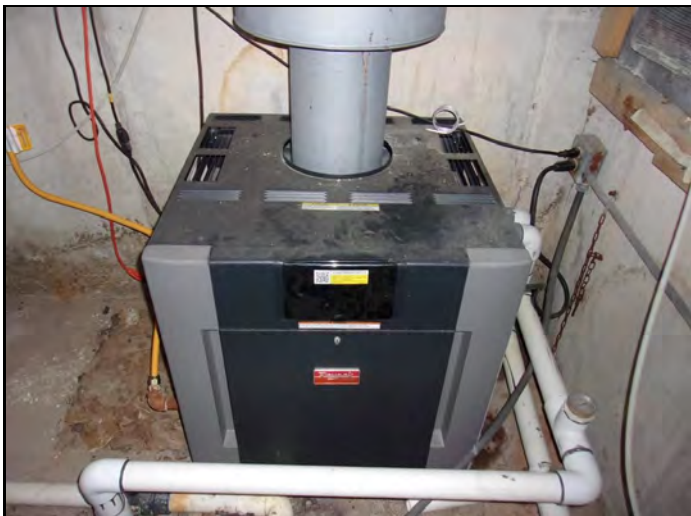
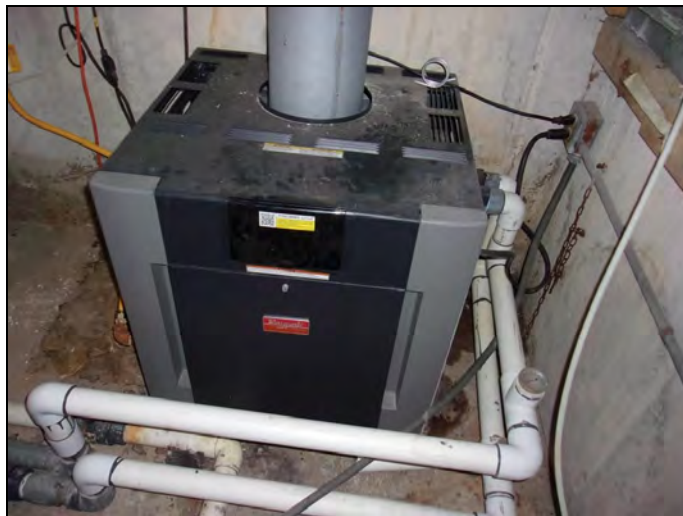
Comp #: 1104 Pool Heater - Replace

The pool heater is in working condition. We recommend funding to replace this component approximately every 12 years. Remaining life based on current age.

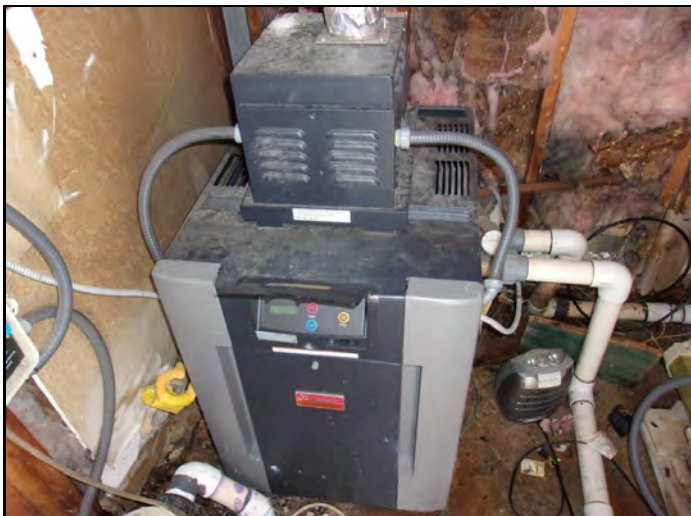
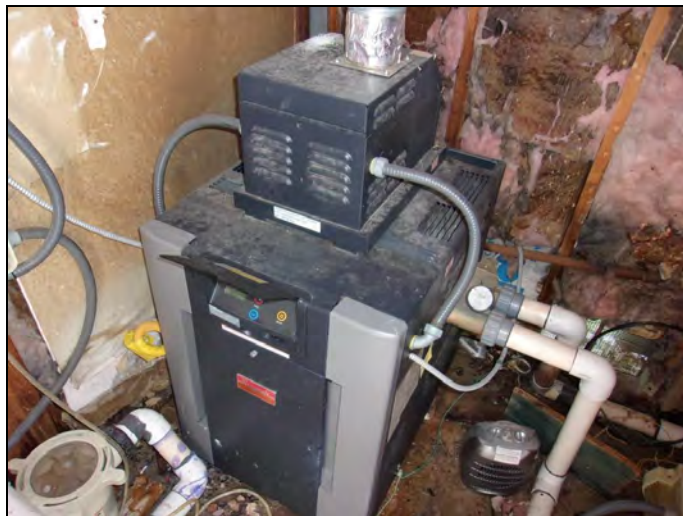
Comp #: 1105 Spa Heater - Replace

The spa heater is in working condition. We recommend funding to replace this component approximately every 12 years. Remaining life is based on current age.

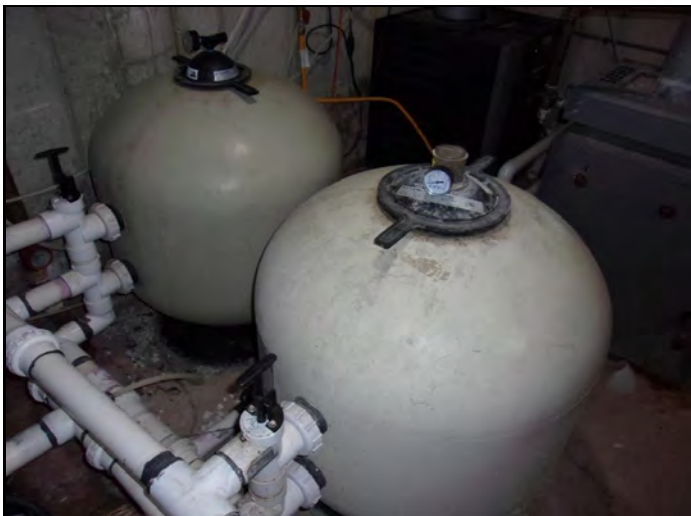
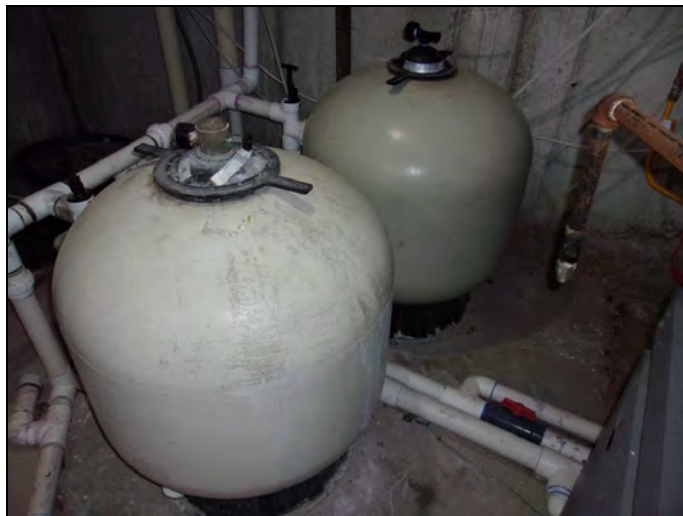
Comp #: 1107 Pool Filters - Replace

The pool filters are in working condition. We recommend funding to replace this component approximately every 12 - 15 years. Remaining life based on current age and condition.

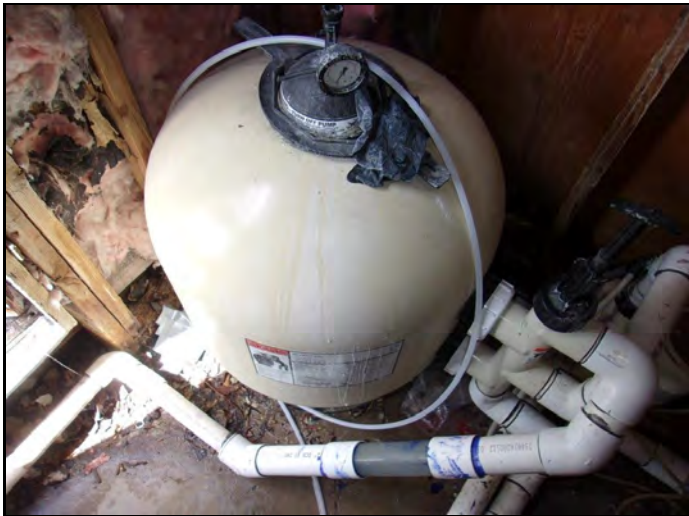
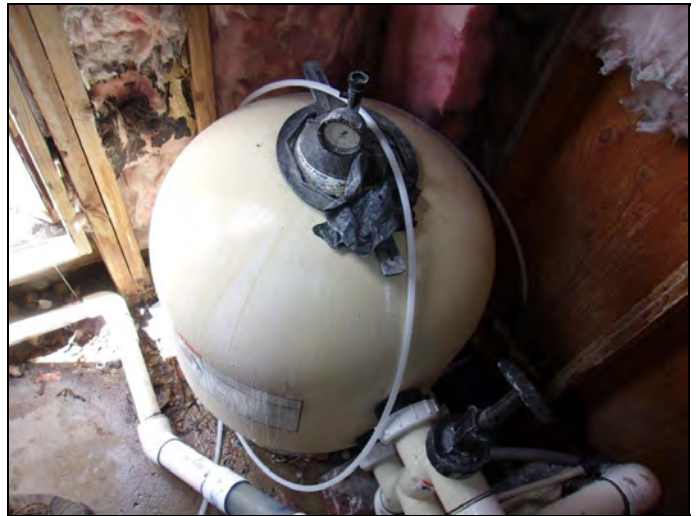
Comp #: 1108 Spa Filter - Replace

The spa filter is in working condition. We recommend funding to replace this component approximately every 12 - 15 years. Remaining life based on current age.

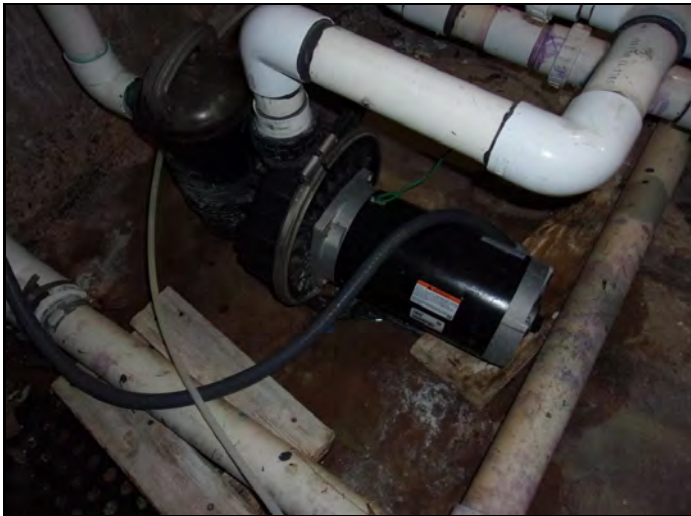
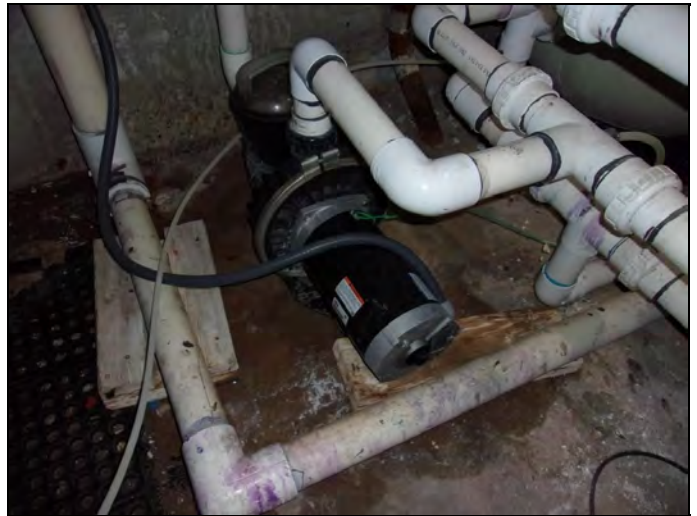
Comp #: 1109 Pool Pump - Replace

The pump is in working condition. We recommend funding to replace this component approximately every 8 - 10 years. Remaining life based on current age and condition.

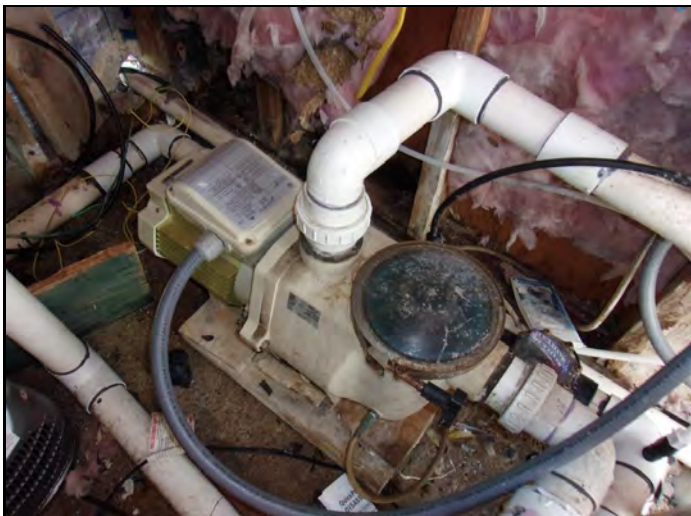
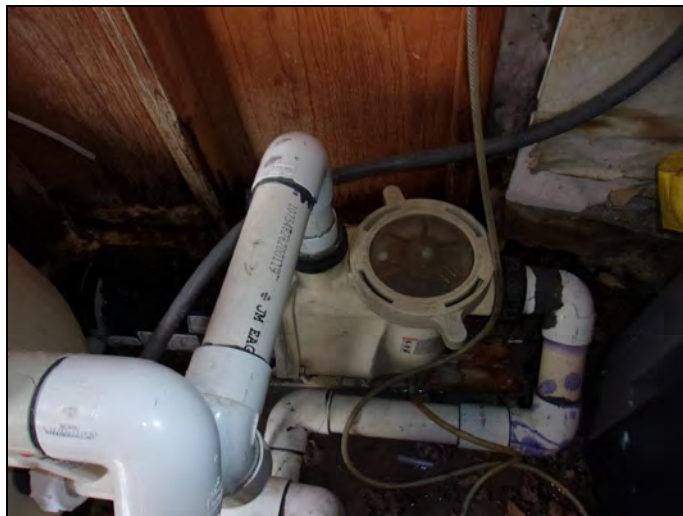
Comp #: 1110 Spa Pumps - Replace

The pumps are in working condition. We recommend funding to replace this component approximately every 8 - 10 years. Remaining life based on current age and condition.

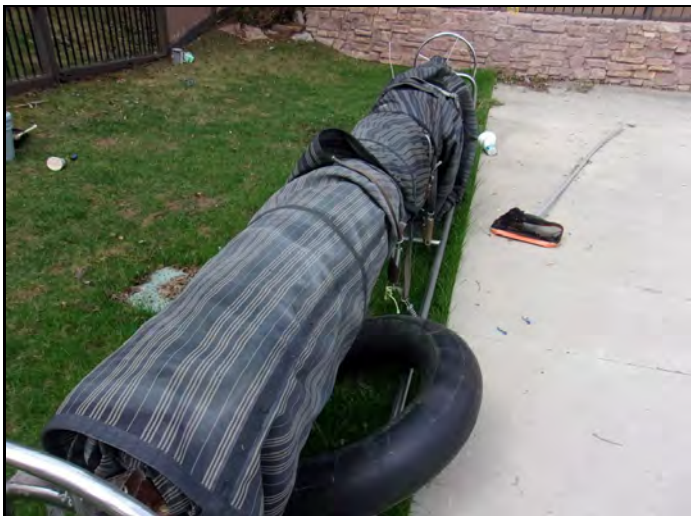
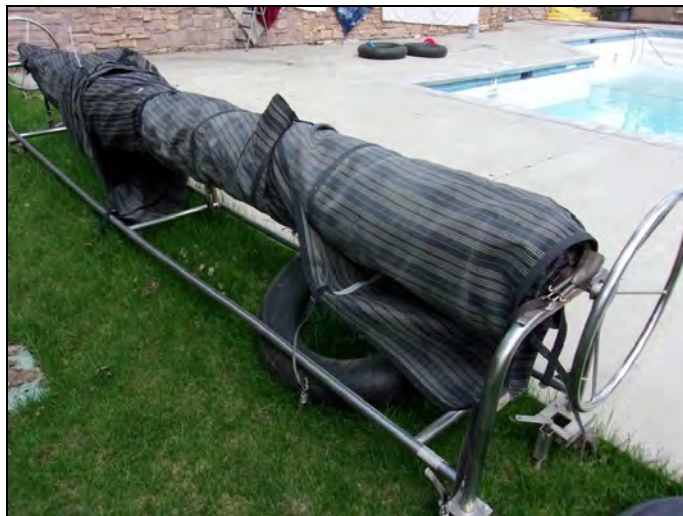
Comp #: 1112 Pool Cover - Replace

The pool cover appears to be in fair condition. We recommend funding to replace this component approximately every 10 years. Remaining life based on current condition.

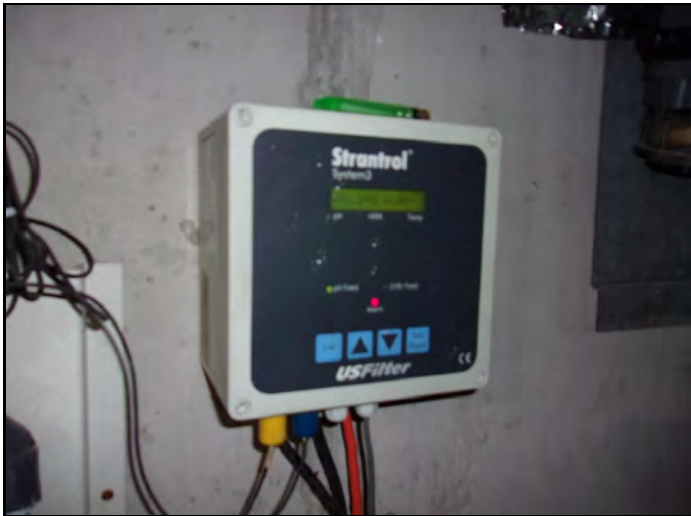
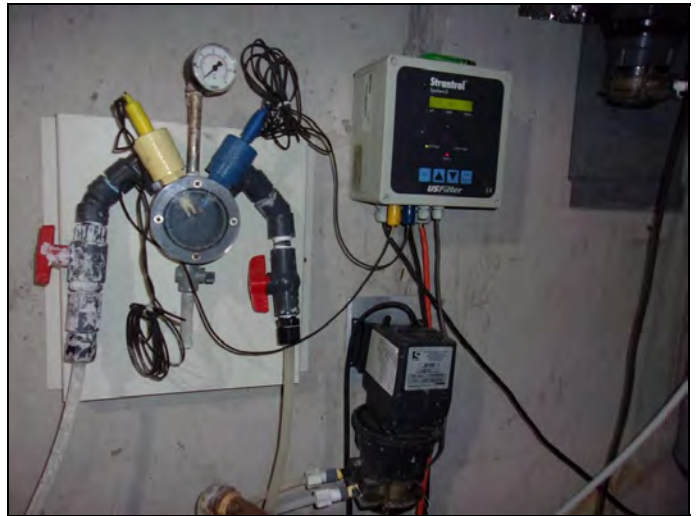
Comp #: 1113 Pool Chemical Controller - Replace

The pool chemical controller is in working condition. We recommend funding to replace this component approximately every 10 - 12 years. Remaining life based on current age.

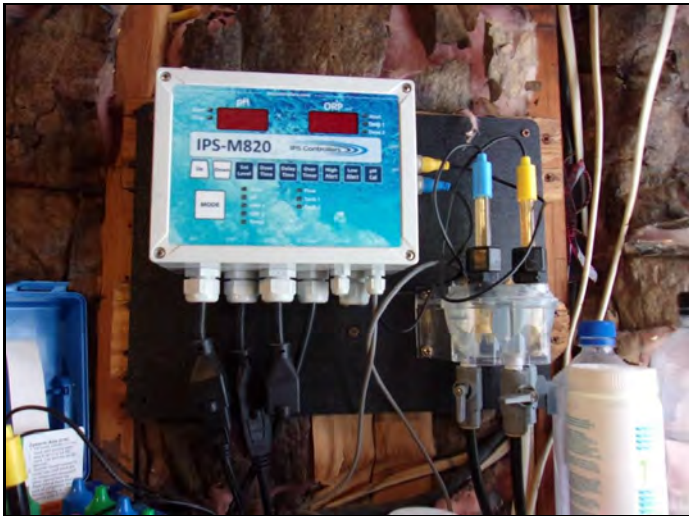
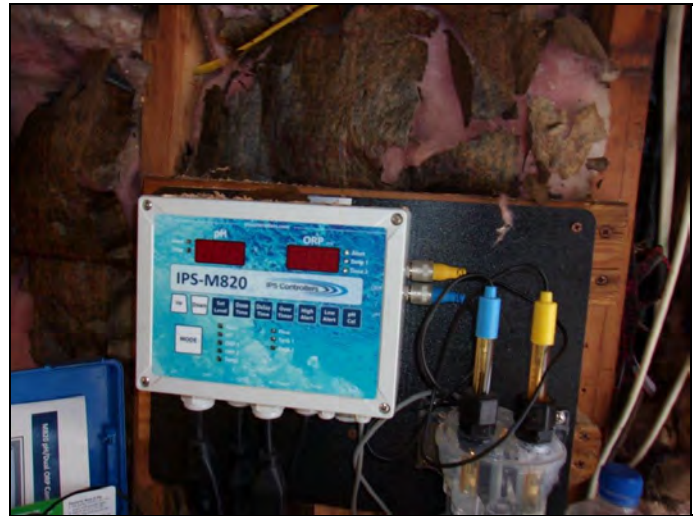
Comp #: 1114 Spa Chemical Controller - Replace

The spa chemical controller is in working condition. We recommend funding to replace this component approximately every 10 - 12 years. Remaining life based on current age.

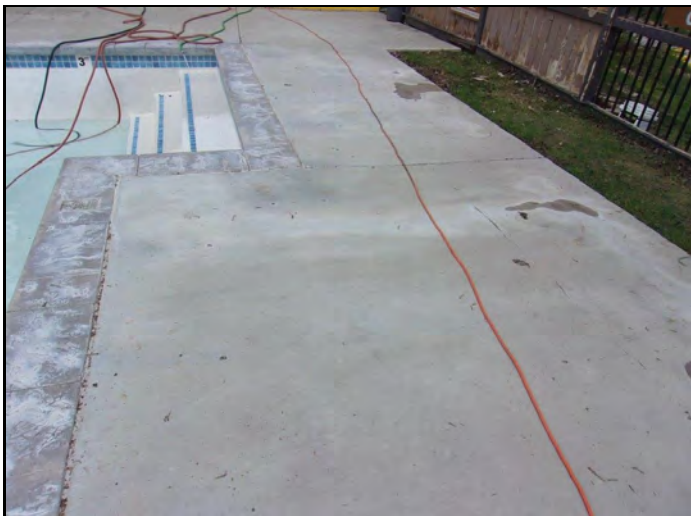
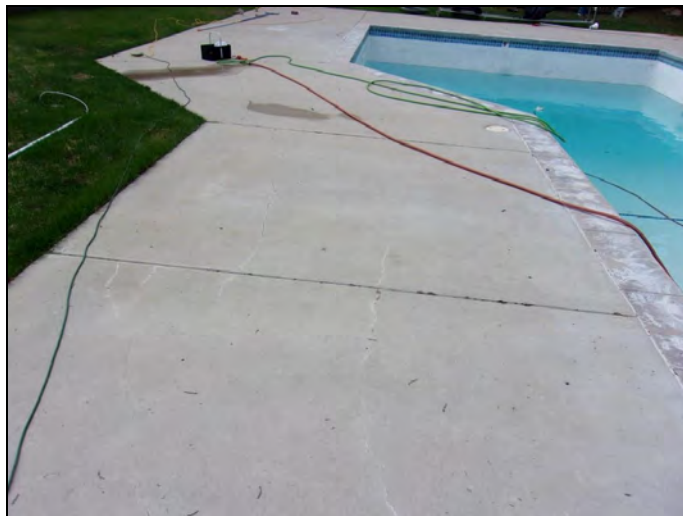
Comp #: 1116 Pool Deck - Replace

The pool deck is in good to fair condition. We recommend funding to replace this component approximately every 40 - 50 years. Remaining life based on current age and condition.

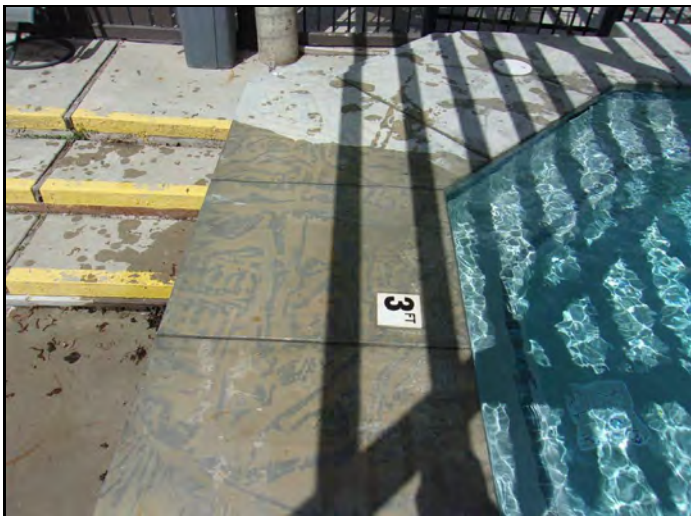
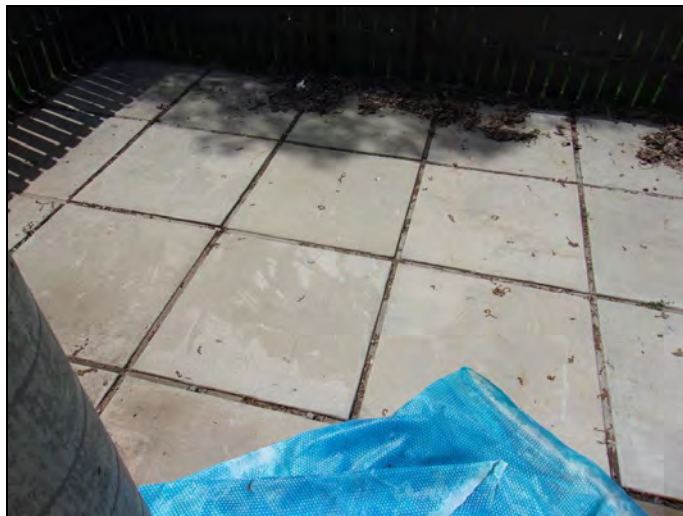
Comp #: 1117 Spa Deck - Replace

The spa deck is in good to fair condition. We recommend funding to replace this component approximately every 40 - 50 years. Remaining life based on current age.

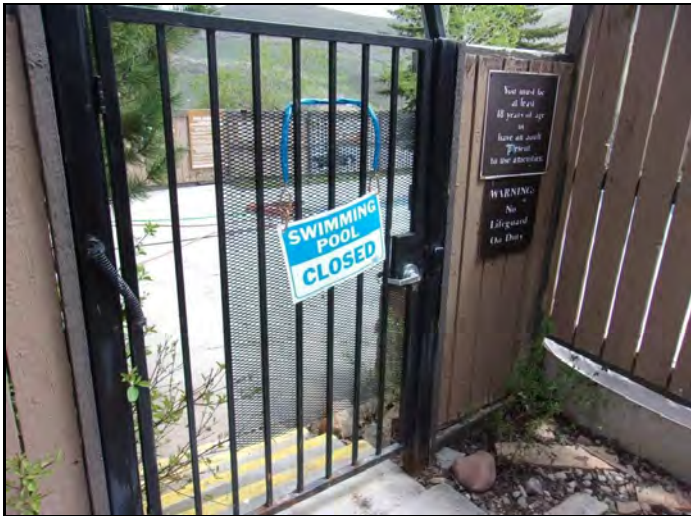
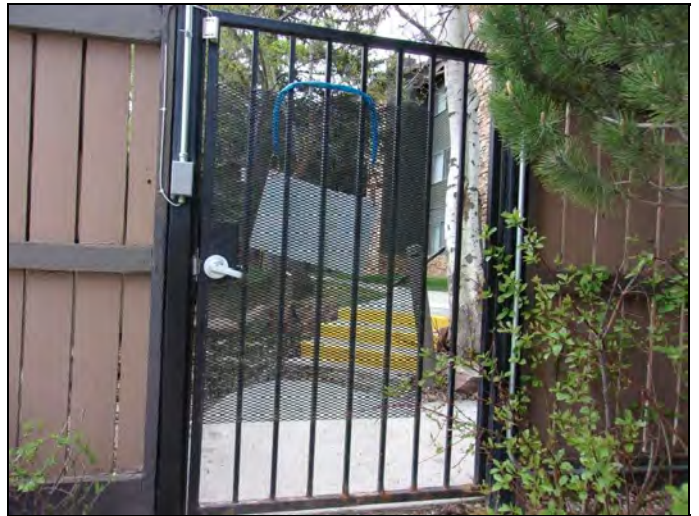
Comp #: 1119 Pool Gate - Replace

We recommend replacing this component with pole lights when the pool fencing is replaced. We recommend funding to completely replace this component approximately every 25 - 30 years. Remaining life based on current age.

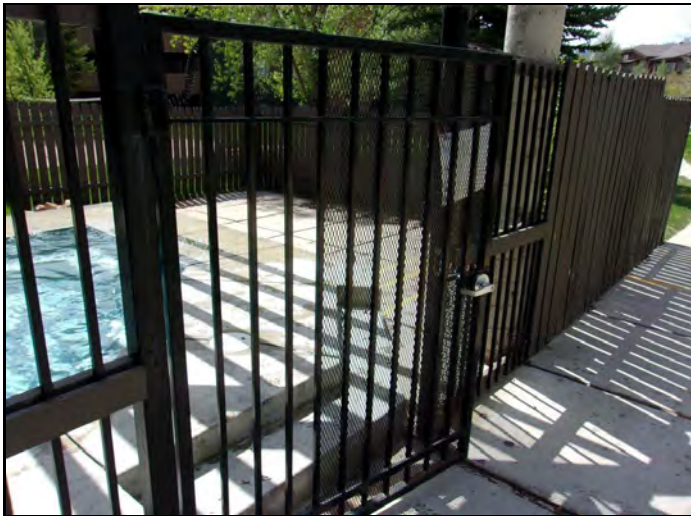
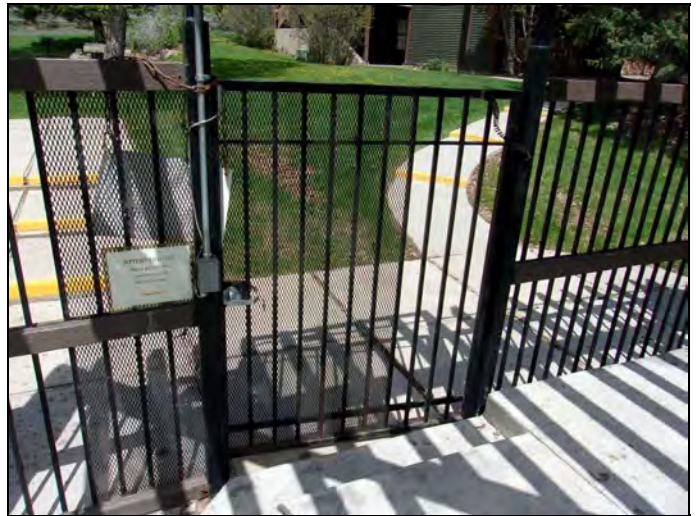
Comp #: 1120 Spa Gate - Replace

The spa gate is in fair condition. We recommend funding to completely replace this component approximately every 25 - 30 years. Remaining life based on current age.

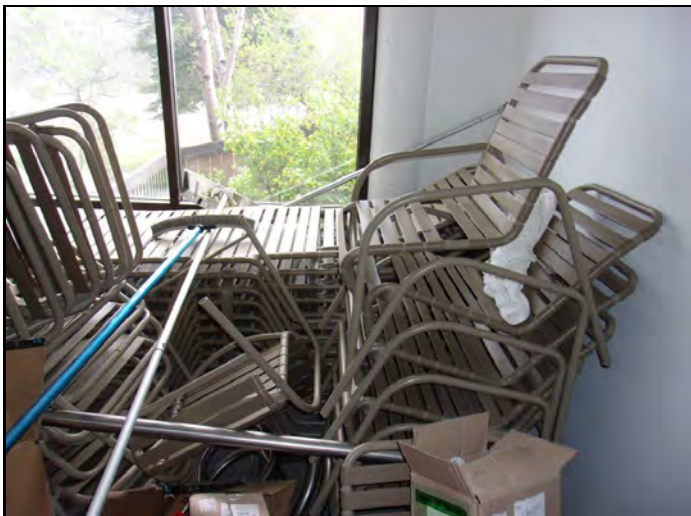
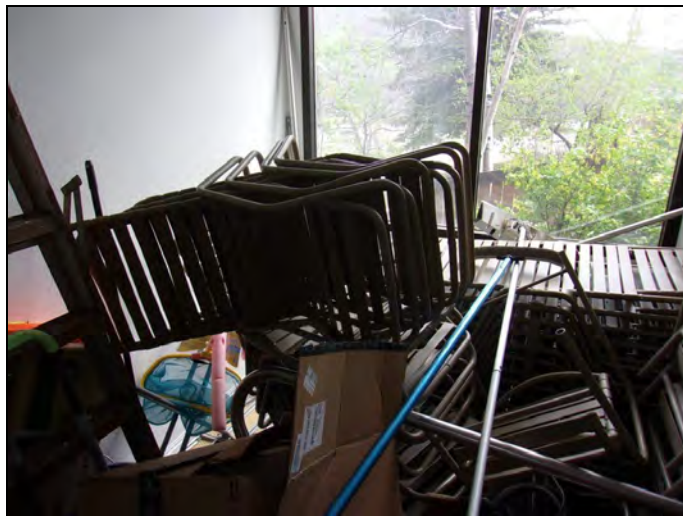
Comp #: 1121 Pool Furniture - Replace

The pool furniture is in fair condition. We recommend funding to replace this component approximately every 6 years. Remaining life based on current age.

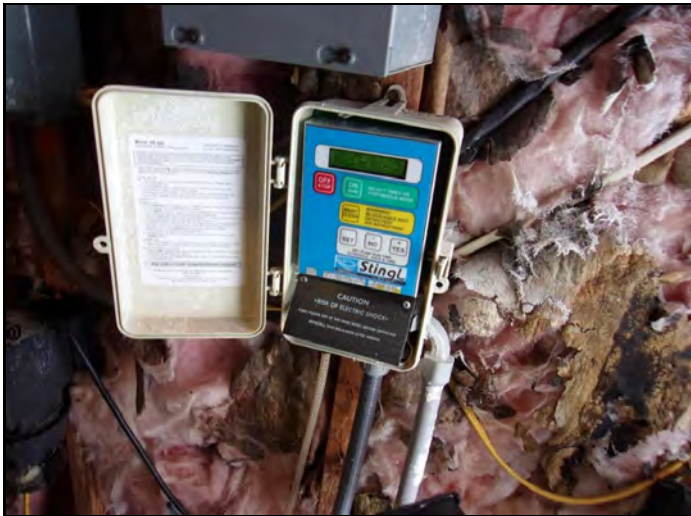
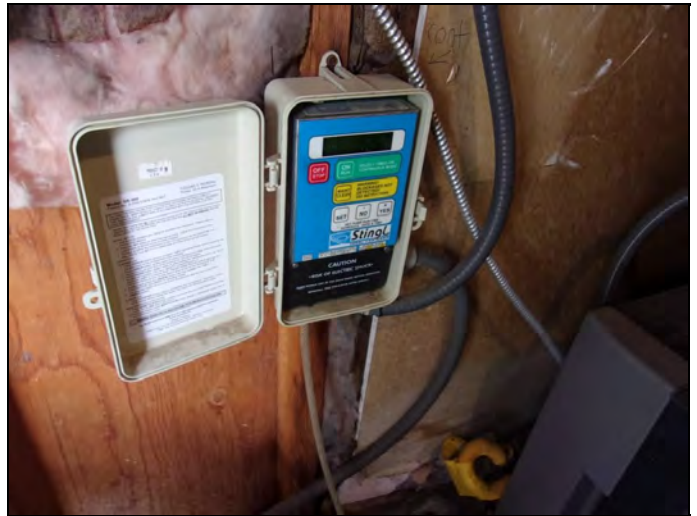
Comp #: 1190 Spa Vacuum Release Systems - Replace

The spa vacuum release system is in working condition. We recommend funding to replace this system approximately every 15 year. Remaining life based on current age.

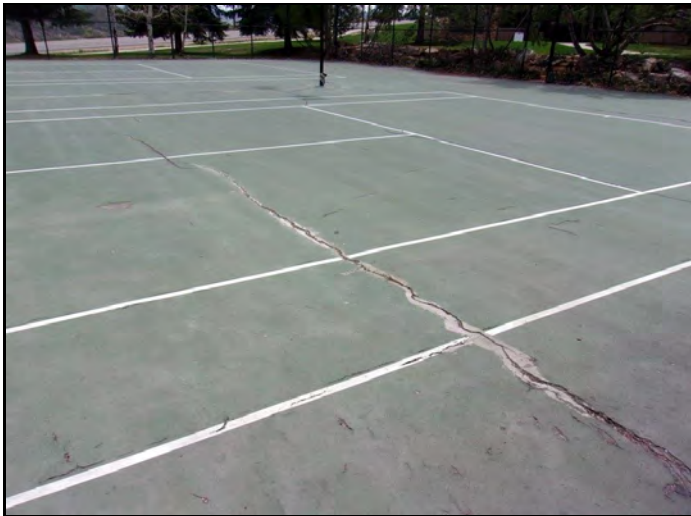
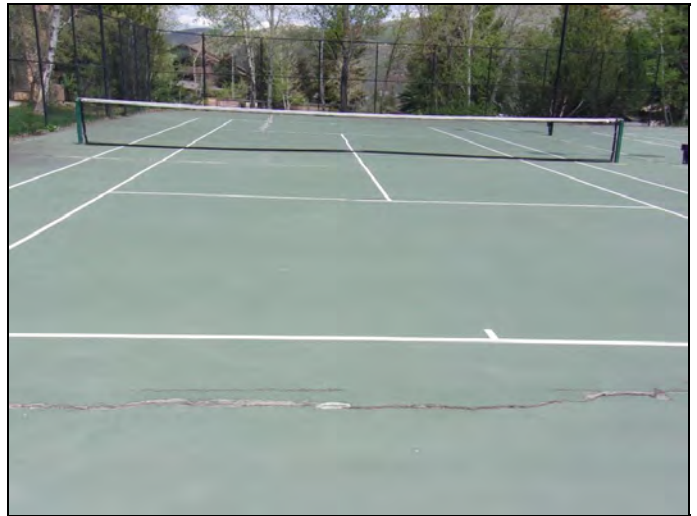
Comp #: 1201 Tennis Courts - Resurface

The tennis court surface is in poor condition. We recommend funding to resurface this component approximately every 8 - 10 years. Remaining life based on current condition.

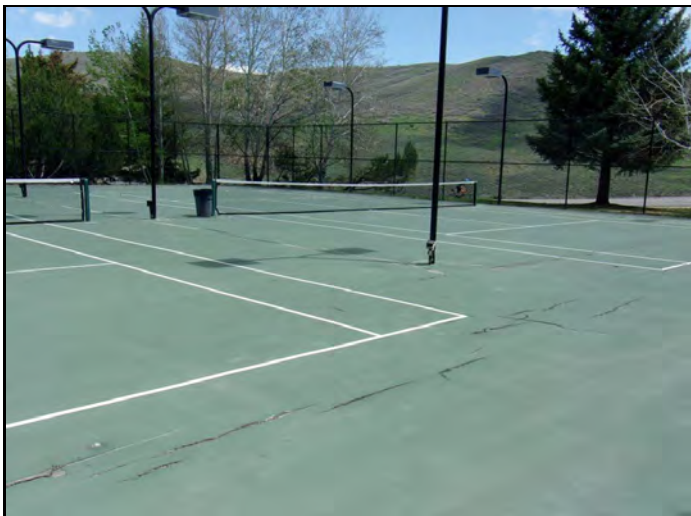
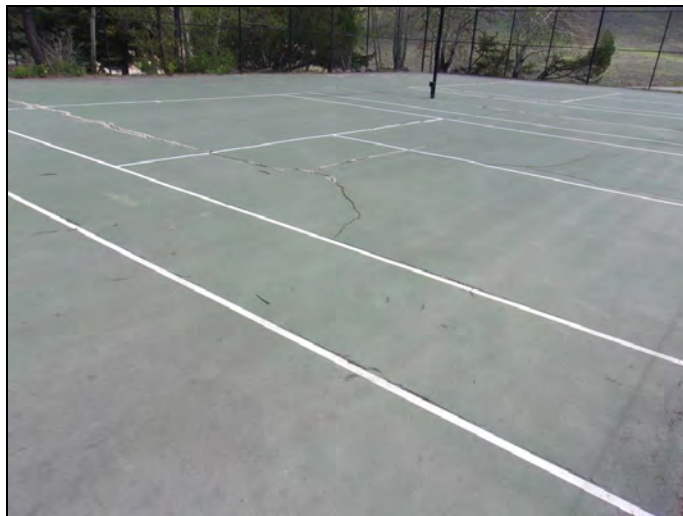
Comp #: 1203 Tennis Courts - Replace

The tennis courts are in fair to poor condition. We recommend funding to replace this component approximately every 40 - 50 years. Remaining life based on current age.

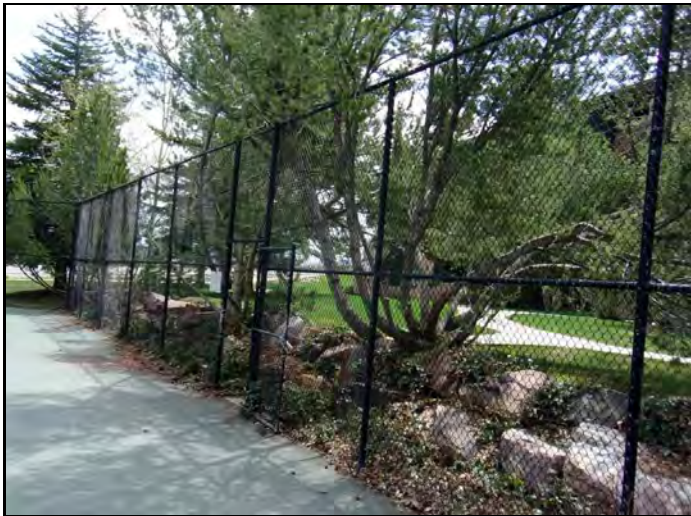
Comp #: 1204 Tennis Court Fencing - Replace

This component is replaced as a part of Component #1203 Tennis Court Replace. No extra reserve funding necessary.

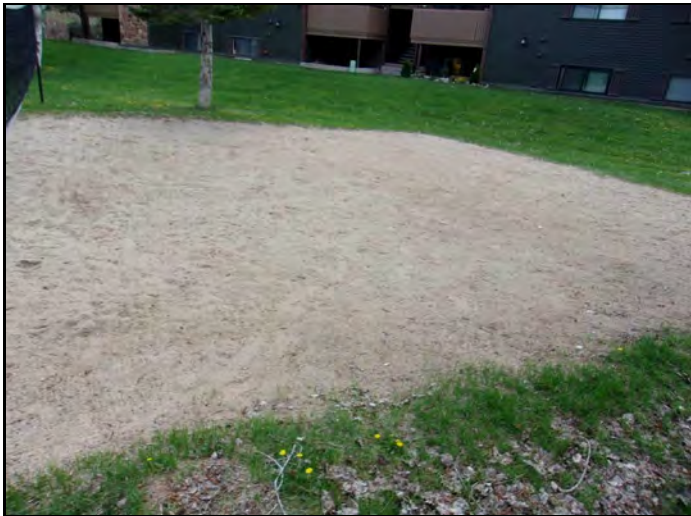
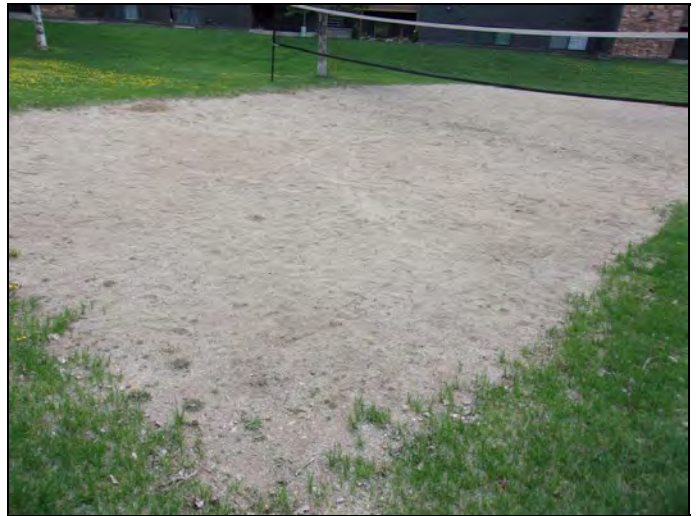
Comp #: 1208 Volleyball Court - Replenish

The volleyball court is in fair condition. We recommend funding an allowance to replenish this component approximately every 8 - 10 years. Remaining life based on current condition.

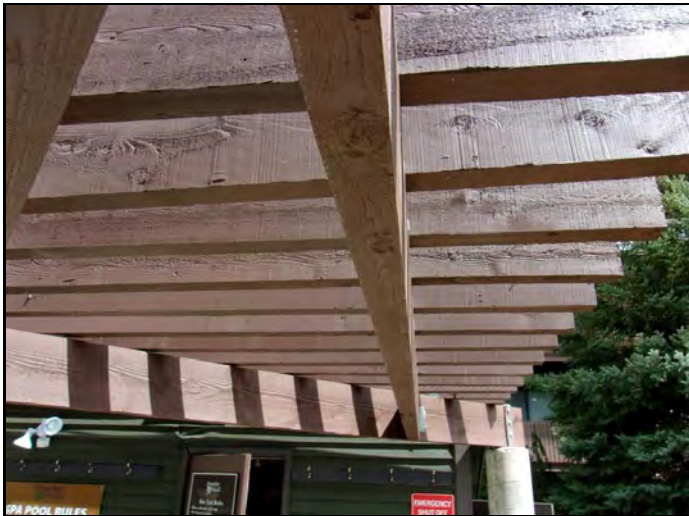
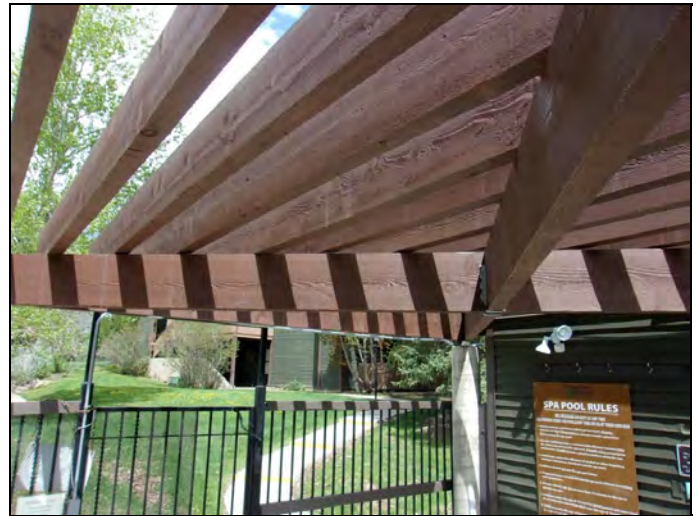
Comp #: 1309 Pergola - Replace

The pergola is in good condition. We recommend funding to replace this component approximately every 25 - 30 years. Remaining life based on current age.

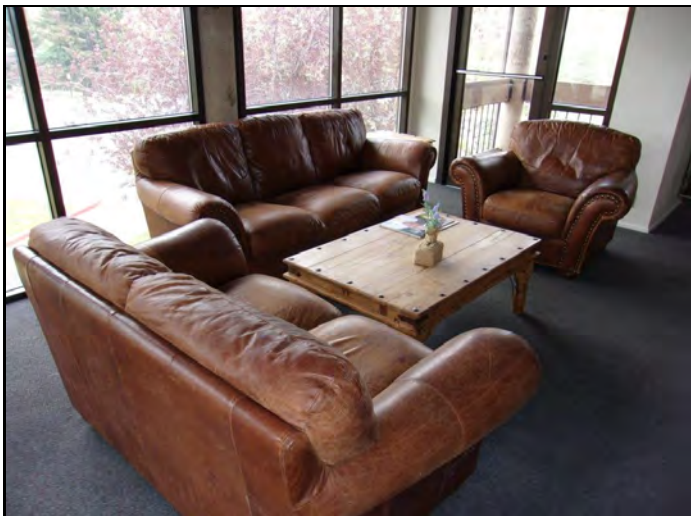
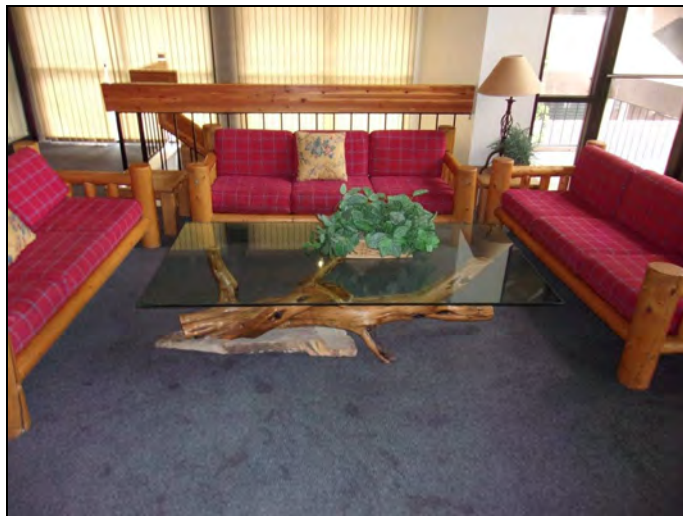
Comp #: 1405 Furniture - Replace

The furniture is in fair condition. We recommend funding an allowance to make replacements approximately every 10 years. Remaining life based on current age.

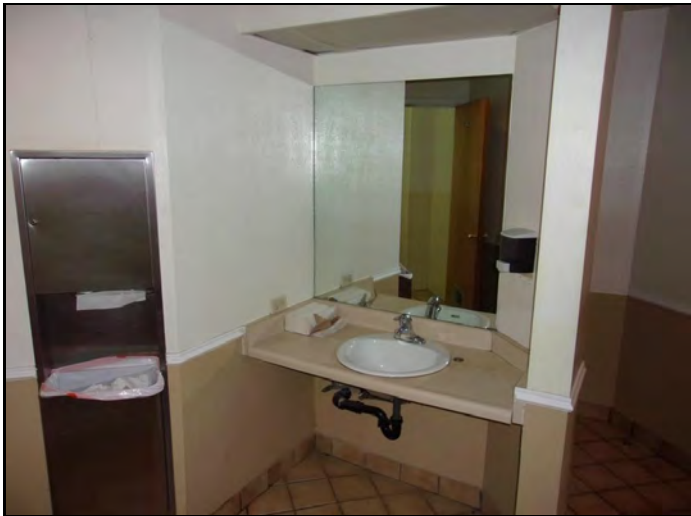
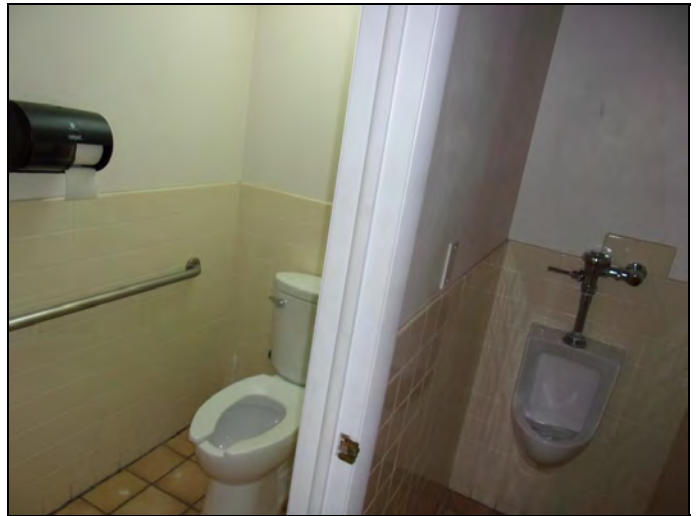
Comp #: 1413 Restrooms - Remodel

The restrooms are in functional condition. We recommend funding to remodel this component approximately every 20 years. Remaining life based on current age and condition.

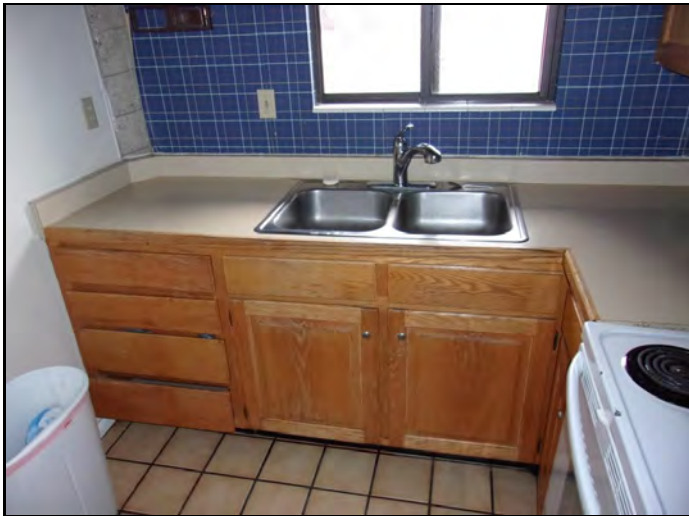
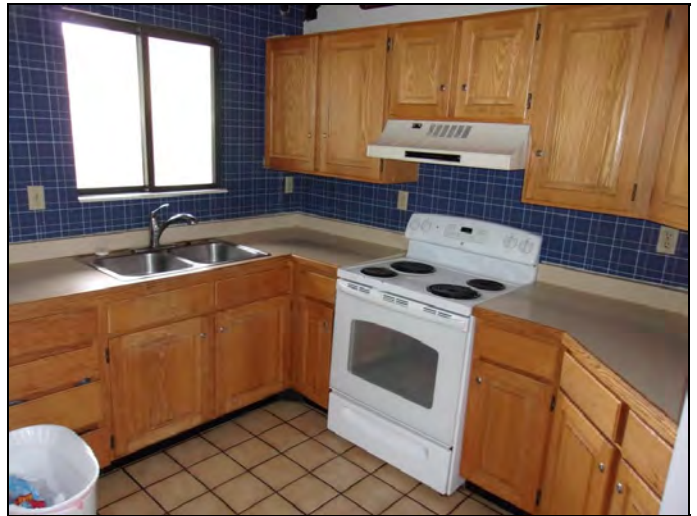
Comp #: 1417 Kitchen - Remodel

The kitchen is in functional condition. We recommend funding to remodel this component approximately every 20 years. Remaining life based on current age and condition.

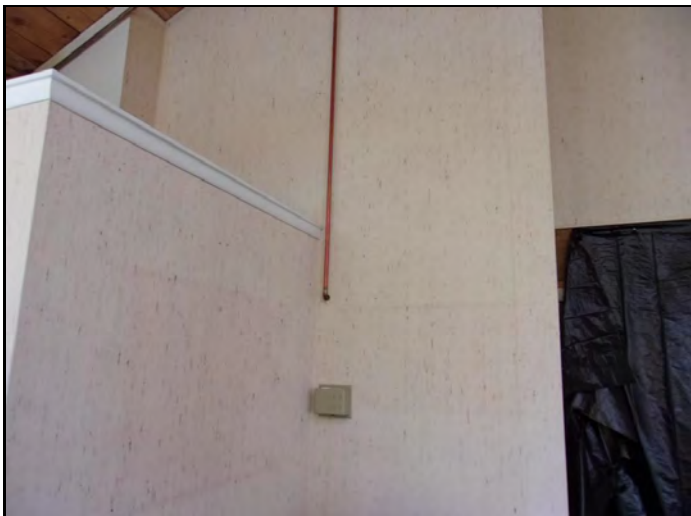
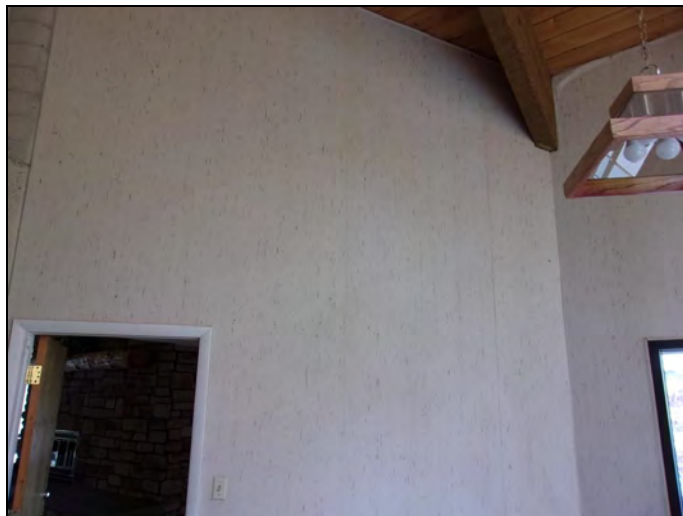
Comp #: 1421 Wall Paper - Replace

The wall paper is in fair to poor condition. No problems were noted at the time of the inspection. We recommend funding to replace this component approximately every 12 - 15 years. Remaining life based on current age and condition

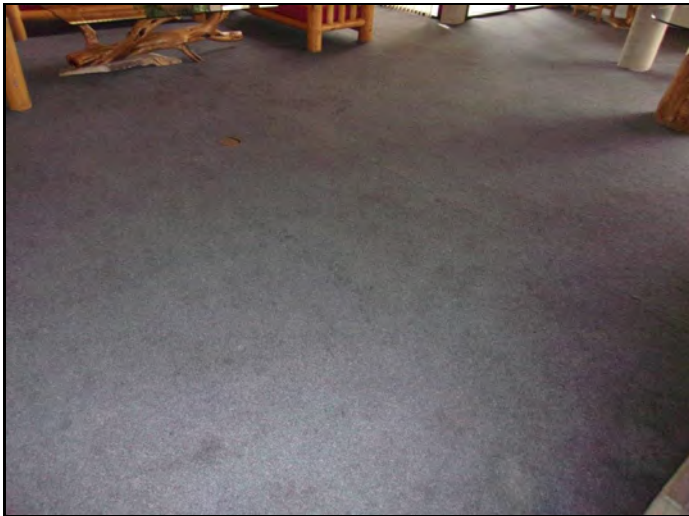
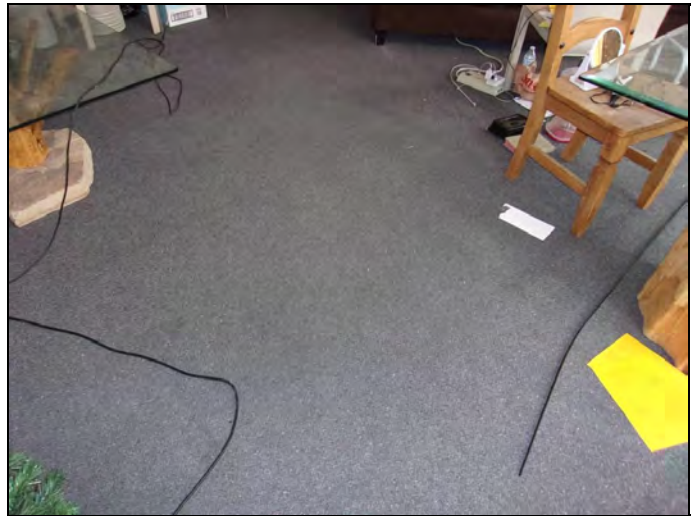
Comp #: 1501 Carpeting - Replace

The carpeting is in fair to poor condition. We recommend funding to replace this component approximately every 8 - 10 years. Remaining life based on current age and condition.
