Powder Wood at Landmark HOA

Level 1 Reserve Study

Report Period – 01/01/2024 – 12/31/2024

Executive Summary – Powder Wood at Landmark HOA – ID # 10228

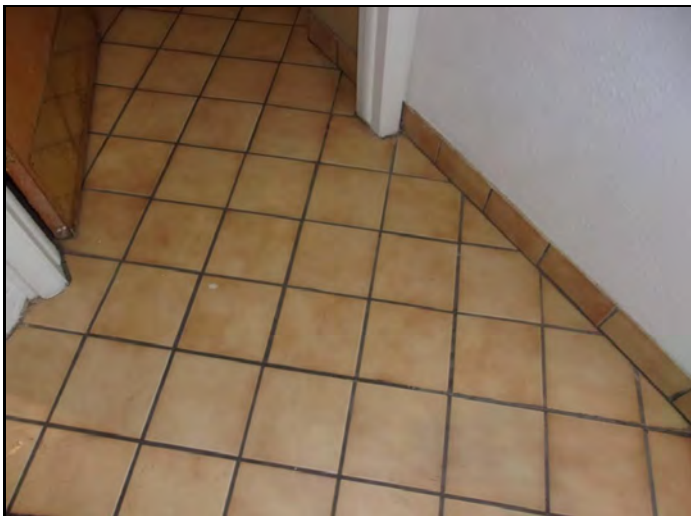
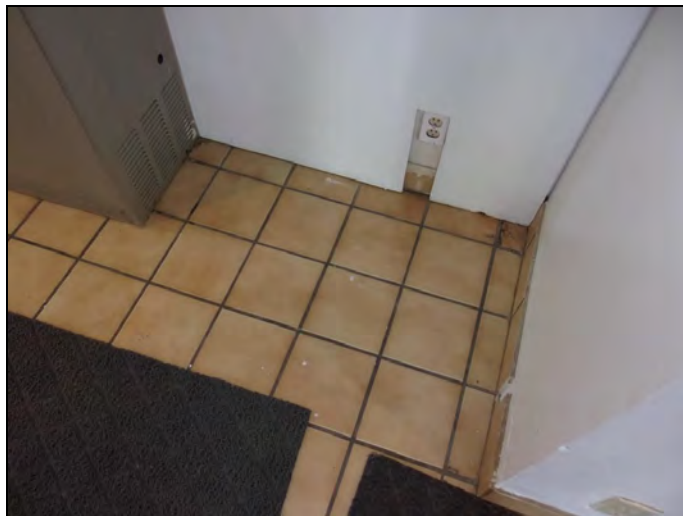
Comp #: 1503 Tile Flooring - Replace

The tile flooring is in good to fair condition. We recommend funding to replace this component approximately every 30 years. Remaining life based on current age and condition.

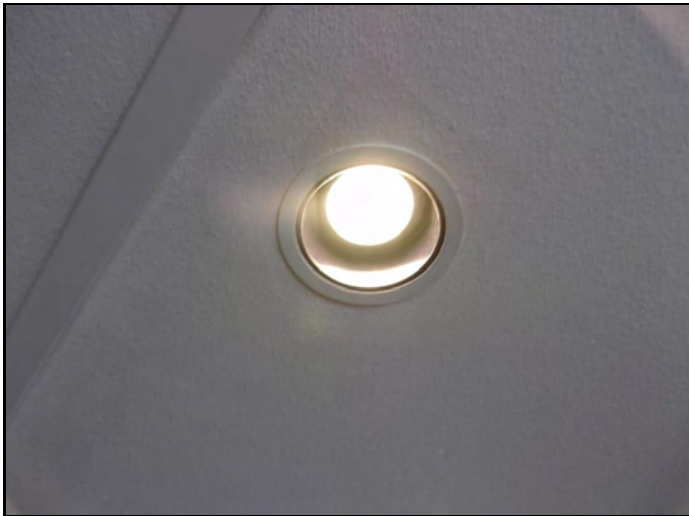
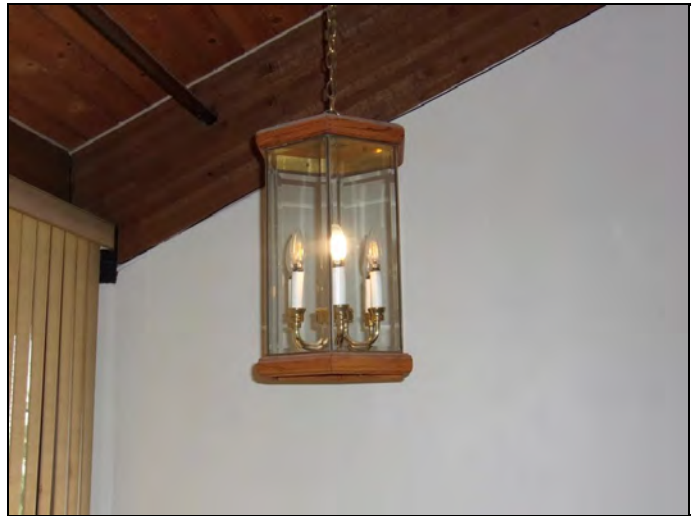
Comp #: 1601 Interior Light Fixtures - Replace

The interior light fixtures are in fair to poor condition. We recommend funding to replace this component approximately every 20 - 25 years. Remaining life based on current age and condition.

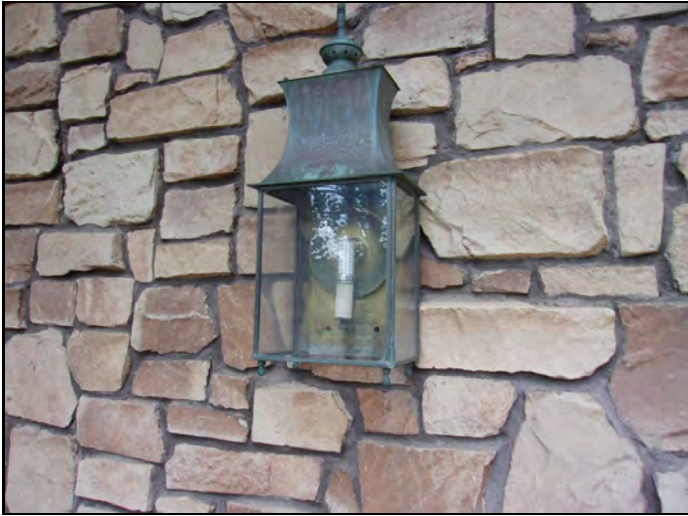
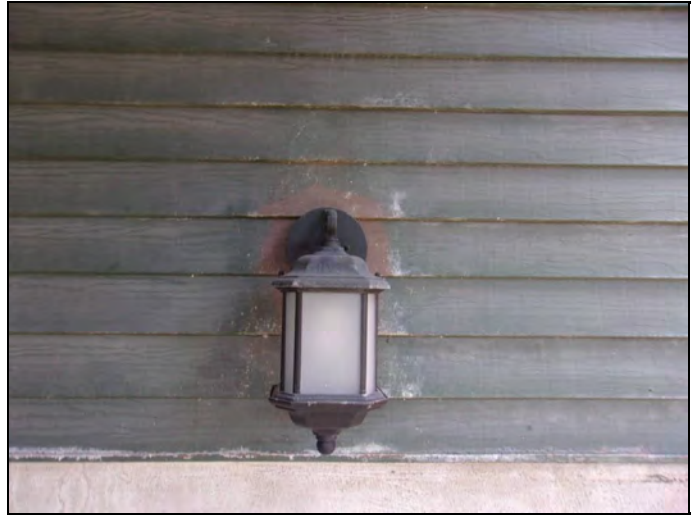
Comp #: 1602 Exterior Light Fixtures - Replace

The exterior light fixtures are in fair to poor condition. We recommend funding to replace this component approximately every 16 - 20 years. Remaining life based on current age and condition.

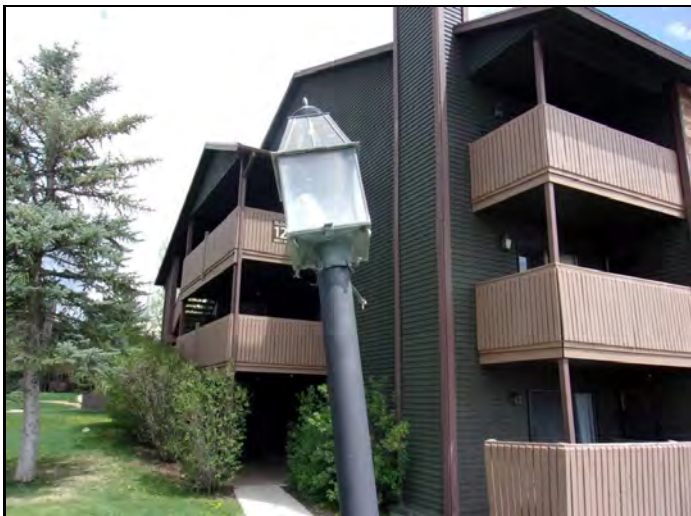
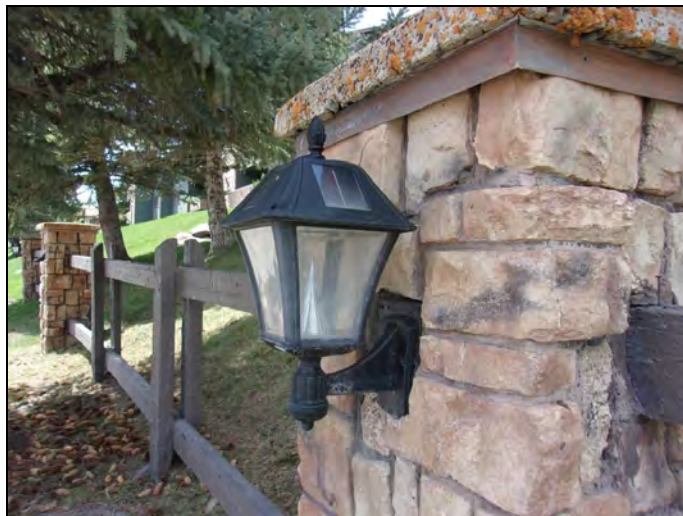
Comp #: 1604 Fence & Pole Lights - Replace

The pole lights are in fair to poor condition. We recommend funding to replace these pole light fixtures, poles and to refurbish the electrical approximately every 16 - 20 years. Remaining life based on current age and condition.

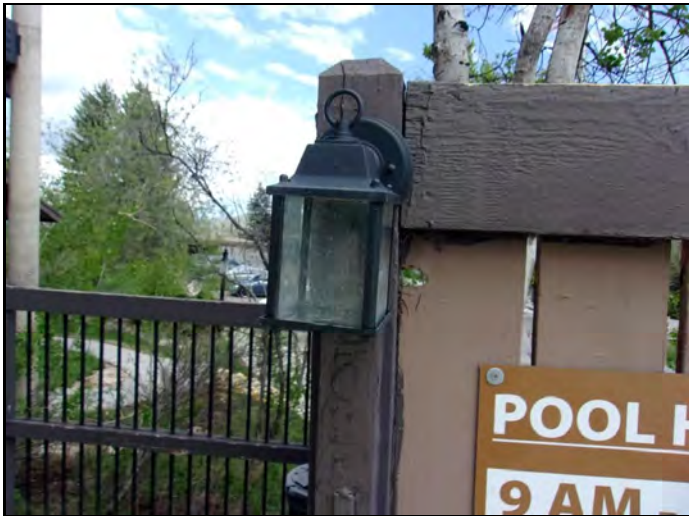
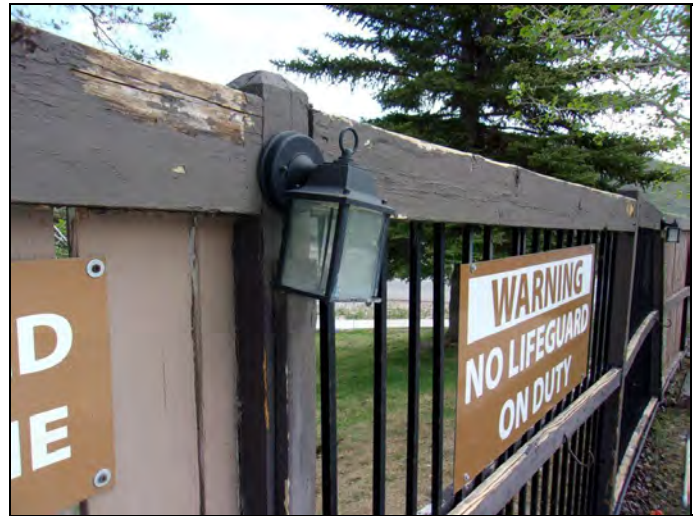
Comp #: 1605 Pool Lights - Replace

Location: **Pool Area**

Quantity: **(12) Pool Lights**

We recommend replacing this component with pole lights when the pool fencing is replaced. We recommend funding to replace these pole light fixtures, poles and to refurbish the electrical approximately every 16 - 20 years. Remaining life based on current age.

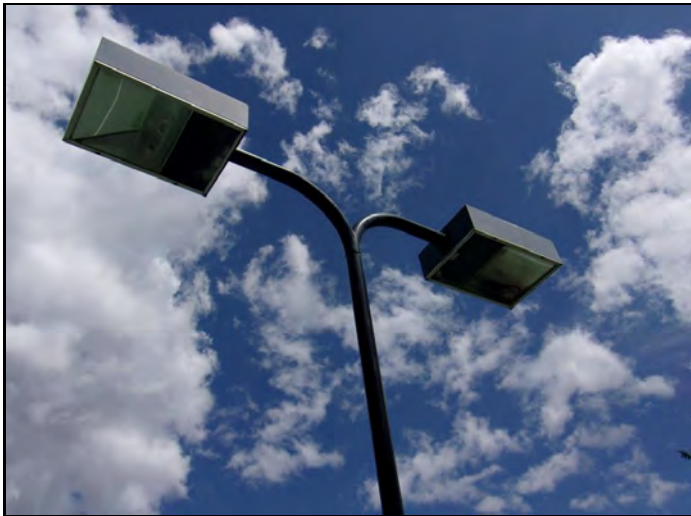
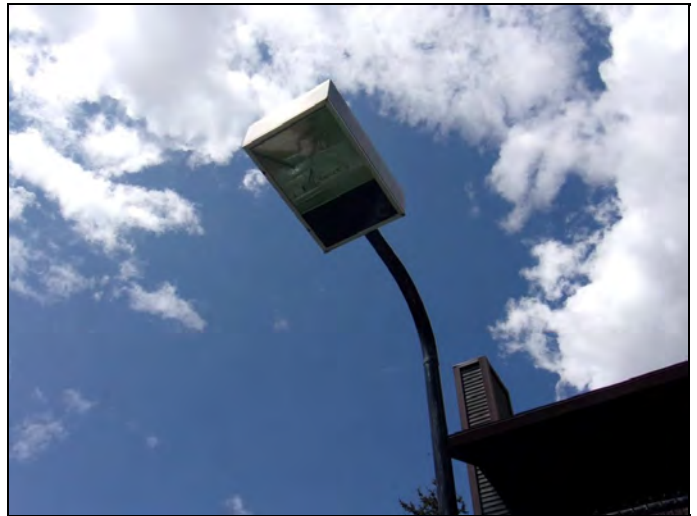
Comp #: 1606 Tennis Court Light Fixtures - Replace

Location: **Tennis Court**

The tennis court light fixtures are in working condition. No expectation to replace the light poles. Paint poles as necessary as an operating expense. We recommend funding to replace this component approximately every 20 years. Remaining life based on current age and condition.

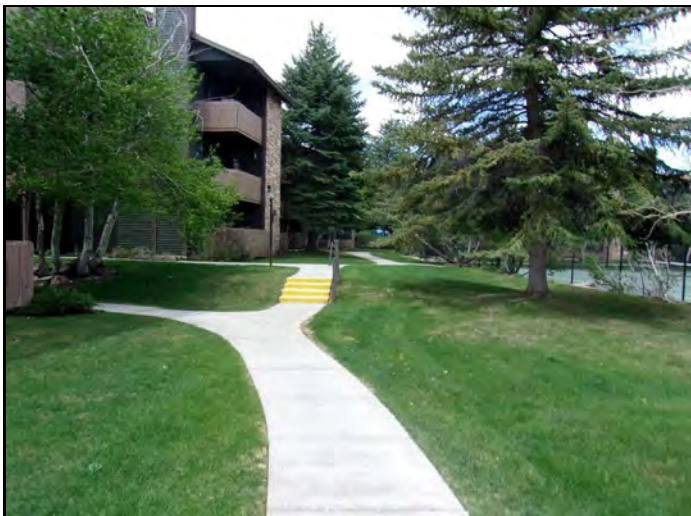
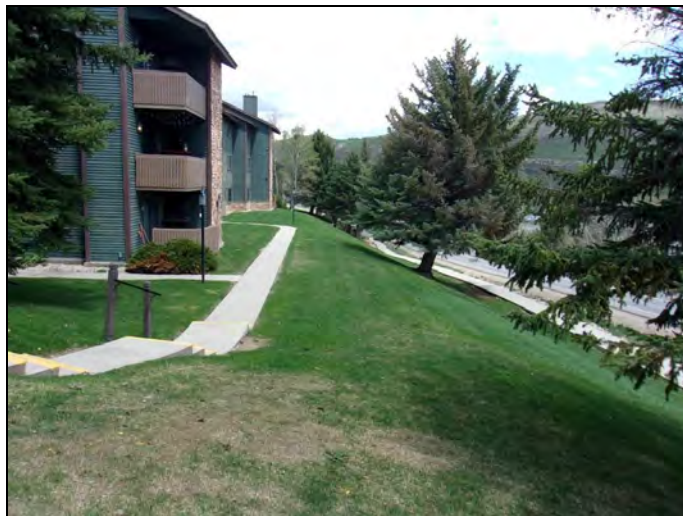
Comp #: 1812 Landscaping & Irrigation System - Renovate

Location: **Common Area**

The landscaping and irrigation system appear to be in fair condition. We recommend funding for an allowance to renovate this component approximately every 20 years. Remaining life based on current age and condition.

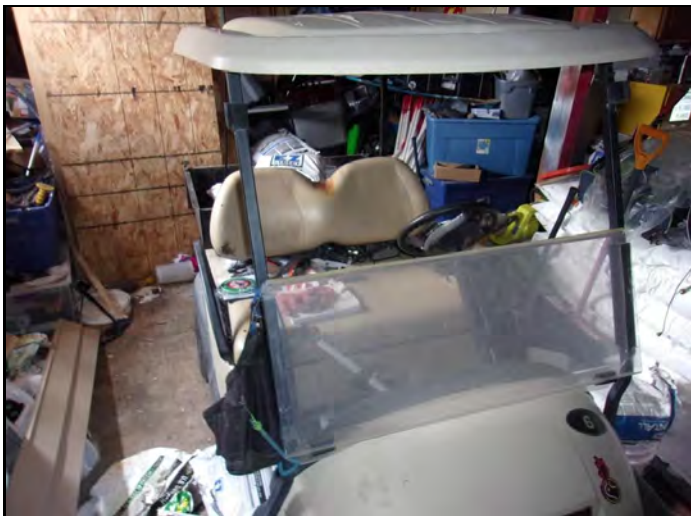
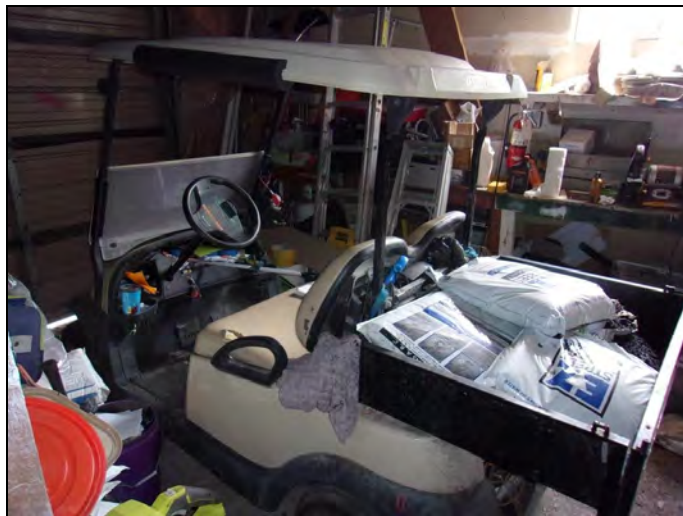
Comp #: 1902 Golf Carts - Replace

Location: **Maintenance Building**

The golf carts are in working condition. We recommend funding to replace this component approximately every 10 years. Remaining life based on average age.

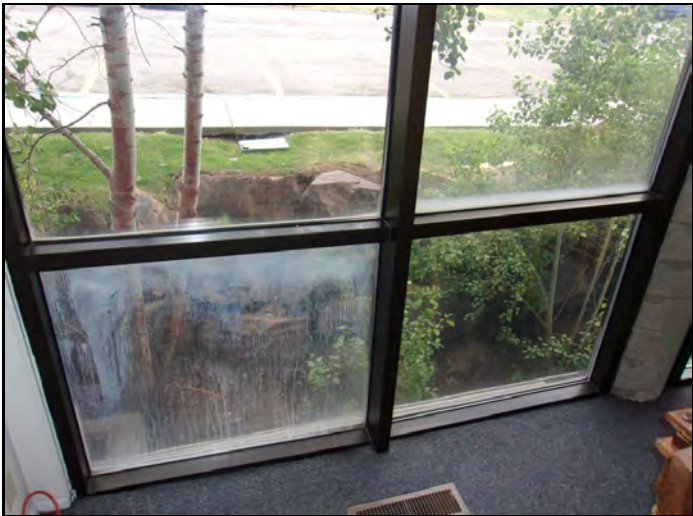
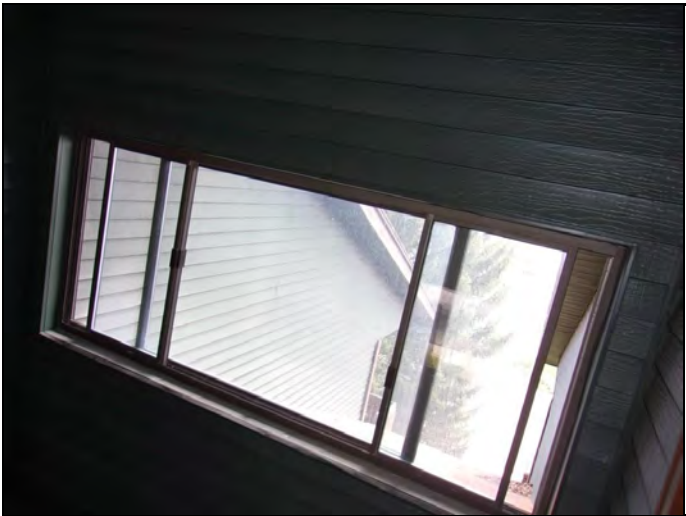
Comp #: 2303 Windows - Replace

Location: Clubhouse, Large Buildings, Maintenance

The windows are in good condition. We recommend funding to replace this component approximately every 40 - 50 years. Remaining life based on current age.

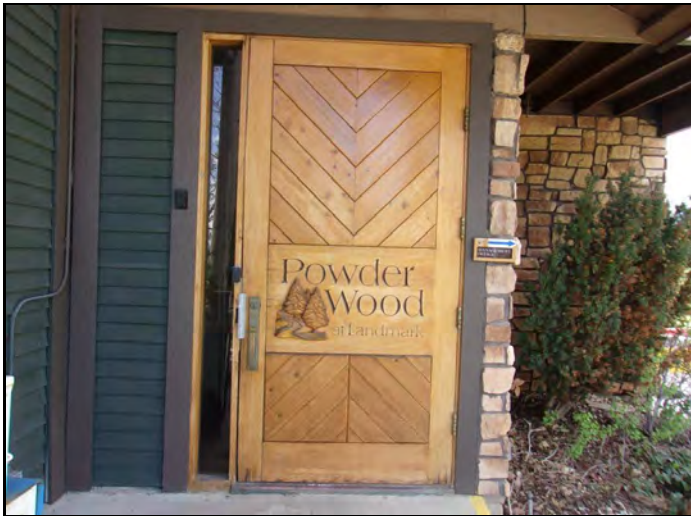
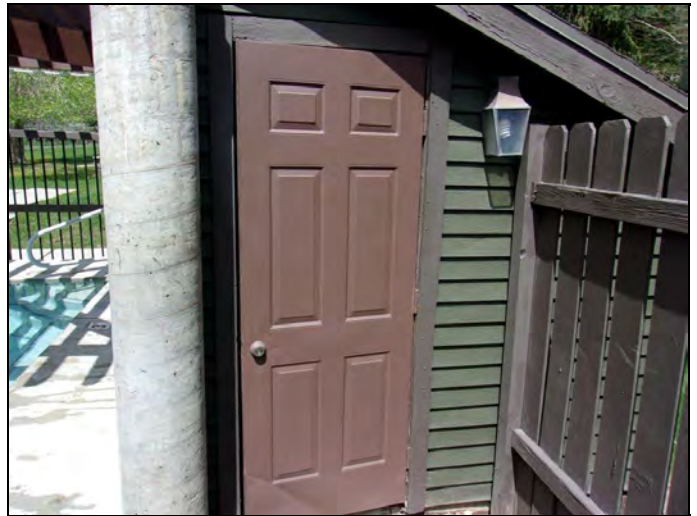
Comp #: 2304 Doors - Replace

Location: Clubhouse, Maintenance, Spa, Storage

The doors are generally in fair condition. We recommend funding to replace this component approximately every 40 - 50 years. Remaining life based on current age.

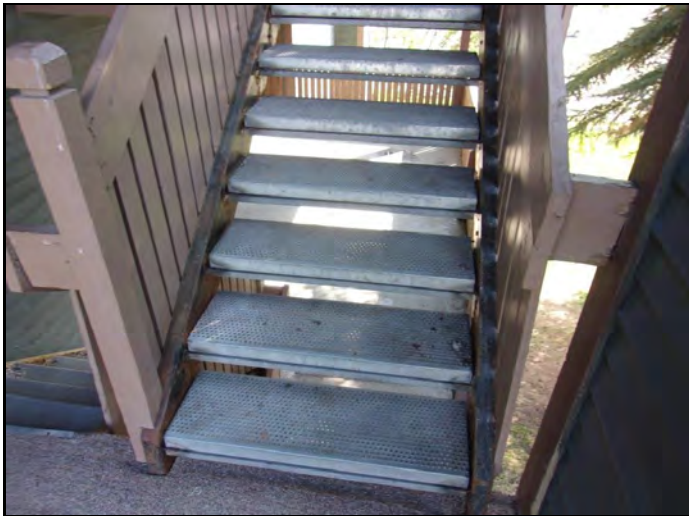
Comp #: 2306 Stair Stringers - 2019 - Replace

Location: **Building Exteriors**

Research with the client reveals this component is being partially replaced each year until they are all replaced. We recommend funding to replace this component approximately every 40 - 50 years. Remaining life based on current age.

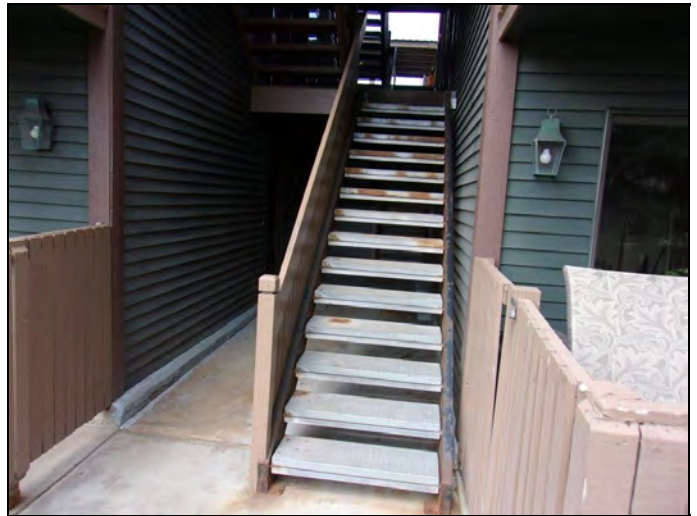
Comp #: 2306 Stair Stringers - 2020 - Replace

Location: **Building Exteriors**

Research with the client reveals this component is being partially replaced each year until they are all replaced. We recommend funding to replace this component approximately every 40 - 50 years. Remaining life based on current age.

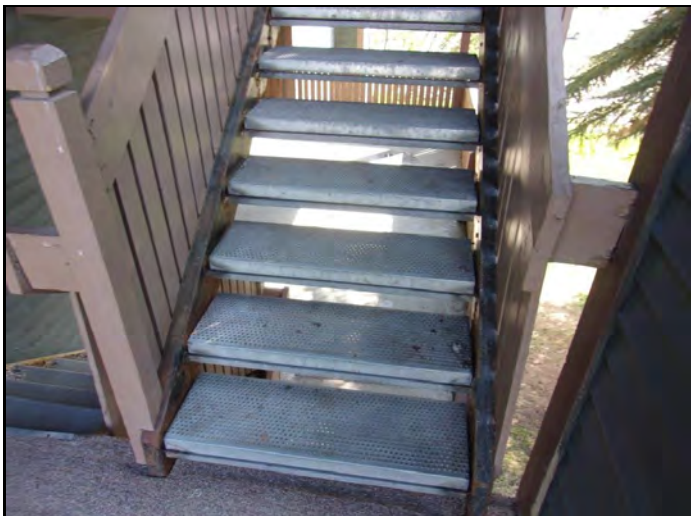
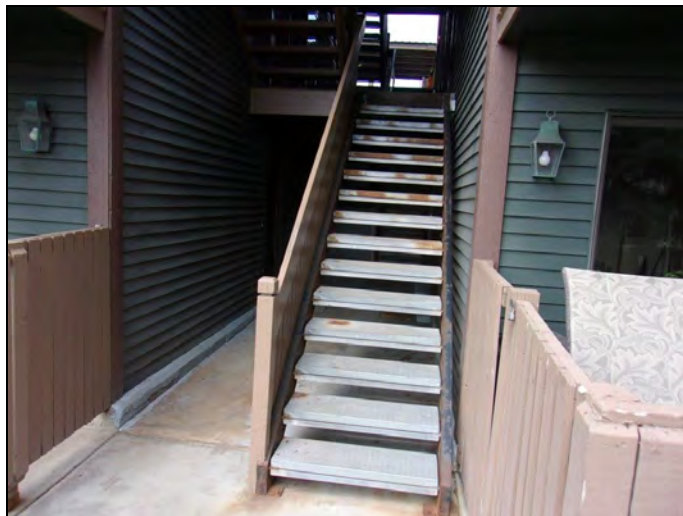
Comp #: 2306 Stair Stringers - 2021 - Replace

Location: **Building Exteriors**

Research with the client reveals this component is being partially replaced each year until they are all replaced. We recommend funding to replace this component approximately every 40 - 50 years. Remaining life based on current age.

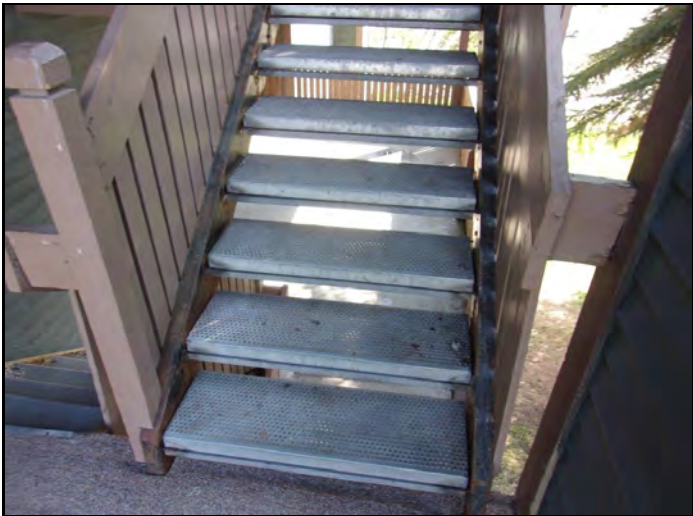
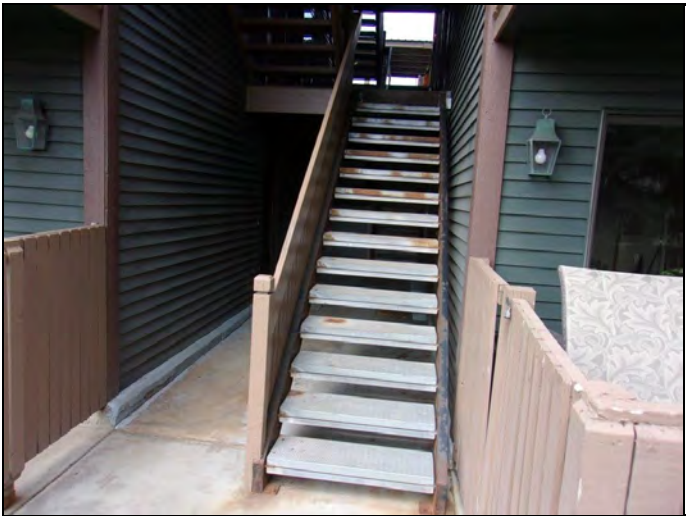
Comp #: 2306 Stair Stringers - 2024 - Replace

Location: Building Exteriors

Research with the client reveals this component is being partially replaced each year until they are all replaced. We recommend funding to replace this component approximately every 40 - 50 years. Remaining life based on current age.

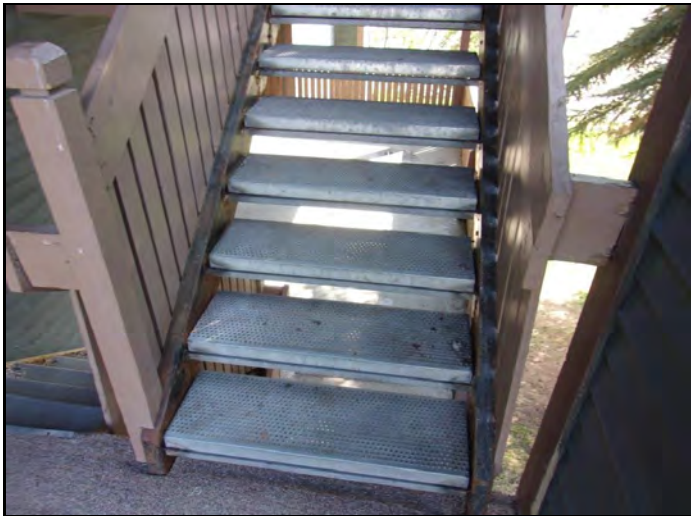
Comp #: 2306 Stair Stringers - 2029 - Replace

Location: **Building Exteriors**

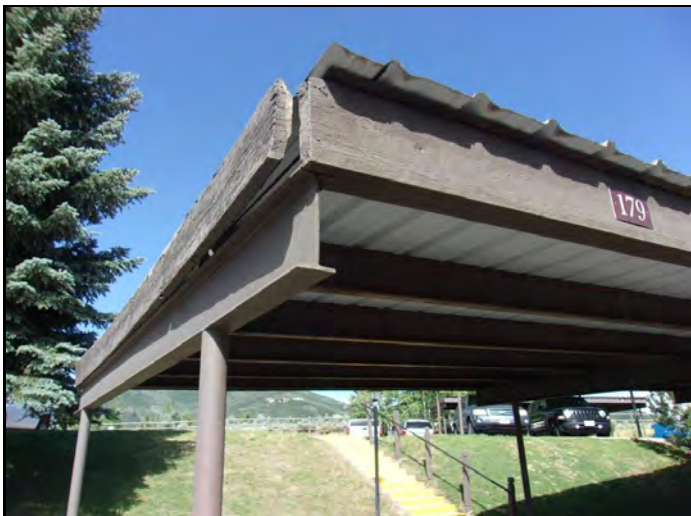
Comp #: 2307 Carport - Repairs

Location: **Common Area**
