# University of California San Diego Pedestrian Audit

Address: 9610 Scholars Dr N, La Jolla, CA 92092

Date: April 10, 2026

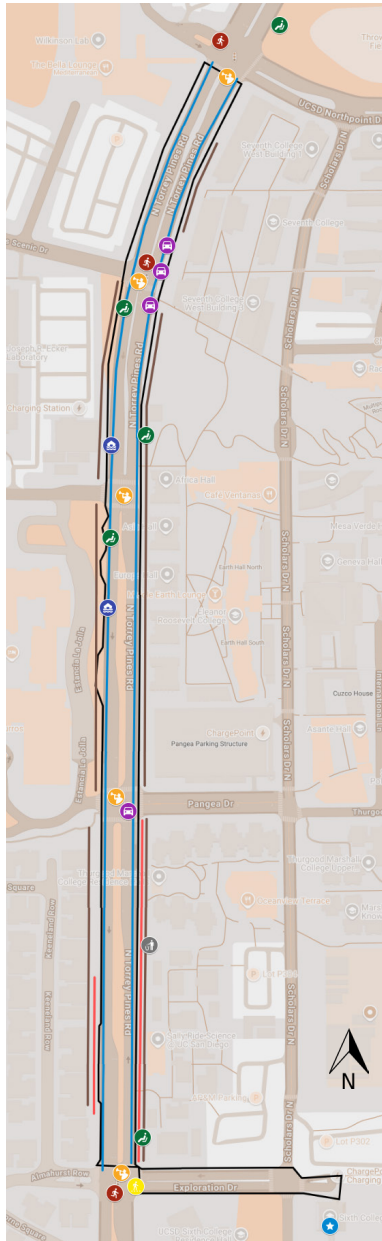
**FIGURE 2: UCSD PEDESTRIAN AUDIT RESULTS**

Throughout the pedestrian audit, participants observed multiple conflicts between drivers, pedestrians, and bicyclists along North Torrey Pines Road. Transit ridership was observed to be high, yet all bus stops along North Torrey Pines Road lacked shade, benches, or a trash can (Figure 2). At the start of the route, participants immediately identified several safety and accessibility concerns at the intersection of Exploration Drive and North Torrey Pines Road. Observations included the absence of audible push buttons, a faded crosswalk, a damaged sidewalk, and a lack of shade at the 101 bus stop (Figure 3). Participants noted that insufficient lighting along the full length of North Torrey Pines Road added to their walking concerns as well. In addition to the pedestrian infrastructure conditions, participants noted concerns regarding bicycle safety. Although a Class II bike lane runs along much of North Torrey Pines Road, drivers were observed speeding, encroaching into the bike lane, and stopping within it at the intersection of Torrey Pines Scenic Drive and North Torrey Pines Road (Figure 4). This intersection has no right turn lane. Survey participants noted that the vehicular speeds made them uncomfortable and noticed driver behaviors such as running red lights or parking violations while traveling on North Torrey Pines Road. The group discussed potential improvements to address these issues, including the installation of bollards or concrete barriers to physically protect the Class II bike lane, pedestrian-scale lighting along North Torrey Pines Road to improve visibility, and the addition of a new pedestrian crossing at Torrey Pines Scenic Drive.

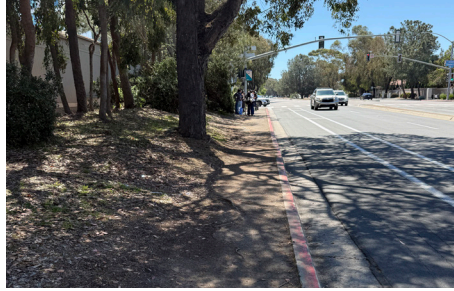
**FIGURE 3: AN UNEVEN SIDEWALK, A LACK OF LIGHTING, AND THE 101 BUS STOP LACKING AMENITIES BY EXPLORATION DRIVE AND NORTH TORREY PINES ROAD.**

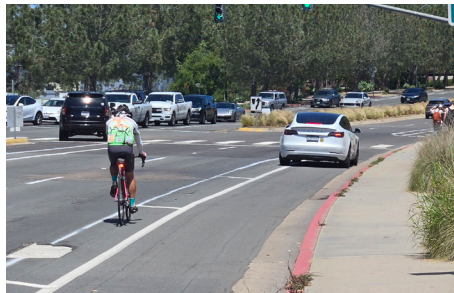
**FIGURE 4: DRIVER WAS OBSERVED ENCROACHING OVER THE BICYCLE LANE, AND THE CYCLIST MERGED ON TO THE TRAVEL LANE. THE POSTED SPEED LIMIT IS 45 MILES PER HOUR.**
