Improving Walkability in San Ysidro

Casa Familiar and the City of San Diego

June 2005

IMPROVING WALKABILITY IN SAN YSIDRO

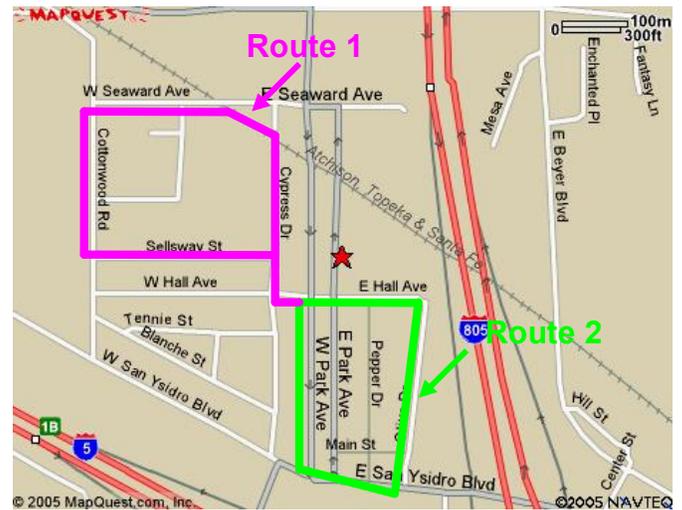
Participants were divided and led on a walk audit of two important routes along the Pathways of Knowledge - the walk to the Trolley and through highly used alleys and the walk to the Recreation Center and San Ysidro Boulevard (though the Blvd. was not specifically audited as part of this project). Participants pointed out the safety and access barriers they and their children face along each of these routes and then identified which problems they see as priorities for improvements. The starting point for each of the walks was the Casa Familiar Recreation Center at 212 East Park Avenue.

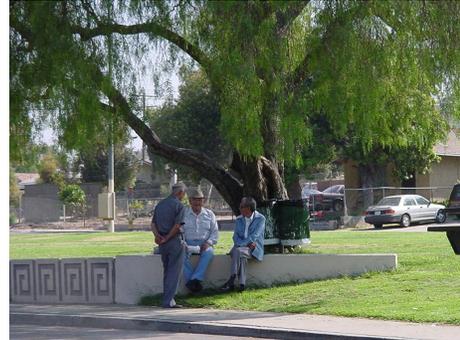
This area is used by children and the area's seniors – gathering to catch-up on the day's events.
